TITLE : AIR CONDITIONING - PRESSURIZATION CONTROL - MODIFICATION OF PIN
PROGRAMMING TO DISABLE USE OF EXTERNAL MODE (RETRO SOLUTION)

MODIFICATION No. : 32221K7821

SERVICE BULLETIN No. : A320-21-1138

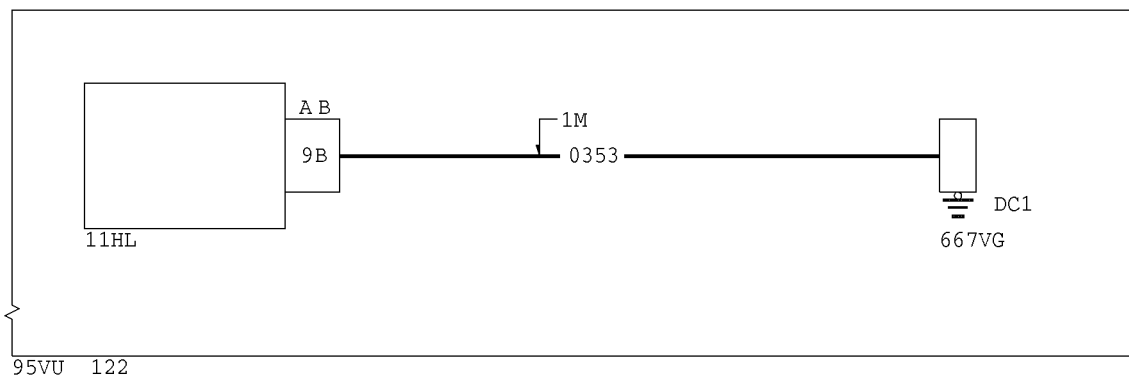
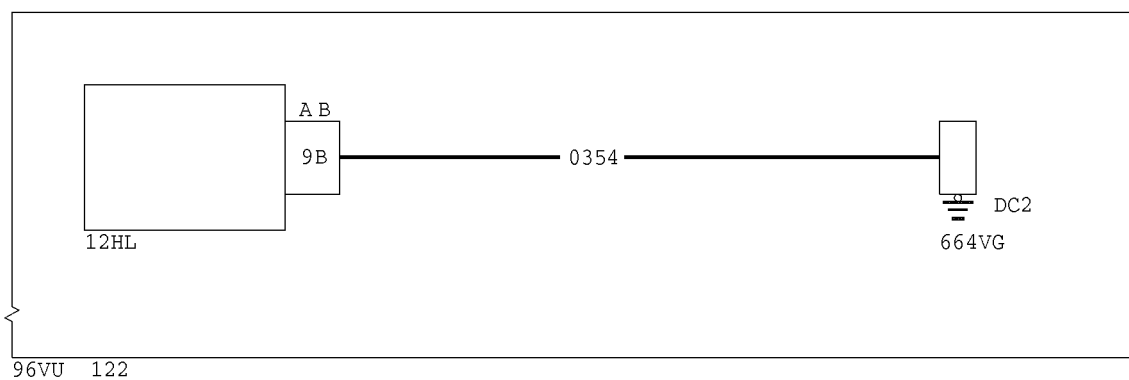
Figure 1 Sheet 1
 Modification of the Wiring in 90VU

Operators have reported cases of cabin pressure fluctuation during the climb and descent phase. Investigations have shown Cabin Pressure Controller (CPC) mode switching between internal and external modes which results in cabin pressure rate schedule changes. CPC switching is caused by a temporary loss of FMS data which is normal during manual updating of the system in flight.

- (1) Modify the wiring in the shelf 95VU.
Refer to Figure 1
Refer to Figure 2

- (f) On the electronics rack 90VU, remove and retain the shelf 95VU and its fasteners.
- (g) Install the wire shown on the line 1, refer to Figure 2 , supplied in :
