SERVICE BULLETIN CHANGE NOTICE

S.B. No. A320-21-1018

TITLE: AIR CONDITIONING - DELETE BILGE AIR INTAKE

T I T L E : AIR CONDITIONING - DELETE BILGE AIR INTAKE

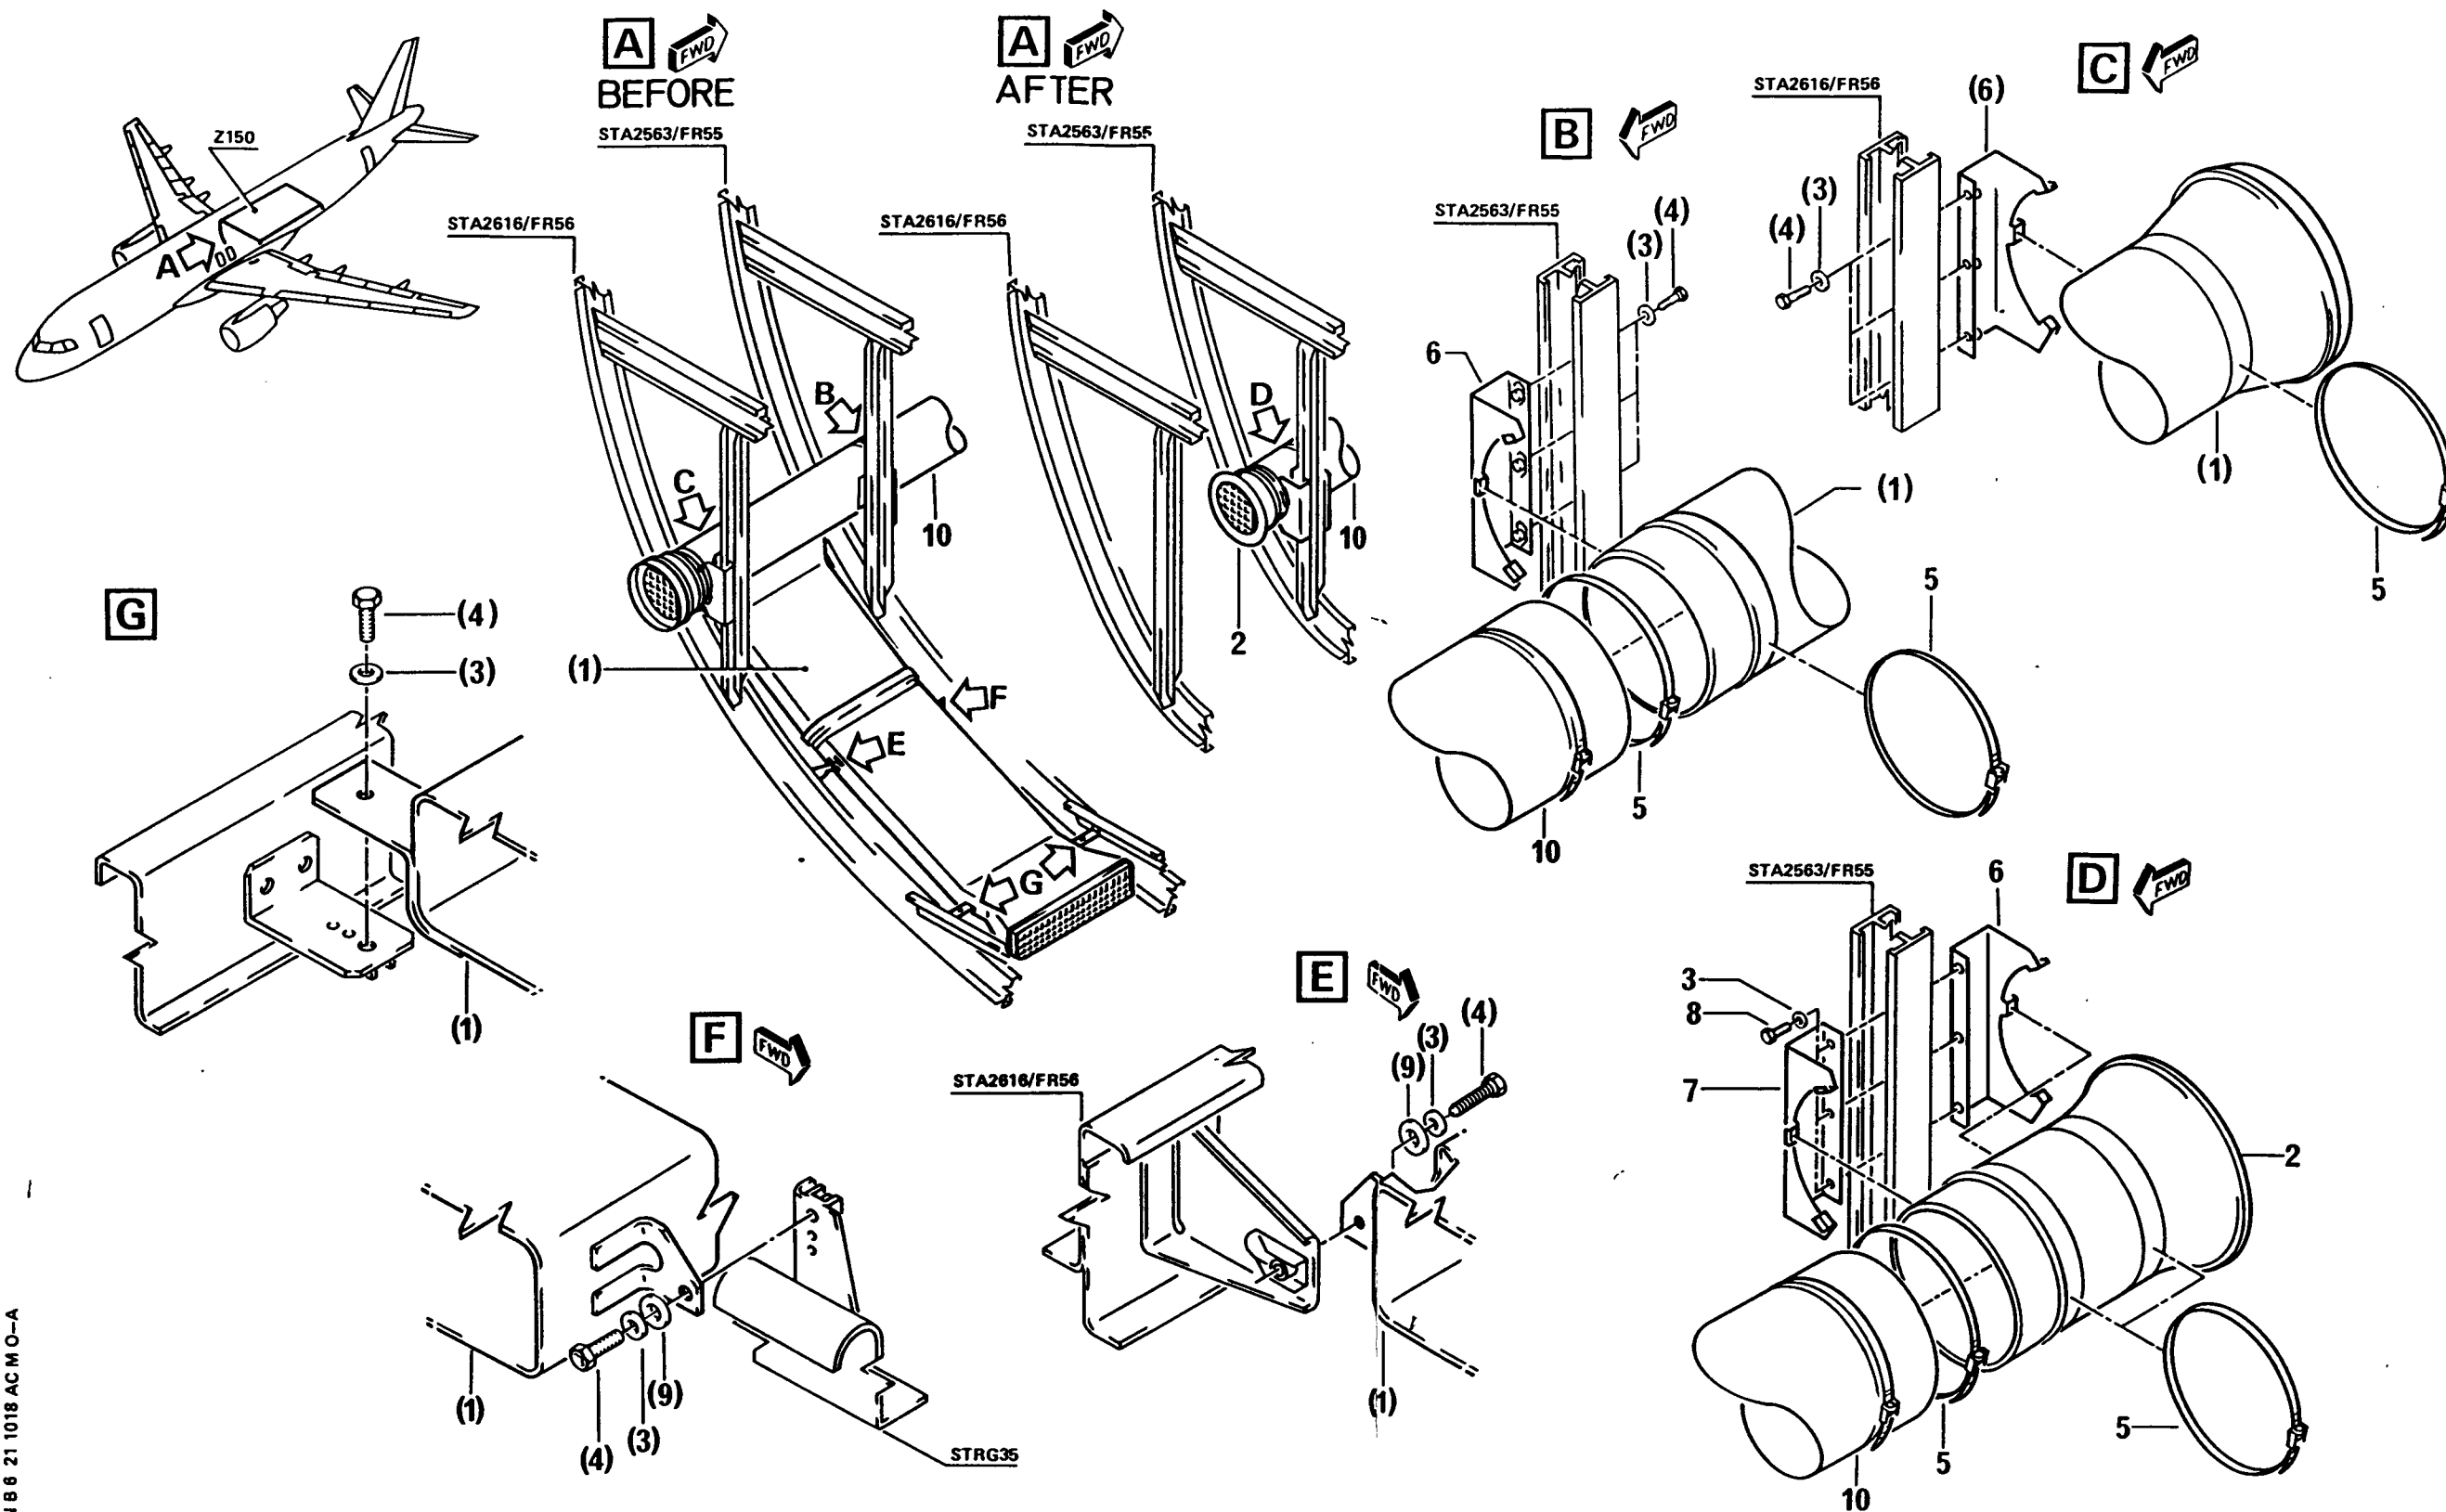
Deletion of the Inlet Funnel
Figure 1

Flight test results show extreme low bilge temperature resulting into low ventilation inlet temperature.

To avoid low ventilation inlet temperature, resulting in a too low cargo compartment temperature, this Service Bulletin proposes to delete the bilge air intake.

(1) Removal of the Inlet Funnel, item (1)

- 4 screws item (4) (discard),
- 4 washers item (3) (discard),
- 2 washers item (9) (discard).

(d) Remove the inlet funnel, item (1) (discard).

(2) Removal of the Brackets, item 6

- 3 screws item (4) (discard),
 - 3 washers item (3) (discard),
 - 1 bracket item (6) (discard),
- as shown in detail C.

- 3 screws item (4) (discard),
 - 3 washers item 3 (retain),
 - 1 bracket item 6 (retain),
- as shown in detail B.

(3) Installation of the Brackets, items 6 and 7

- 1 retained bracket, item 6,
 - 1 bracket D2127349720000, item 7,
 - 3 retained washers, item 3,
 - 3 screws NAS1096-3-8, item 8,
- as shown in detail D.

(4) Install the inlet funnel D212725370000, item 2, on the tube, item 10, with the retained clamp, item 5.

(5) Install the inlet funnel, item 2, on the brackets, items 6 and 7, with the 2 retained clamps, item 5.
