**TITLE: AIR CONDITIONING - CONDITIONED SERVICE AIR SYSTEM (CSAS) -
INSTALLATION OF IMPROVED CSAS CONTROL UNIT (CCU)**

This page transmits Revision No.01 of Service Bulletin No.A320-21-1196

SERVICE BULLETIN No.: A320-21-1196

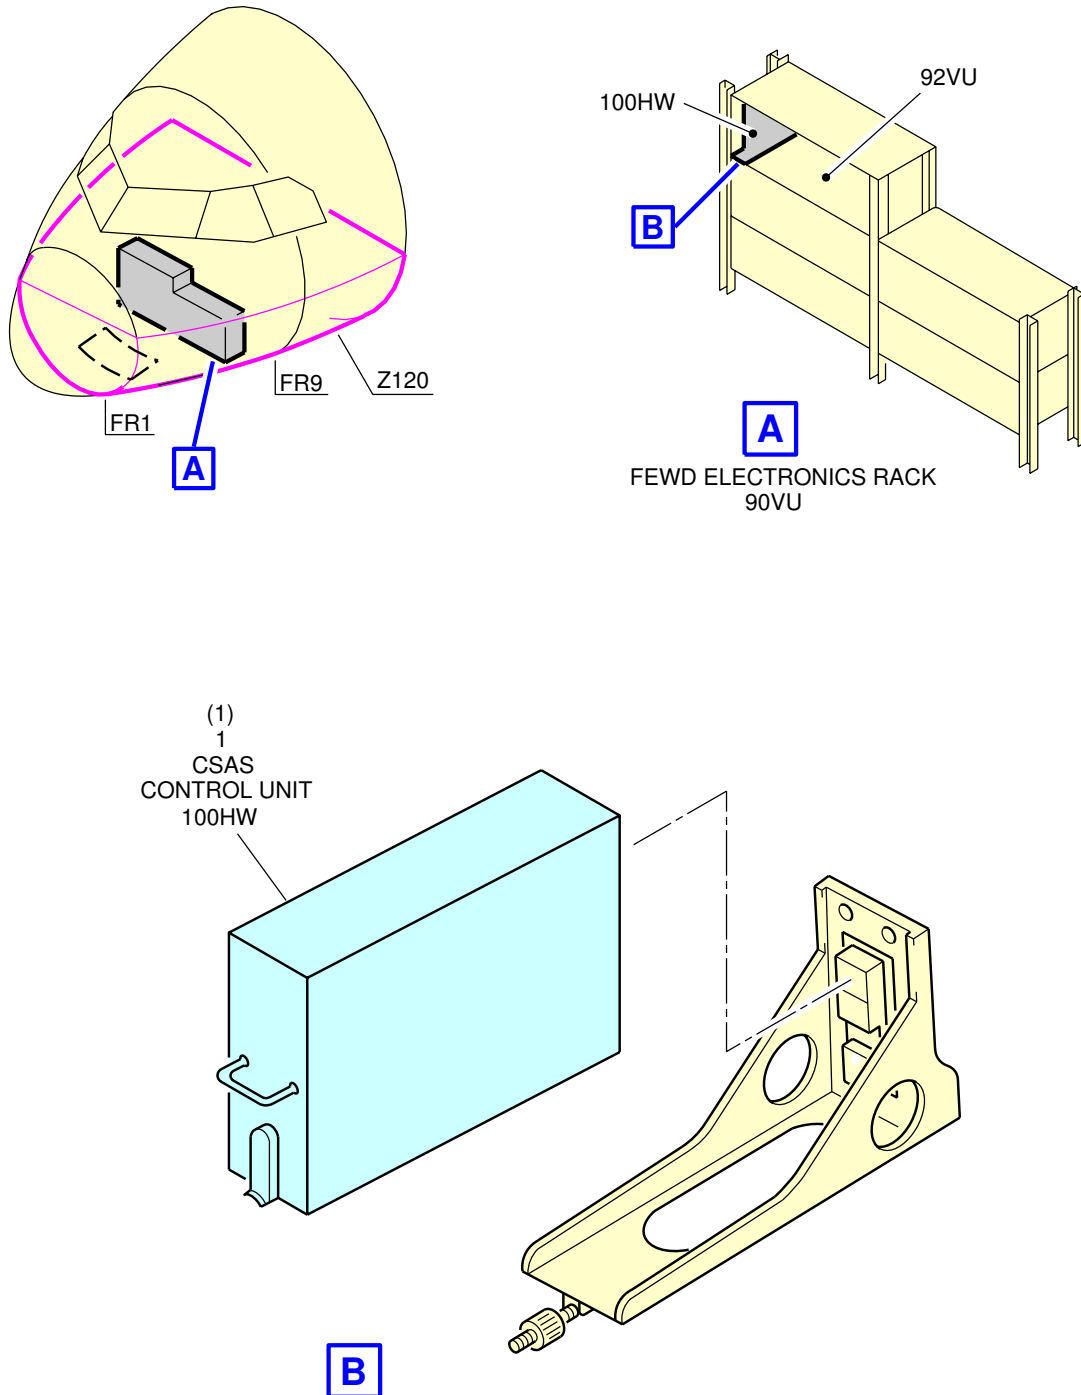
Figure A-GBAAA - Sheet 01
Replace the CSAS Control Unit

In-Service experience has identified some deviations in the Conditioned Service Air System (CSAS) software PN 3959A0000K03.

- CSAS Control Unit does not calculate the value for CSAS_GO during power up.
- Fuel Tank Interting System (FTIS) creates inconsistent failure reports.

- (a) Remove (Refer to AMM Task 21-58-34-000-001) and [Fig. A-GBAAA Sheet 01](#):

1 Controller-CSAS 3959A0000K03 Item (1)

- (b) Send the CSAS Control Unit for modification to LIEBHERR AEROSPACE TOULOUSE SAS (Refer to LIEBHERR AEROSPACE Service Bulletin No.3959A-2101).

- (c) Install (Refer to AMM Task 21-58-34-400-001) and [Fig. A-GBAAA Sheet 01](#):

1 Controller-CSAS 3959A0000K04 Item 1
