S.B. No. A320-21-1007

Mod. No. 21062/K1048

TITLE: AIR CONDITIONING - AIR GENERATION - MODIFY AIR CONDITIONING PACK

SERVICE BULLETIN NO: A320-21-1007
CHANGE NOTICE NO: 0A

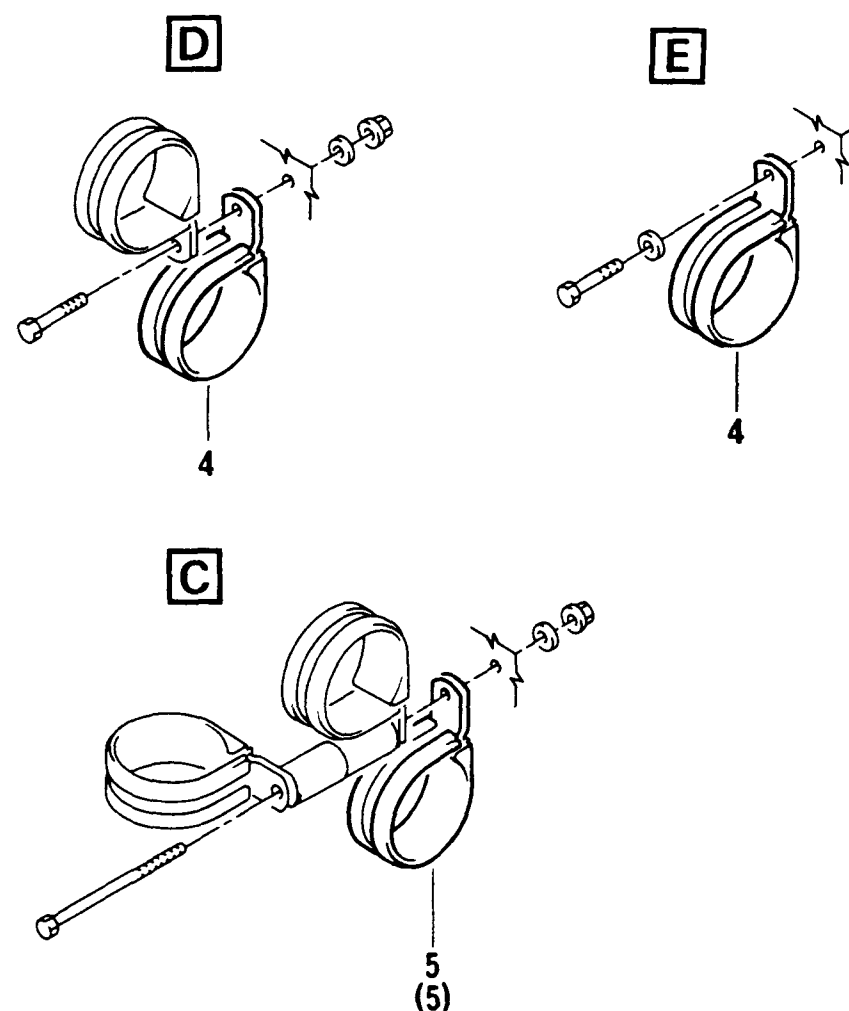
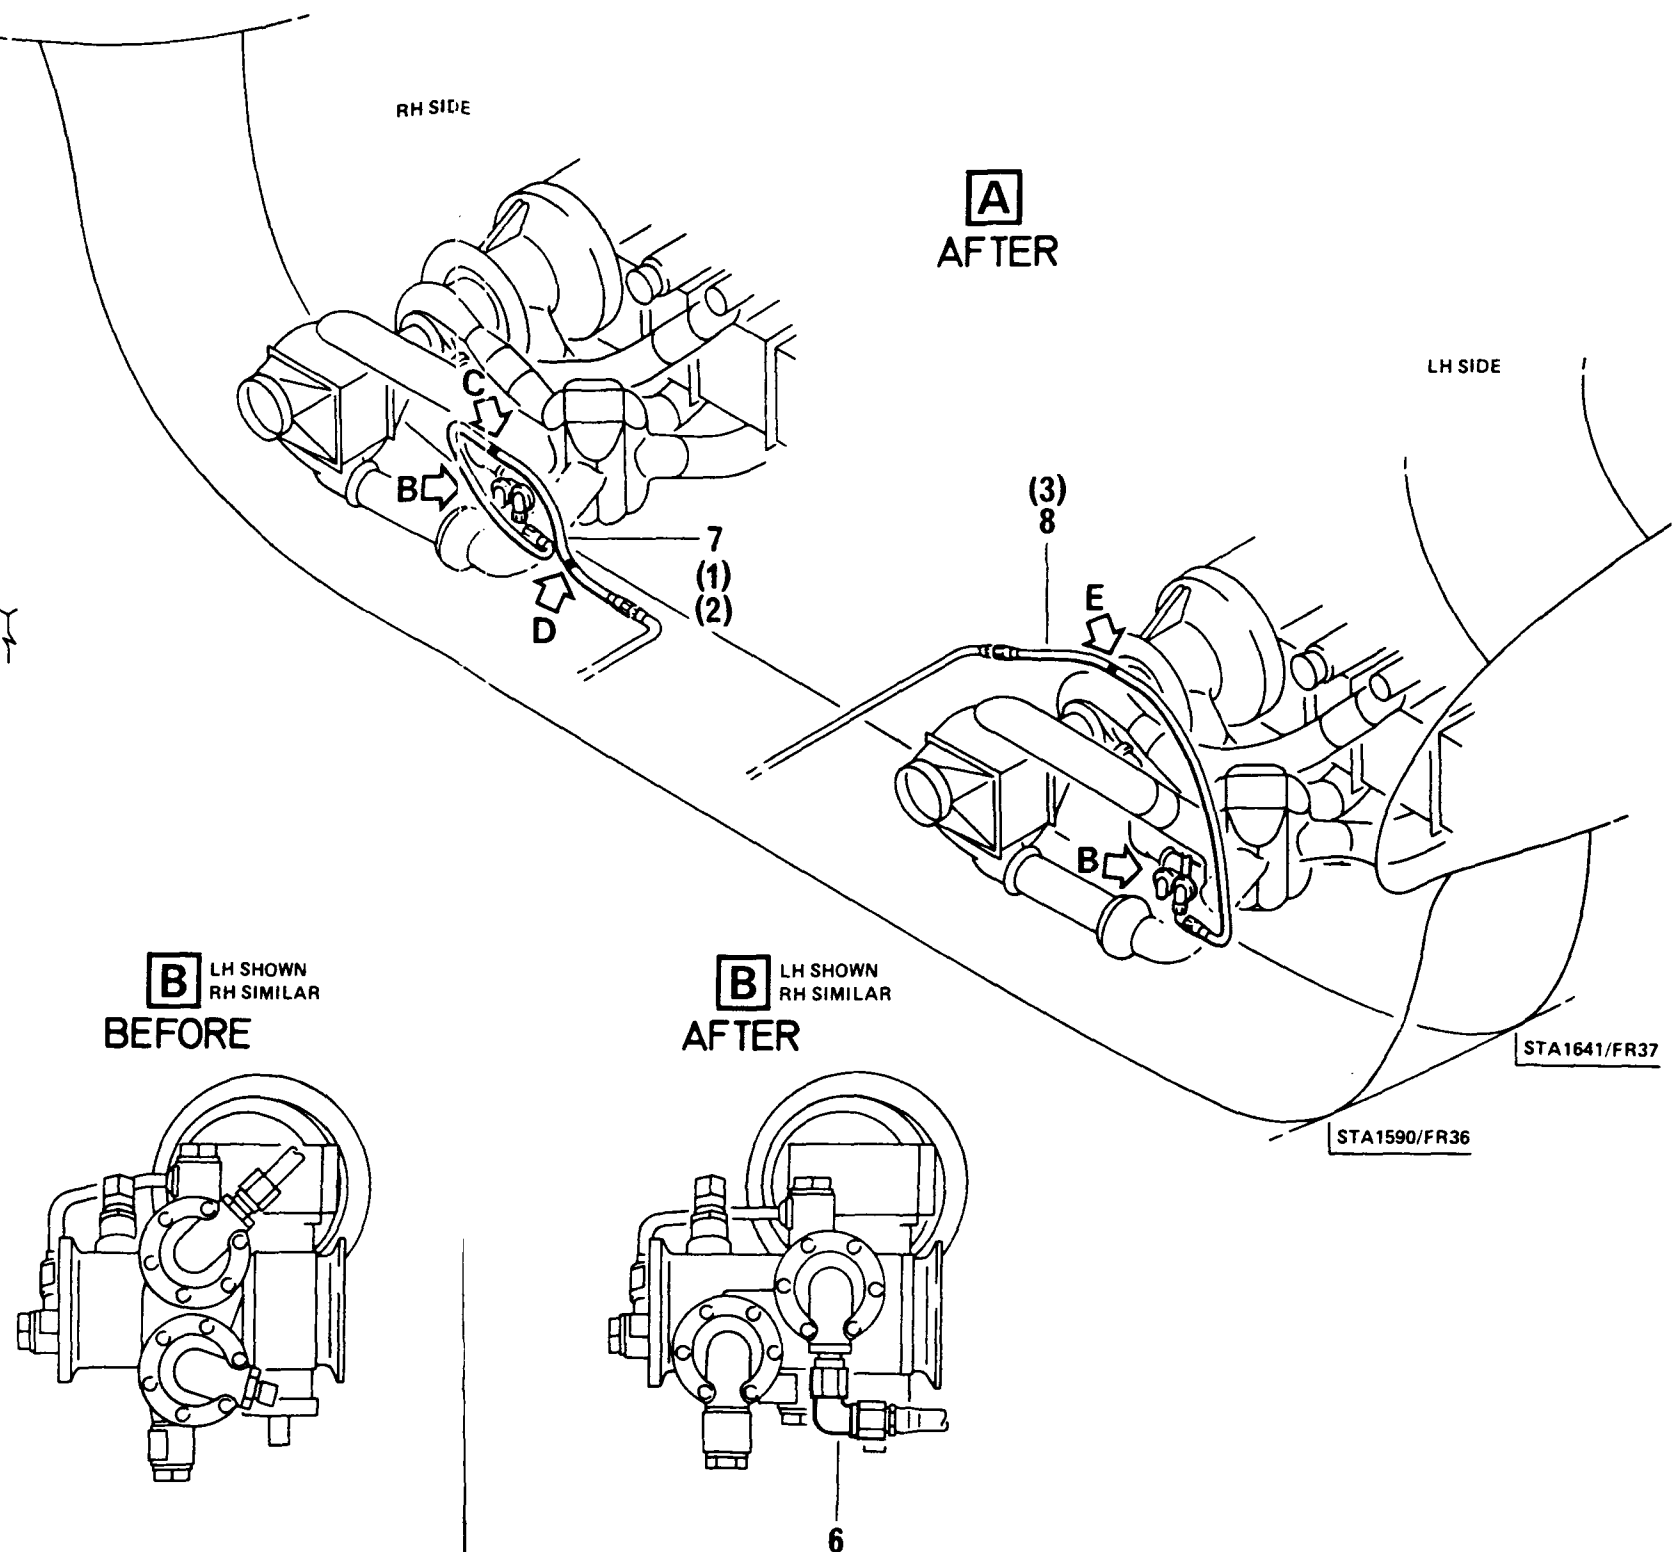
Replacement of Hoses and Pipe with
Hoses and Elbows to the Anti-icing Valves
Figure 1

- (12) Remove hoses and pipe items (1), (2) and (3) between the anti-icing valves LH and RH and existing pipes (Refer to Figure 1).
 - (a) Remove the clamps, items 7 and (5) from hoses, item (2) and (3) and pipe, item (1).
 - (a1) Retain the hardware and the clamps, item 4, discard the clamp, item (5).
 - (b) Remove and discard following parts:
 - 2 hoses, item (2) and (3)
 - 1 pipe, item (1)
- (13) Replace pipe assemblies which are specified in the LIEBHERR ABG-SEMCA Service Bulletin No. 748A-21-01.
- (14) Install hoses items, 7 and 8 and elbows, item 6, to the anti-icing valves LH and RH and to the existing pipes (Refer to Figure 1).

- (a) Install to each anti-icing valve:
 - 1 elbow, NSA855120-6C, item 6.
- (b) Install to the elbow, item 6 of the RH anti-icing valve and to the existing pipe:
 - 1 hose 02157143703400, item 7.

- (c) Install to elbow, item 6 of the LH anti-icing valve and to the existing pipe:
1 hose D2157143703200, item 8.
- (d) Install the retained clamps, item 4, and 1 new clamp NSA5516-13NJ, item 5, to the new installed hoses, use the retained hardware.
- (15) Remove the pack outlet pneumatic sensors 10HM10 (11HM10), (Refer to AMM 21-61-19, P. Block 401).
- (16) Install the pack outlet pneumatic sensors 10HM10 (11HM10), which have a reduced setting as referred to in the LIEBHERR ABG-SEMCA Service Bulletin No. 767A-21-01. (Refer to AMM 21-61-19, P. Block 401).
- (17) Reidentify air conditioning pack as per Para. 3.C.

NOTE: For installation of hoses and elbows use sealant Mat. No. 09-016.

NOTE: ALL ITEMS IN BRACKETS ARE TO BE DISCARDED
