Number: 737-24-1206
Original Issue: April 03, 2014
ATA System: 2400

SUBJECT: ELECTRICAL POWER - General - E8-1 Shelf Assembly - Vinyl Marker Replacement

BOEING SERVICE BULLETIN 737-24-1206

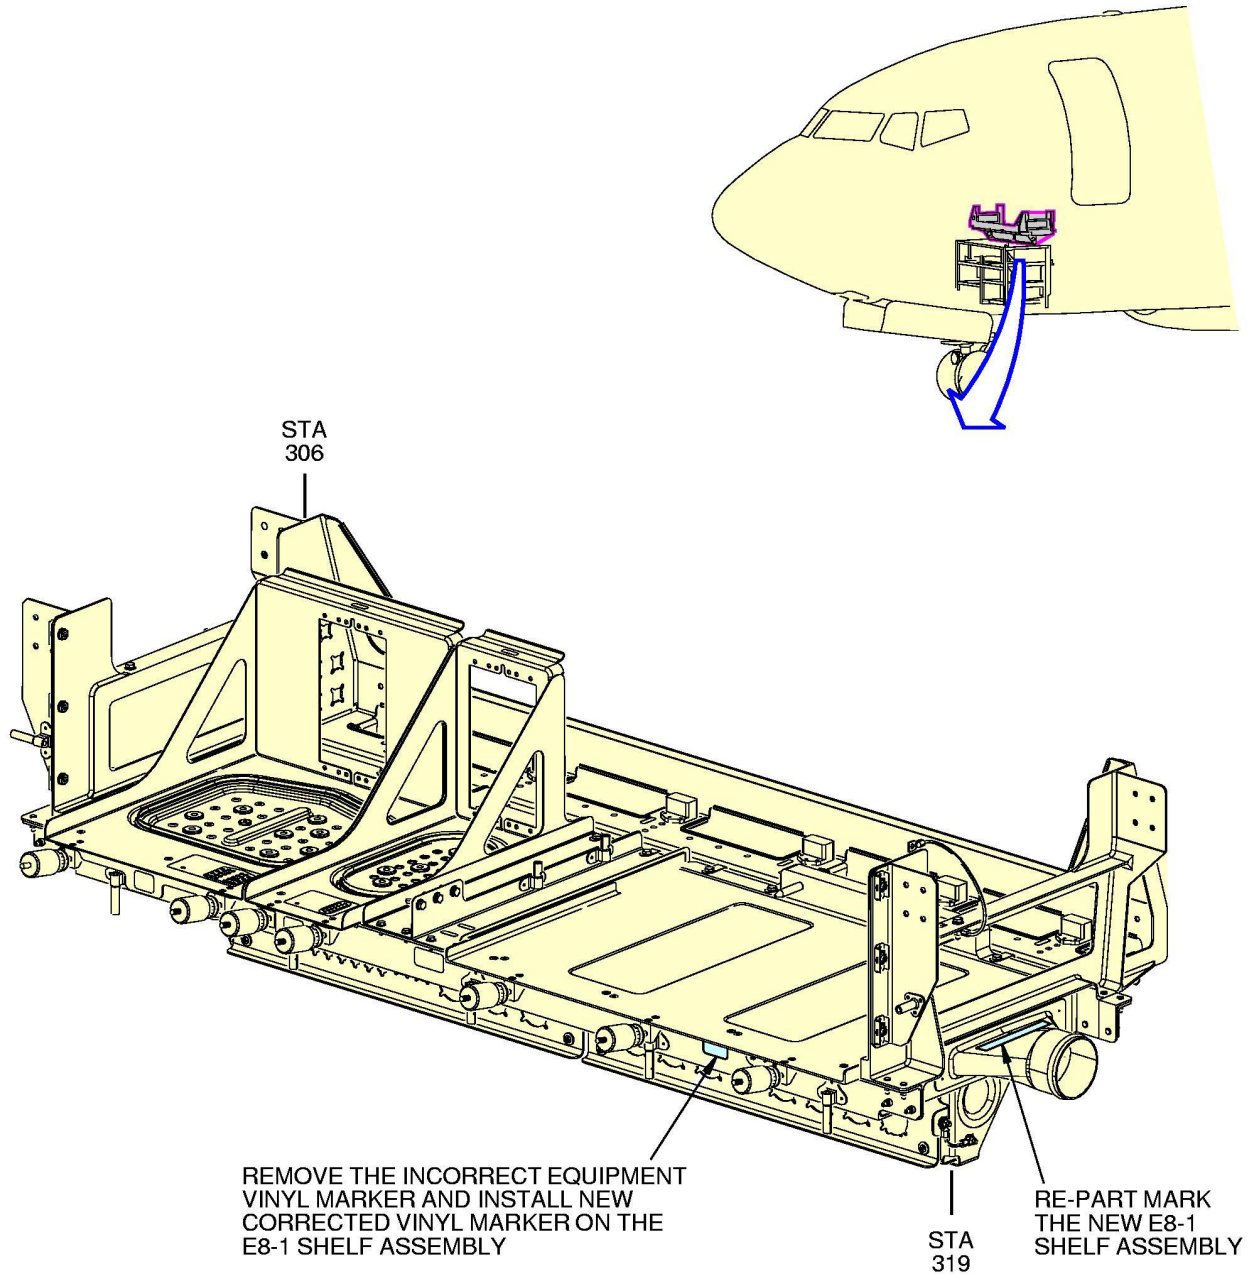
**E8-1 ELECTRONICS SHELF
(TYPICAL)**

This service bulletin gives instructions to replace a vinyl marker on the E8-1 shelf assembly (located in the electrical/electronics compartment above the E1 Rack). The marker shows an incorrect electrical equipment item number and is not in accordance with airplane schematics. If the change given in this service bulletin is not done, misidentified equipment could cause potential damage to the airplane and injury to personnel.

There has been an operator report of the incorrect equipment marker on the right side of the E8-1 shelf assembly in the electrical/electronics compartment above the E1 Rack.

Open access to the electrical/electronics compartment. Remove the incorrect equipment vinyl marker. Install the new corrected vinyl marker. Re-part mark the new E8-1 shelf assembly.

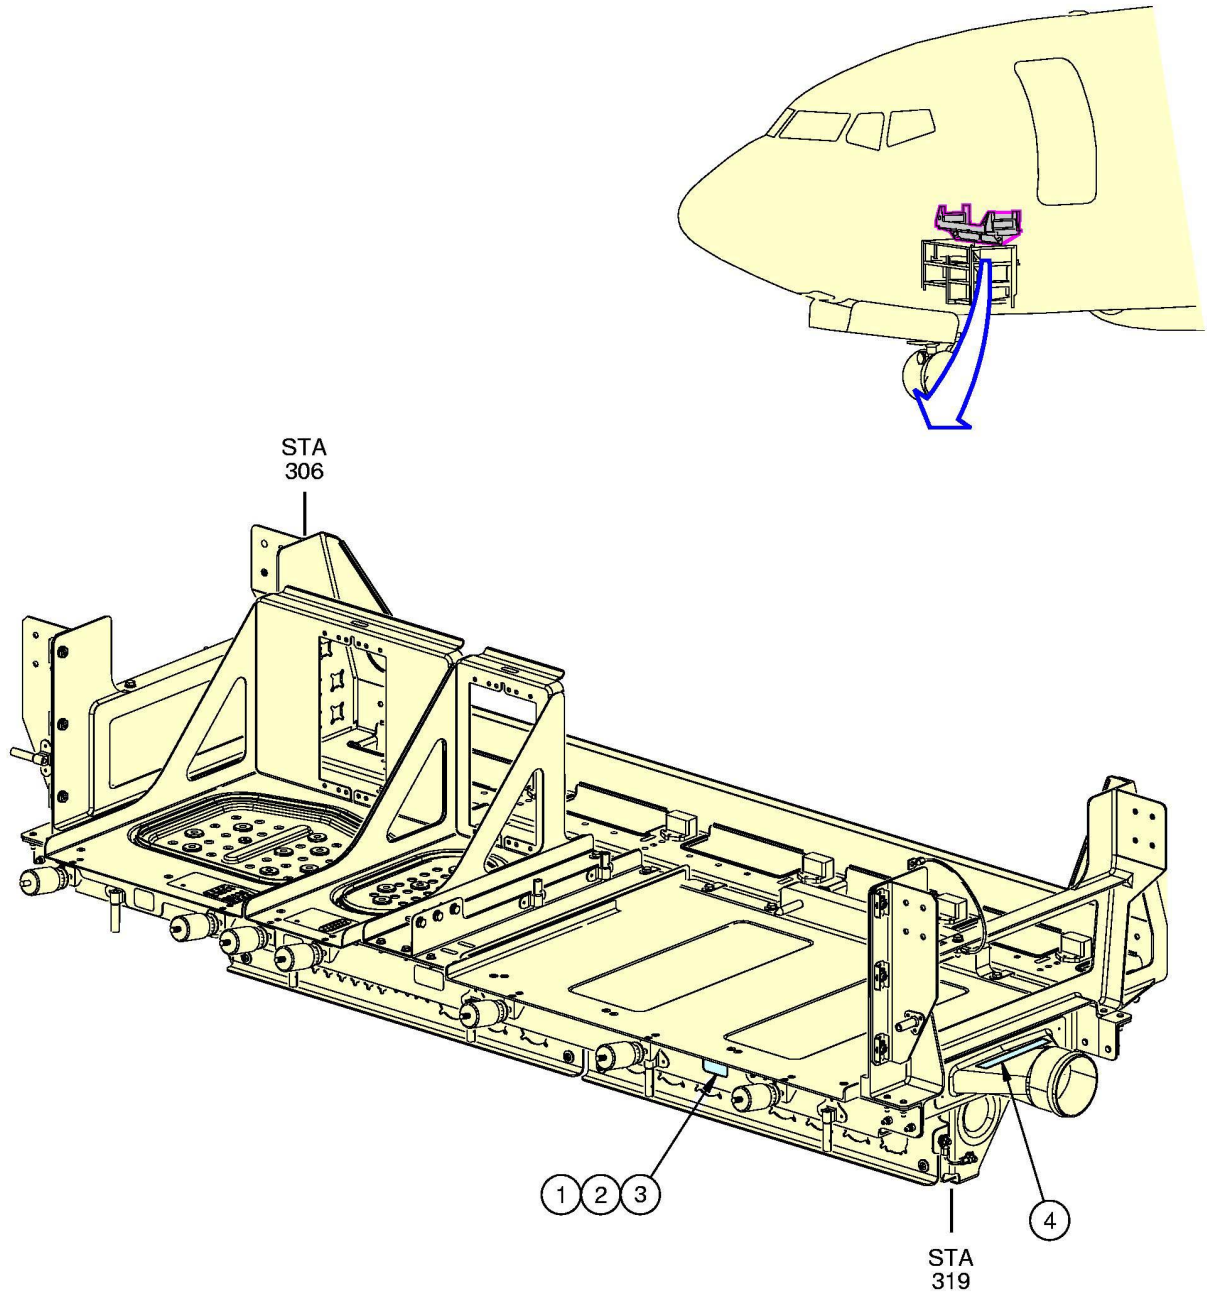
**FIGURE 1: REPLACEMENT OF THE E8-1 SHELF ASSEMBLY VINYL MARKER
(SHEET 1 OF 2)**

This service bulletin gives instructions to replace a vinyl marker on the E8-1 shelf assembly (located in the electrical/electronics compartment above the E1 Rack). The marker shows an incorrect electrical equipment item number and is not in accordance with airplane schematics. If the change given in this service bulletin is not done, misidentified equipment could cause potential damage to the airplane and injury to personnel.

There has been an operator report of the incorrect equipment marker on the right side of the E8-1 shelf assembly in the electrical/electronics compartment above the E1 Rack.

1. Open access to the electrical/electronics compartment. Refer to 737-600/700/800/900 AMM 06-41-00 as an accepted procedure.
2. Change the E8-1 shelf assembly vinyl marker in accordance with FIGURE 1.
3. Close access to the electrical/electronics compartment. Refer to 737-600/700/800/900 AMM 06-41-00 as an accepted procedure.
4. Put the airplane back to a serviceable condition.

Step	Task	Name	Identification	Qty	More Data
1	Remove	MARKER	BAC27DEX7203	1	Refer to SOPM 20-50-05 as an accepted procedure.
2	Clean	SURFACES	ISOPROPYL ALCOHOL, TT-I-735, OR EQUIVALENT	4 Oz	Refer to SOPM 20-30-03 as an accepted procedure.
3	Install (New)	MARKER	284A6002-12	1	In location of existing marker, as shown. Refer to SOPM 20-50-05 as an accepted procedure.
4	Identify	SHELF SUBASSY - E8-1, E/E EQUIPMENT	284A1781-77 (FOR EXISTING 284A1781-67)	1	With new dash number. Refer to SOPM 20-50-10 as an accepted procedure.
