737

Service Bulletin

Number: 737-28-1303
Original Issue: April 26, 2012
Revision 1: January 22, 2015
ATA System: 2800

SUBJECT: FUEL - General - Left Environmental Control Systems Bay Wire Clamp - Inspection and Replacement

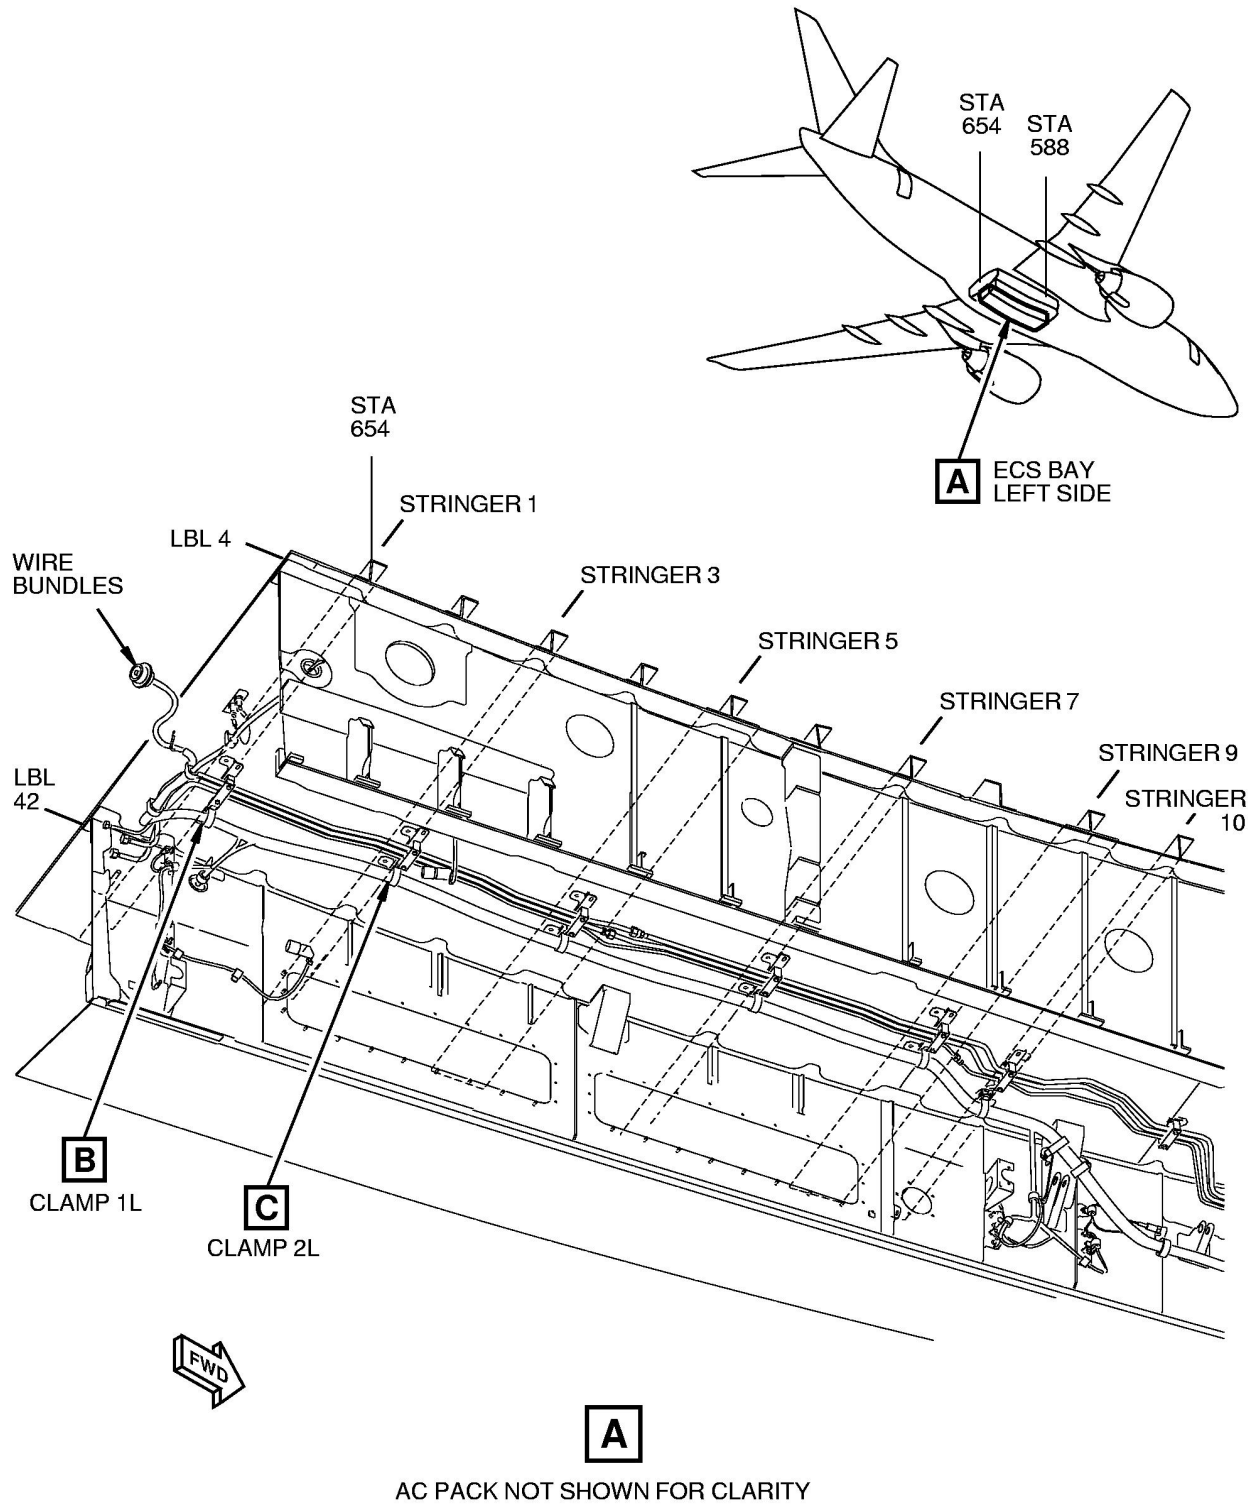
FIGURE 1: LEFT SIDE - ENVIRONMENTAL CONTROL SYSTEMS (ECS) BAY - WIRE CLAMP - INSPECTION (SHEET 1 OF 3)

- a. **Group 1:**
In accordance with FIGURE 1.
 - (1) If the installed wire clamps are not TA0930034-10, TA0930034-10P, TA0930034-11 or TA0930034-12P, do a Detailed Inspection for wire damage, repair any damage found, and install new wire clamps in accordance with FIGURE 3.

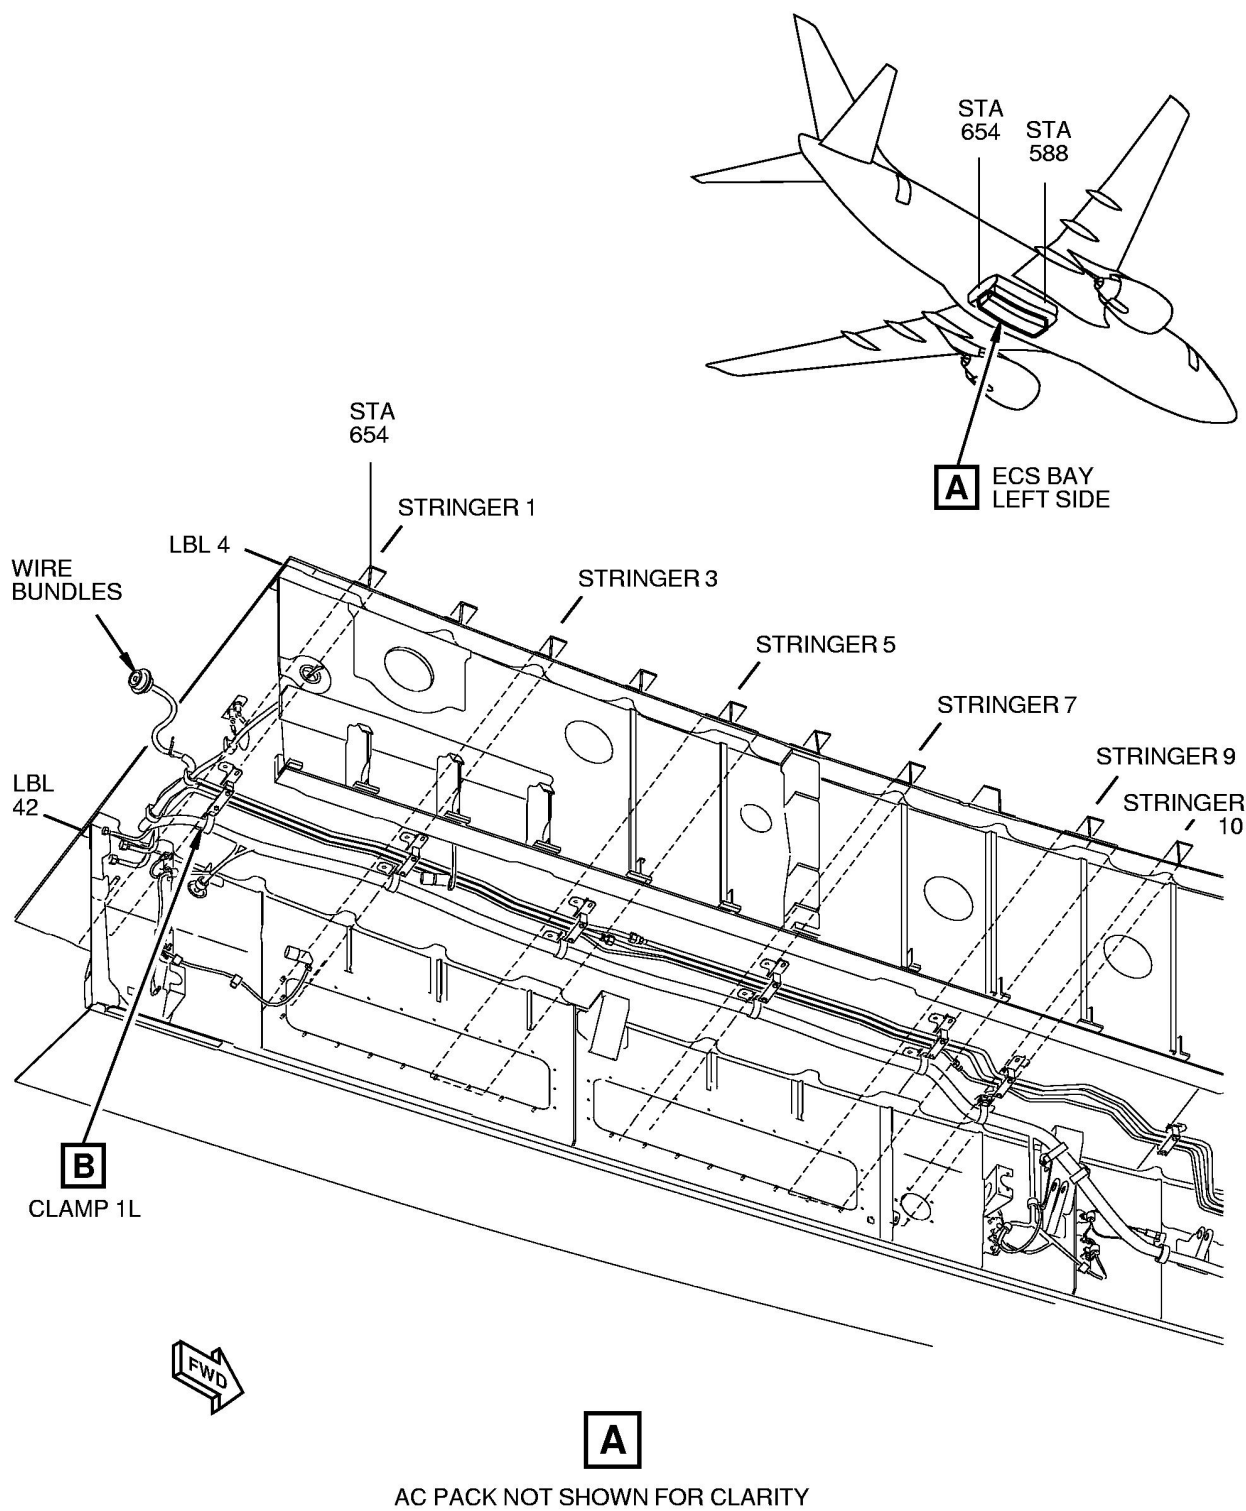
FIGURE 2: LEFT SIDE - ENVIRONMENTAL CONTROL SYSTEMS (ECS) BAY - WIRE CLAMP - INSPECTION (SHEET 1 OF 3)

- (1) If the installed wire clamp is not TA0930034-10, TA0930034-10P, TA0930034-11 or TA0930034-12P, do a Detailed Inspection for wire damage, repair any damage found, and install a new wire clamp in accordance with FIGURE 4.

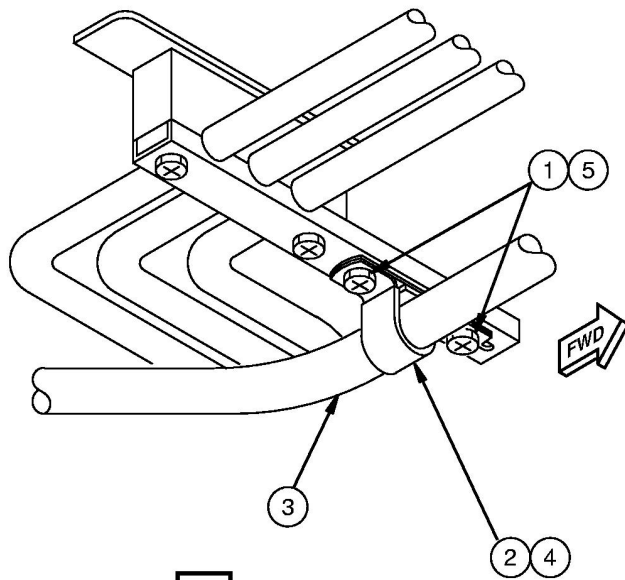
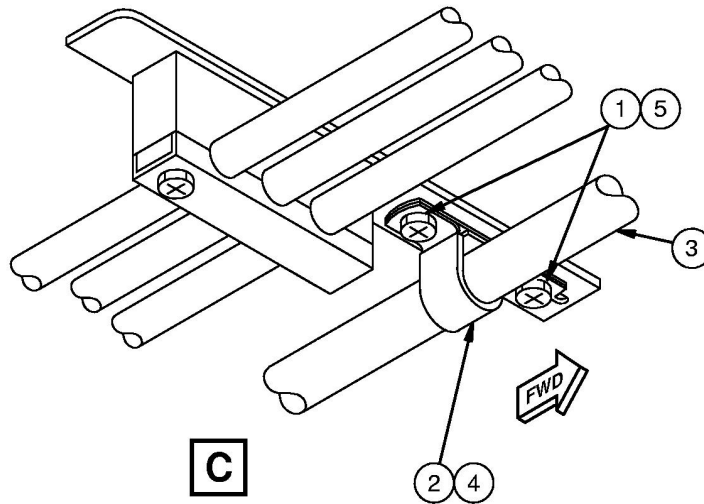
FIGURE 3: LEFT SIDE - ENVIRONMENTAL CONTROL SYSTEMS (ECS) BAY - WIRE CLAMP - REPLACEMENT (SHEET 2 OF 3)

CLAMP 1L
TYPICAL INSTALLATION

CLAMP 2L
TYPICAL INSTALLATION

Step	Task	Name	Identification	Qty	More Data
1	Remove / Keep	Fasteners	-	4	(a)
2	Remove	Clamp	-	-	
3	Inspect	Wire Bundle	-	1	(b)
4	Install (New)	Clamp	TA0930034-10 (TA0930034-10P or TA0930034-11 or TA0930034-12P optional)	2	(c) (a)
5	Install (Kept)	Fastener	-	4	(c) (a)
(a) The Quantity shown is the maximum amount that is necessary if both clamps must be replaced.					
(b) Do a Detailed Inspection of the wire bundle for damage (chafing) at the specified clamp locations. If damaged wires are found, repair damaged wires. Refer to SWPM 20-10-13 as an accepted procedure for damage conditions and repair instructions.					
(c) Refer to SWPM 20-10-12 as an accepted procedure.
