# A case study on causation of the landslide on 26 October 2016 in the northern Colombian Andes•

Article in *Dyna* (Medellin, Colombia) · February 2021

This paper presents the results of a technical investigation on the causation of the landslide that occurred in Las Nieves quarry on October 26/2016 in the municipality of Copacabana, located in the northern part of the Colombian Andes. This landslide caused the highest number of fatalities in Colombia in 2016 (16 deaths). The study included field visits, soil sampling, study of geology and geomorphology, analysis of rainfall and groundwater flows presented in the area. The information collected is consistent with the hypothesis that the regional groundwater flow generated an increase in water levels in the landslide zone thus triggering the landslide. Finally, a stability analysis (statistical and sensitivity analysis) was performed using the limit equilibrium method, where the effect of the rise in the groundwater table was modelled as the trigger. The stability analysis results showed a low safety factor for the slope, even when low water levels were considered.

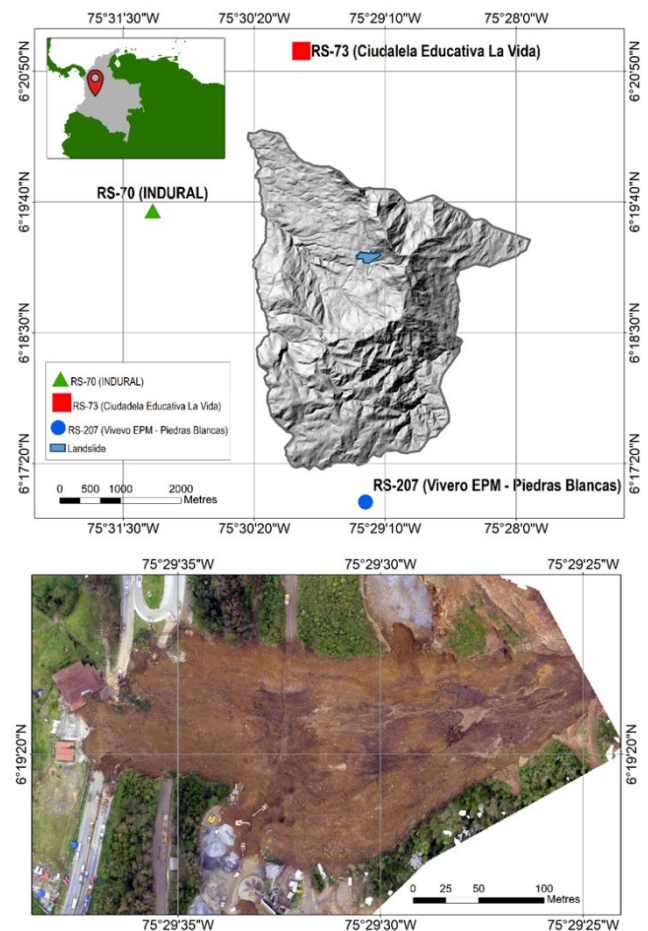
landslide began in the upper part of the slope, between the southern and northern banks of the quarry. Fig. 1 presents the location of the event and a photograph of the magnitude of the movement. The crown of the landslide presented a spoon shape with its middle portion adopting a slightly conical shape and the toe (accumulation area) was clearly wider, suggesting a high degree of water content in the sliding mass. The mass, initially solid, was transformed into a flow that buried the industrial facilities of Las Nieves quarry, both lanes of the Medellín-Bogotá highway, and part of a restaurant located next to the highway.

Figure 1. Location of the landslide in Las Nieves quarry, municipality of Copacabana, Colombia.

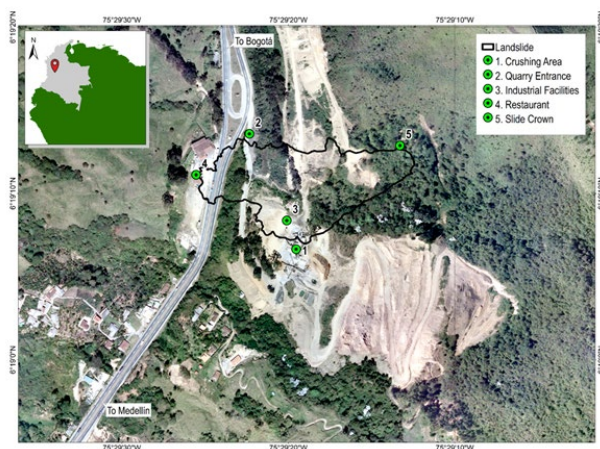
Figure 2. Location of reference sites in the area of the landslide in Las Nieves quarry, municipality of Copacabana, Colombia.

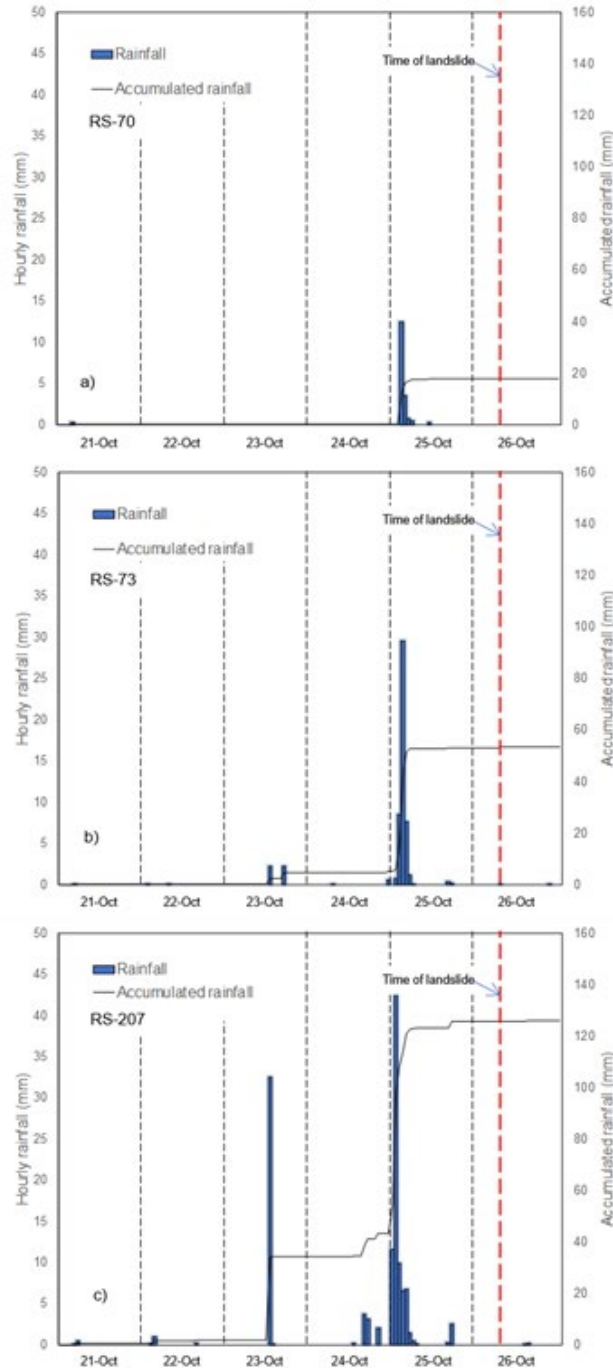
Fig. 4 shows the analysis of hourly rainfall intensity for the selected stations, from 21–26 October 2016. From this figure, it is seen that RS-207 presented a total accumulated rainfall of 125.9 mm for the five days prior to the slide, with a rainfall duration concentrated in the early morning of October 25, one day before the landslide, with a maximum hourly rainfall of 43.3 mm. This condition reflects the reduced presence of rain during the five days prior to the landslide and the dispersed distribution of significant rainfall during the 24 hours prior to the landslide. At RS-70 and RS-73, the total accumulated rainfall was 17.5 and 50.9 mm, respectively, which occurred during the five days prior to the event, with a maximum hourly rainfall of 12.4 and 28.8 mm, respectively. At these stations, the duration of the events was concentrated, as at RS-207, in the early hours of October 25. None of the stations analysed in this study indicated that rainfall occurred at the time of the landslide. This information was corroborated by personal interviews with people that were at the quarry at the time of the slide.

Figure 4. Rain intensity analysis. Hourly rainfall and accumulated rainfall between 22 and 26 October, 2016. a) RS-70 station (Indural), b) RS-73 station (Ciudadela Educativa La Vida), and c) R-S207 station (Vivero EPM - Piedras Blancas). Source: The authors.

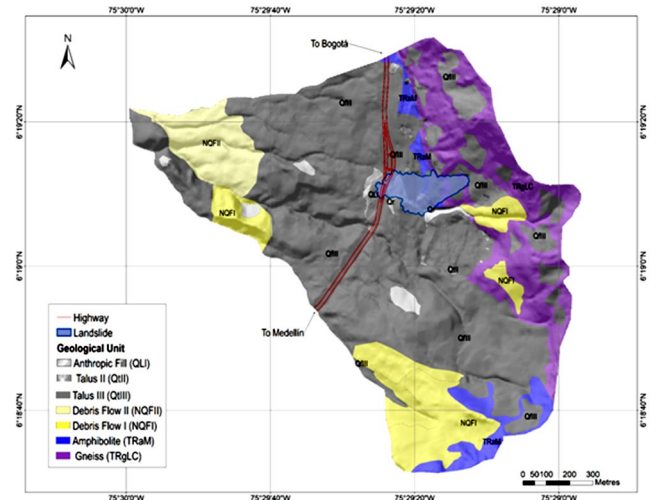
Figure 5. Geological map of the study area. Source: The authors.

Much of the area is covered by slope deposits with complex spatial and temporal relationships contextualised in the geological map. The slope deposits located in the failure zone correspond to a talus type deposit and that corresponds to deposits formed mainly by the action of gravity. These deposits produced accumulation of angular rock fragments with scarce or absent matrix in areas of steep slopes (Fig. 5). The average thickness of the talus is on the order of 2 metres. There are also rocky materials in the area that can be mapped at a working scale, but whose origin is due to anthropogenic intervention and excavation of quarry material.

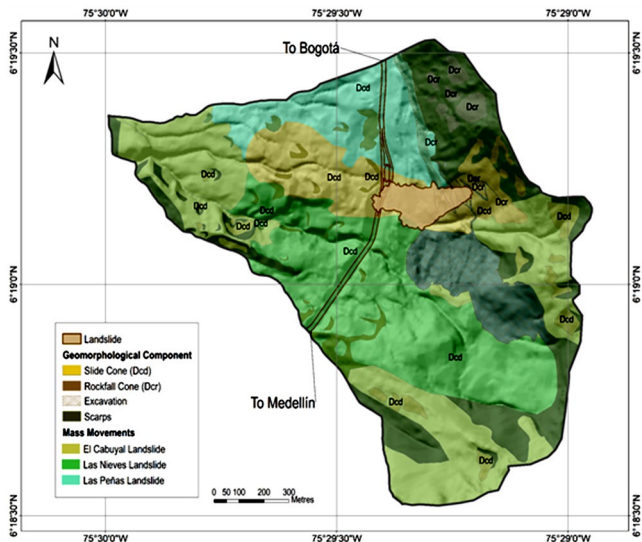
From the geomorphological point of view, it was found that more than 70% of the study area is composed of slope deposits, the multitemporal and spatial analysis of the area of interest allowed us to identify and map three series of past landslides that were grouped to be presented. These show a direct relationship with the intense denudation processes occurring in the Aburrá Valley. The first and most relevant is a huge relict landslide complex named, El Cabuyal, located in the central part of the area, which includes Las Nieves quarry. The second denudation process corresponds to a relict landslide complex namely, Las Peñas, located in the north near the southern portal of the tunnel. The third landslide complex is called Las Nieves. These landslides complexes show at least three phases of activity. The most recent phases correspond to active and/or latent landslides (Fig. 6).

Figure 6. Geomorphological map of the study area.  
Source: The authors.

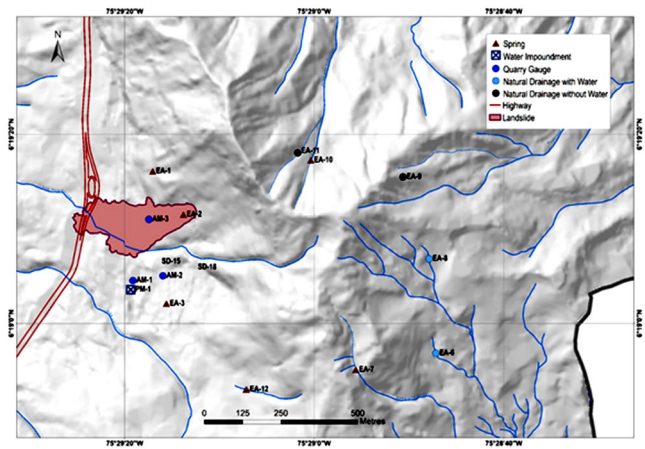
Fig. 7 presents the location and inventory of surface water sources. Due to the importance of understanding the processes that originated the Las Nieves quarry landslide, emphasis should be placed on the quarry gauging points (AM-1, AM-2, and AM-3), which roughly represent the position of the ground water table in the zone of immediate influence on the landslide. These points, together with the springs at EA-1, EA-2, and EA-3, represent the vertical oscillation band of the ground water table in the area of Las Nieves quarry. Specifically, point EA-2, located in the escarpment of the landslide, was gauged in the days following the landslide and yielded a flow of 3 L/s which gradually decreased over the following weeks until it stabilised at approximately 1 L/s between January and February 2017.

Figure 7. Location of water sources.  
Source: The authors.

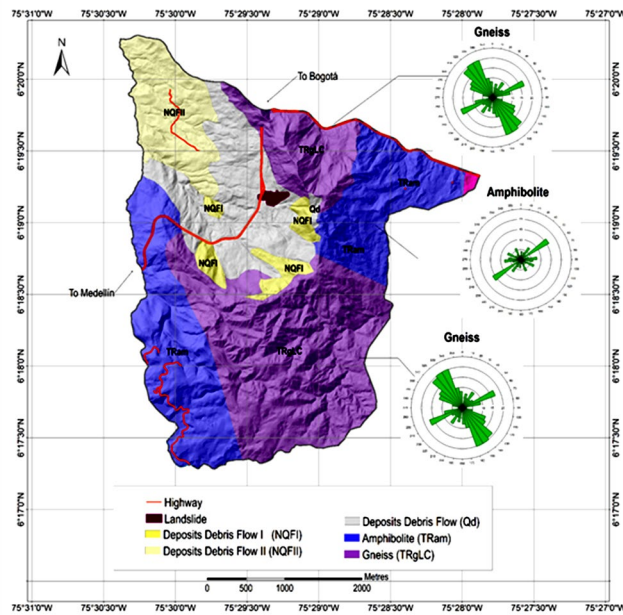
In the study area, the nearly vertical dip of the gneiss favours deep water flow in this rocky mass. By combining the sets of discontinuities, it is possible to establish a network of planes with north-west orientations which favours the hydraulic connection between the plateau and the failure zone (Fig. 8).

Figure 8. Directions of discontinuities for the two different lithological environments found in the landslide zone.

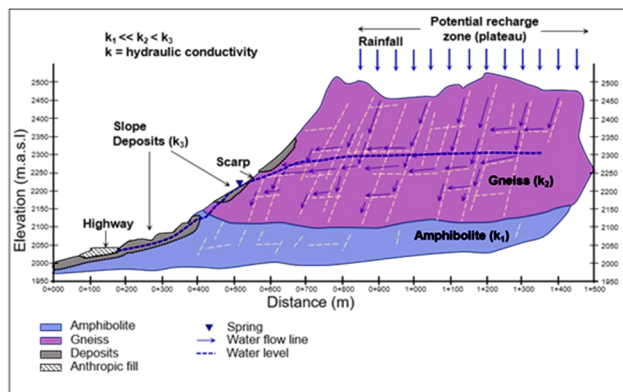
Based on the information described above, the hypothesis for the triggering factor of the landslide, is that the water from antecedent precipitation recharged the plateau zone, predominantly at sites of low slope and in the presence of residual soil, thus favouring processes of water infiltration and retention. Consequently, the infiltrated water was conducted through the discontinuities existing in the gneiss, to the slopes where the landslide occurred. The water that infiltrated through the discontinuities in the gneiss accumulated over the amphibolite, causing an increase in the water level at the failure zone. A diagram of the hydrogeology is presented schematically in Fig. 9.

Figure 9. Conceptual model of flow behaviour in the zone of Las Nieves landslide.

- The conceptual hydrogeological model indicates that precipitation on the plateau easily infiltrates the intensely fractured gneiss, a lithological unit that outcrops in the upper part of the failed slope, facilitating an underground flow that moves preferentially towards the north-west. Subjacent to the gneiss is the amphibolite unit, clearly less fractured and therefore with less secondary permeability, in which the flow is delayed causing a localised increase in the phreatic level and permanent discharge of water evidently controlled by the gneiss-amphibolite contact.

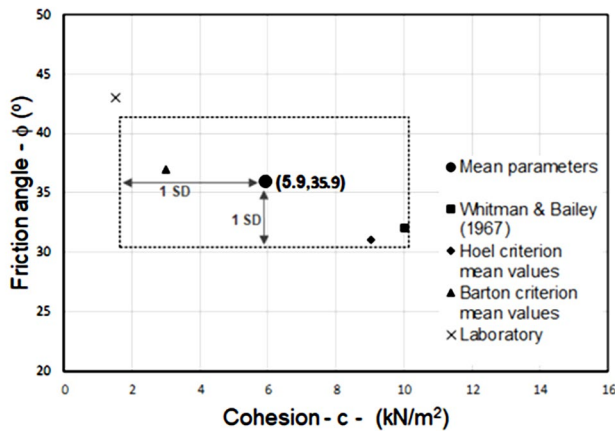
With the strength parameters obtained, assumed, and estimated, the average values for cohesion and friction angle were calculated (Fig. 10). In addition, the standard deviation (SD) of the parameters and their coefficients of variation were calculated. Finally, a region determined by the mean values of cohesion and friction ( $\pm$  SD) of the strength parameters was obtained, from which the stability analyses were performed.

Figure 10. Region of variability considered for the cohesion and friction angle values used in the stability analysis.

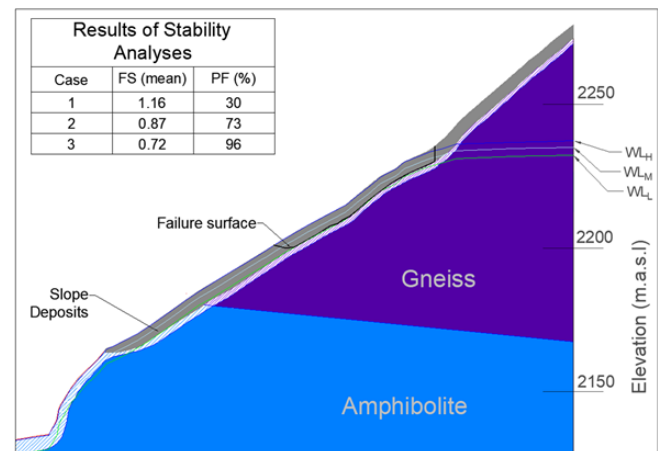
According to the information presented above, and from the values of the mechanical strength parameters and their variation (Fig. 10), a limit equilibrium statistical analysis was performed to determine the effect of the ground water table on the overall stability of the analysed slope. For the analysis, the SLIDE program [20] was used. For the analysis, normal distribution functions for cohesion and friction were assumed according to the mean values ( $\pm$  SD) established in Table 2. Three cases of groundwater-level positions were analysed, as shown in Fig. 11, and the results are described below:

- Case 1: ground water level position (WLL). The position of the ground water table at the boundary between the colluvial deposit and the rock base is assumed. For this case, a mean safety factor of 1.16 was obtained with a probability of failure of 30%.
- Case 2: Middle ground water level position (WLM). It is assumed that the ground water table is located at a height equal to half the thickness of the colluvial deposit. In this case, a mean safety factor of 0.87 was obtained with a probability of failure of 73%.
- Case 3: High ground water level position (WLH). A phreatic level is assumed which mostly saturates the colluvial deposit. In this case, an average safety factor of 0.72 and a probability of failure of 96% were obtained. For all cases, the failure surface was naturally located along the contact between the rock base and the colluvial deposit as shown in Fig. 11.

Figure 11. Profile along the central axis of the slide and position of the water levels.

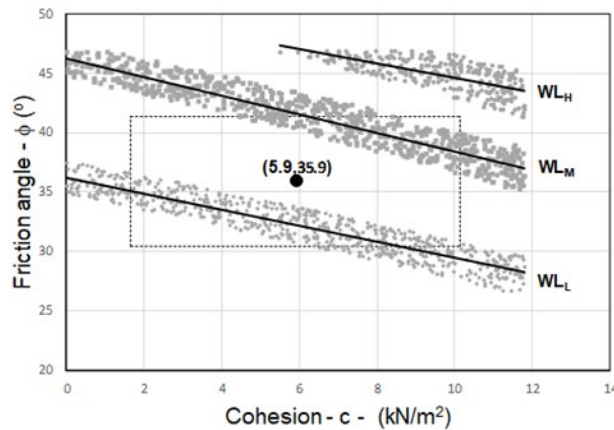
Fig. 12 shows a shaded rectangle within the estimated parameters used for the analysis are located as explained above. The comparison of the assumed parameters for the soil and the results of the safety factors equal to 1 for the three cases studied allowed us to conclude the following:

- Case 1: WLL. In this case, there is a large area above the trend line that would indicate the possibility of combinations of friction angle and cohesion that generate safety factors greater than 1. However, some combinations of these strength parameters could generate safety factors below 1 (area of the rectangle below the line).

Figure 12. Results of the sensitivity analysis of the ground water table position on slope stability.

- Case 2: WLM. In this case, the vast majority of parameter combinations results in safety factor values less than 1, indicating a high probability of failure.
- Case 3: WLH. In this case, all possible combinations of strength parameters produced safety factors less than 1, which indicate the impossibility of mass stability under these conditions.

The overall result presented in Fig. 12 indicates low initial stability conditions in the area studied (Case 1), with a considerable reduction in stability for cases in which the ground water table rises in the soil (Cases 2 and 3).
