# Home Inspection Report

251 N Bristol Ave, Los Angeles, CA 90049

Inspection Date: 2025-08-13

Inspector: Binsr | Client: Binsr Demo

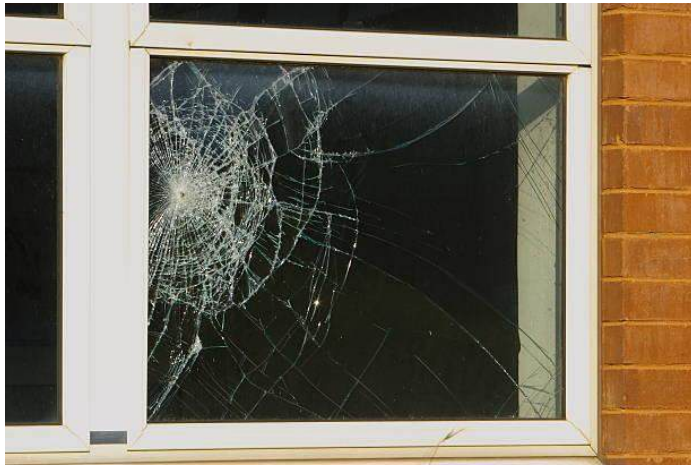
**M#2: photo**

A glass pane on one or more windows was broken. It is recommended to replace broken windows to restore their intended function.

The damaged glass pane may expose sharp edges and reduce the thermal barrier against the elements. Further evaluation by a qualified contractor is recommended to repair or replace the damaged window as needed.

A missing insect screen was observed on the backside of the house (window or door). Replace or reinstall a properly fitted screen to restore insect protection and normal function. If the opening is part of a door, ensure the replacement screen is installed to allow safe operation and proper sealing.

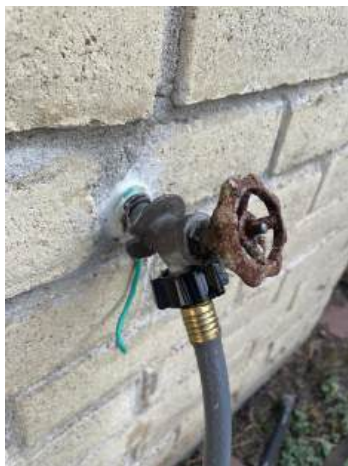
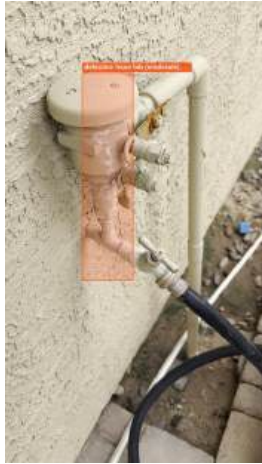
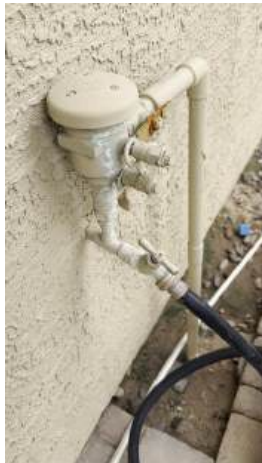
The exterior hose bib (outdoor faucet) was observed to be non-operational or not functioning properly at the time of inspection. Repair or replacement is recommended to restore function and prevent water intrusion or damage. Recommend evaluation and repair by a licensed plumber or qualified handyperson.

The handle for the exterior spigot was damaged or missing. Repairs or replacement as needed are recommended to be performed by a qualified individual to ensure proper operation.

The exterior hose bib was observed to be non-functional. It is recommended to have a licensed plumber evaluate the unit and perform necessary repairs or replacement to restore proper water flow and prevent potential water damage.

The exterior hose bib located at the front of the house requires replacement. Replace the damaged/failed exterior faucet to prevent leaks and potential water intrusion. It is recommended that a qualified plumber or licensed contractor replace the unit and verify the isolation valve operation.

An exterior hose bib (outdoor faucet) was missing on the northwest side of the house. This limits water access and may leave an exposed plumbing stub. Recommend a licensed plumber or qualified contractor install a properly functioning exterior hose bib, verify the isolation/shutoff valve, and cap or seal any exposed plumbing until replacement. Obtain estimates as needed.

The broken exterior hose bib on the front side of the house should be repaired or replaced by a licensed plumbing professional. Verify the isolation/shutoff valve and confirm the hose bib is fully operational and leak-free after repairs.

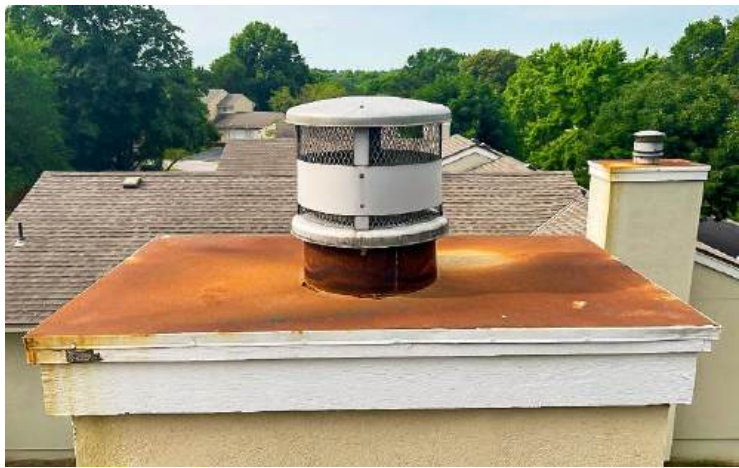
M#6: photo

Stucco damage was observed. Gaps or cracks in stucco can allow for moisture intrusion, accelerating deterioration. It is recommended that a qualified contractor evaluate and perform necessary repairs.

The chimney cap displayed signs of corrosion. Regular maintenance, such as sealing, is recommended to prevent further damage and extend its longevity.

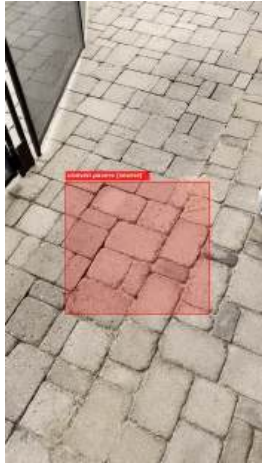
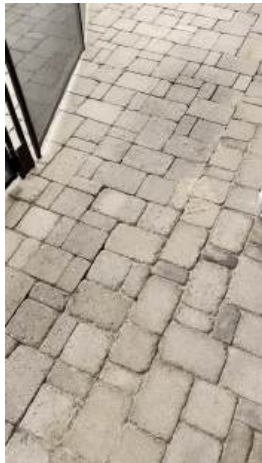
Uneven paver stones were observed in the backyard, creating a potential trip hazard to occupants and visitors. This condition presents an immediate safety concern and should be corrected. Recommend evaluation and repair by a qualified hardscape contractor or landscaper to re-level, reset, or replace affected pavers to eliminate the trip hazard.

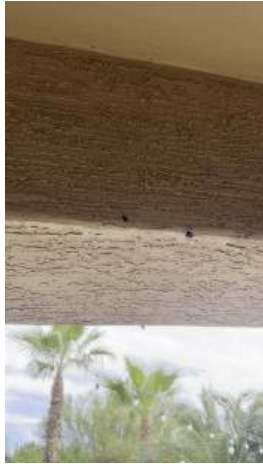
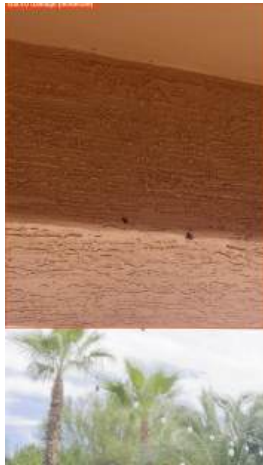
Evidence of prior repairs was noted on the exterior cladding. It is advisable to consult with the property owner to ascertain the nature of these repairs and whether any associated moisture intrusion incidents were reported.

Stucco damage was observed. Gaps or cracks in stucco can allow for moisture intrusion, accelerating deterioration. It is recommended that a qualified contractor evaluate and perform necessary repairs.

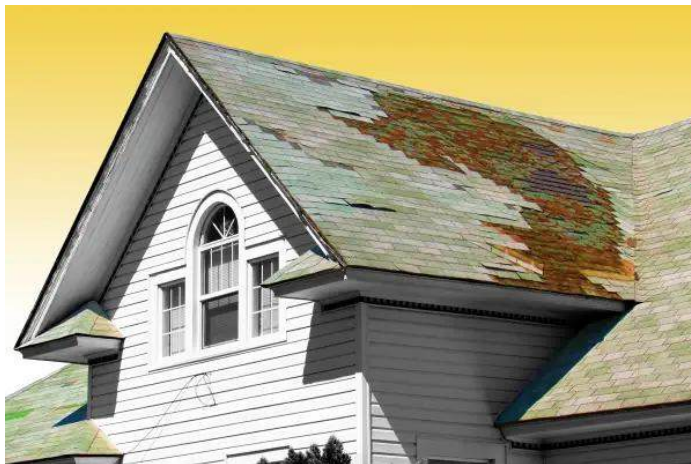
### M#12: photo

Several roof shingles were observed to be broken. This condition may lead to water intrusion and should be addressed promptly to maintain the roof's integrity.

Based on the age and type of shingle, the roof has exceeded its expected service life. Even with current repairs, the design of the shingle is beyond its intended lifespan. It is recommended to consult a qualified roofing professional for suggestions and quotes regarding roof replacement.

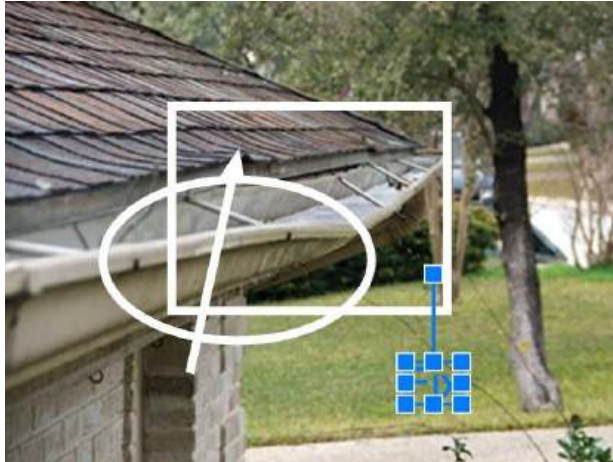
**M#13: photo**

One of the gutters was observed to be improperly installed and hanging off the structure. This can lead to ineffective drainage and potential water damage to the property.

A gutter hanger was observed to be missing or damaged. It is recommended to properly secure or replace the gutter hangers to ensure the intended stability and proper alignment of the gutter system.

The inspector recommends that gutter replacement/repair be performed by a licensed contractor to ensure proper attachment, flashing, and drainage performance. Obtain quotes and confirm contractor licensing and insurance prior to work.

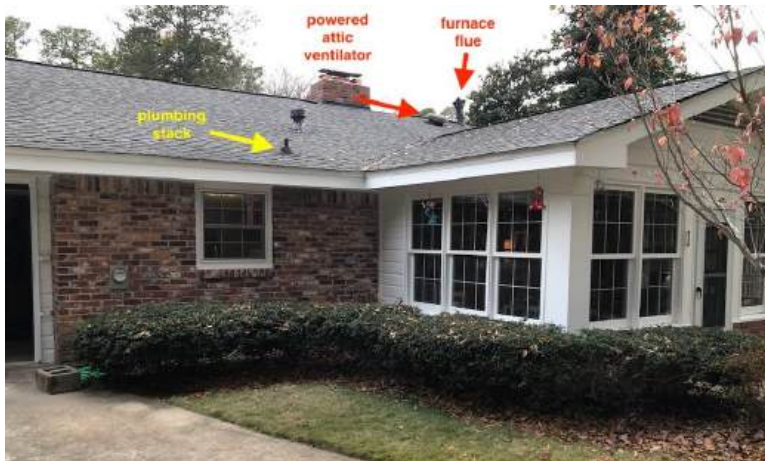
**M#14: photo**

The plumbing vent displayed insufficient clearance from a rooftop deck. For proper ventilation and to prevent sewer gases from entering recreational areas, vents should typically extend at least 6 feet above a rooftop deck. It is recommended to consult with a licensed professional to ensure appropriate vent height and mitigate potential health concerns.

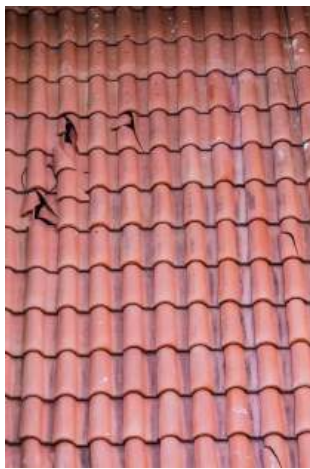
#### M#15: photo

One or more composition roof shingles exhibited cracking and/or brittleness. Cracked and brittle shingles typically indicate that the roof is nearing the end of its useful life. It is recommended to have a qualified licensed roofing contractor further evaluate and perform necessary repairs.

Cracked tiles were observed in various locations on the roof. It is recommended that a qualified roofing contractor assess and repair these areas as necessary. This type of roofing system typically benefits from annual evaluations and prompt repairs.

Inspector flagged the broken roof tiles as a maintenance item for repair/replacement. Refer to the Roofing Material Integrity comment for details and recommended actions.

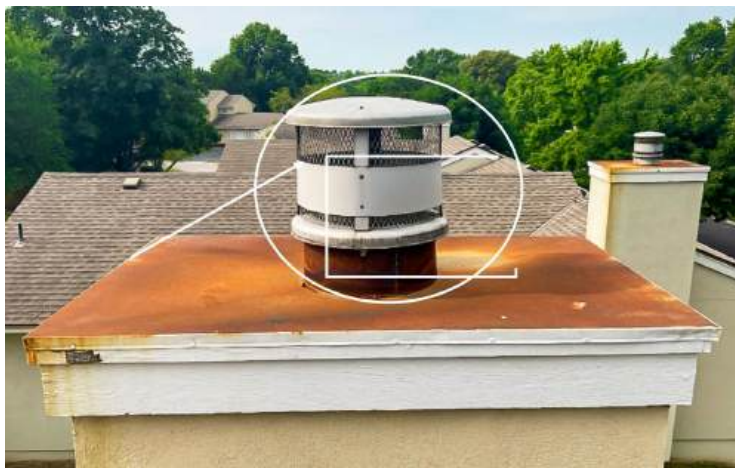
#### M#17: photo

A damaged or missing vent cover could allow debris and small pests to enter. It is recommended to repair or replace the vent cover to ensure proper operation.

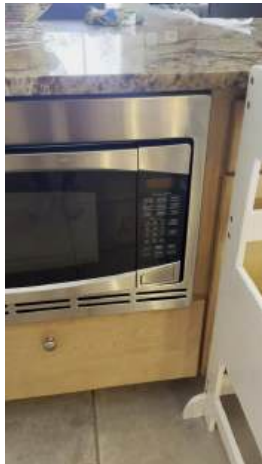
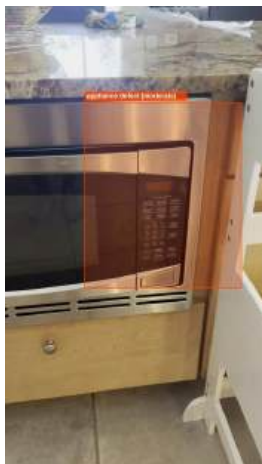
The microwave oven appeared to be non-operational or was malfunctioning. It is advised that a qualified appliance technician evaluate and perform necessary repairs or replacement.

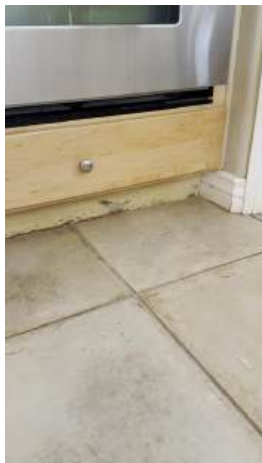
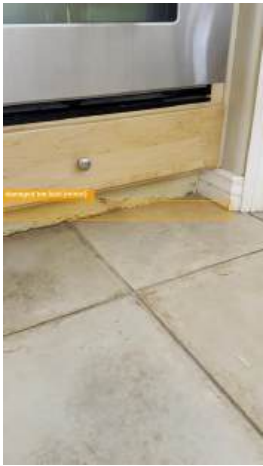
The cabinetry exhibited damage in various areas. Repairs or replacement of any damaged sections are recommended to be performed by a qualified individual.

One or more cabinet doors were observed to be damaged, faulty, or otherwise amiss. Repairs by a qualified contractor are recommended.

The paint finish exhibited signs of failure or peeling in one or more locations. It is recommended that a qualified contractor perform the necessary repairs.

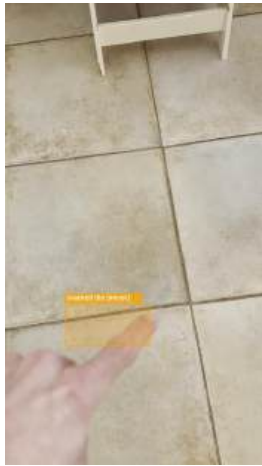
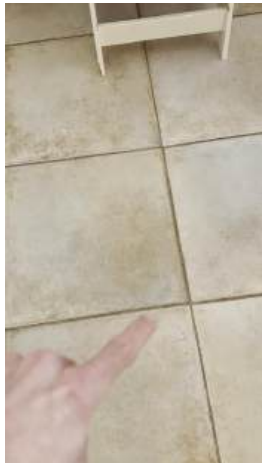
Two small cracks were observed in the kitchen floor tile. Cracked tile can allow moisture to penetrate the substrate and may deteriorate further over time. Recommend repair or replacement of the affected tile(s) by a qualified flooring contractor and verify the integrity of the surrounding substrate and grout. Obtain estimates as needed.

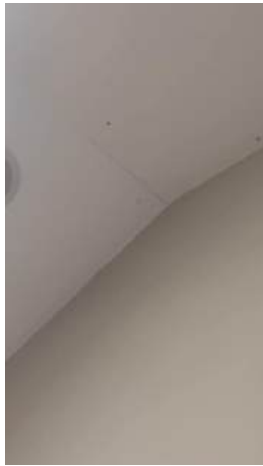
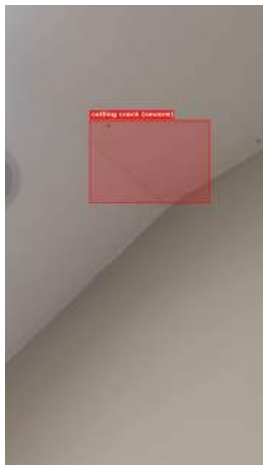
Significant drywall imperfections, including damage, cracking, or inconsistencies, were noted in the referenced area(s). It is advisable to inquire with the current homeowner(s) regarding any past alterations. Repairs should be undertaken by a drywall contractor as desired.

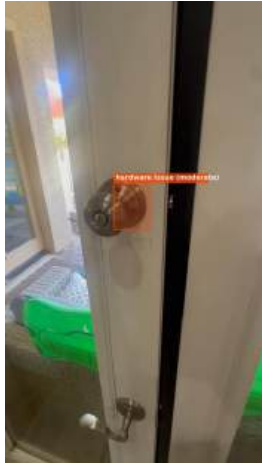
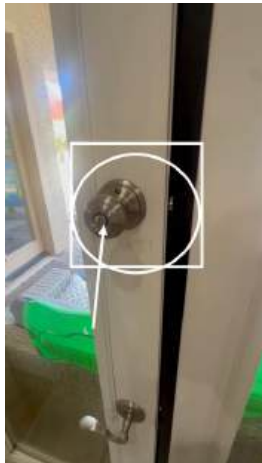
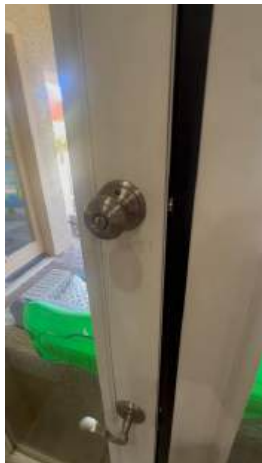
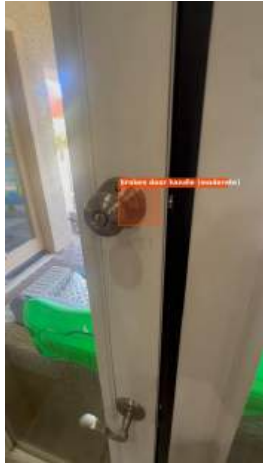
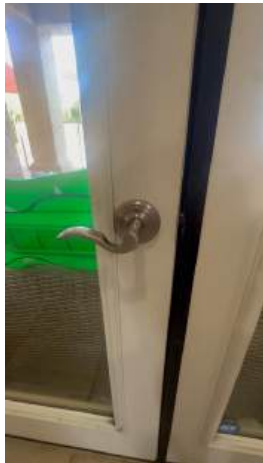
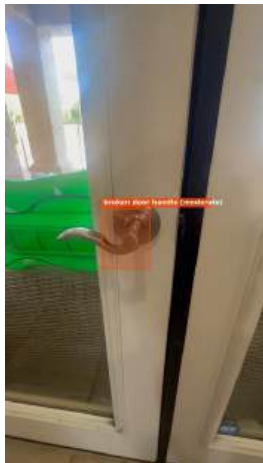
The handle lock on one or more exterior entryways was found to be inoperable or challenging to use. Replacement of the locking doorknob by a qualified professional is recommended.

Various exterior door hardware components, including locksets, hinges, and pulls, were observed to be inoperable, damaged, loose, or absent. It is advised that a qualified contractor perform necessary repairs or replacements.

The door handle is either damaged or missing. It is recommended that a qualified professional evaluate and repair or replace it as necessary.

The deadbolt mechanism exhibits difficulty in proper operation. It is recommended to consult a qualified locksmith for necessary adjustments or replacement of the lock.

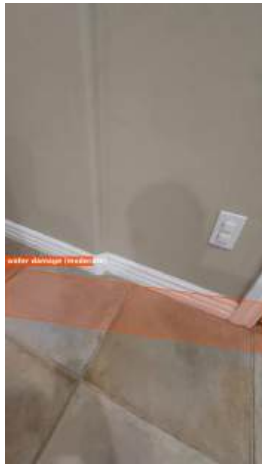
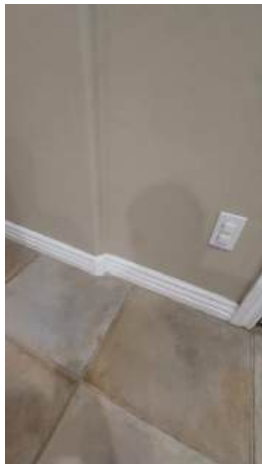
Water damage was observed on the subflooring during the assessment. This damage may signify a historical or ongoing leak. It is advised to consult with the seller regarding the nature of the damage and any prior repairs. Alternatively, monitor the affected area for any subsequent deterioration.

It is advised to engage a certified pest control company to address any wood-destroying organisms. Upon completion, have the affected areas repaired by a licensed building or remodeling contractor.

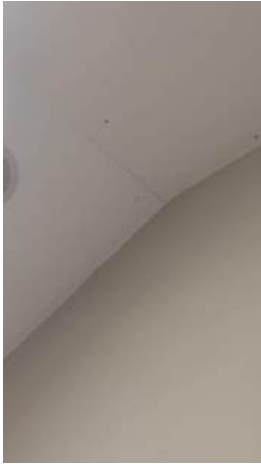
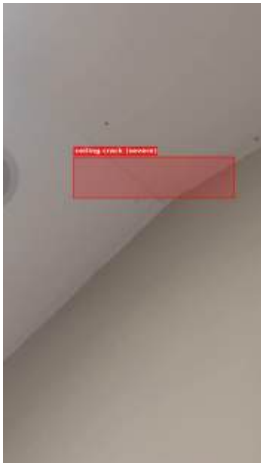
Significant cracking was observed in the ceiling in the Living Room that may indicate underlying structural movement or damage. A licensed contractor or structural engineer should be engaged to evaluate the extent and cause of the cracking and to recommend necessary repairs. This condition may represent a safety risk and should be addressed promptly.

Visible indications of atypical settlement or foundation movement were present. A comprehensive evaluation by a licensed structural engineer is strongly recommended, with subsequent repairs performed as determined necessary.

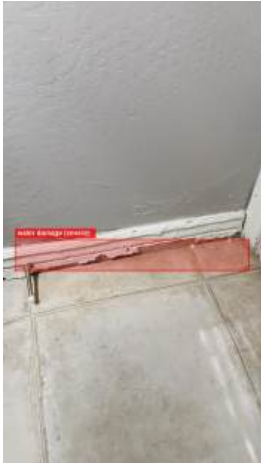
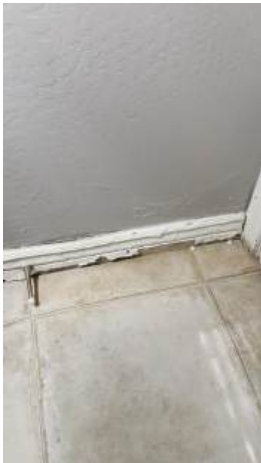
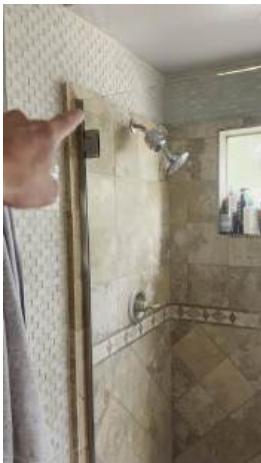
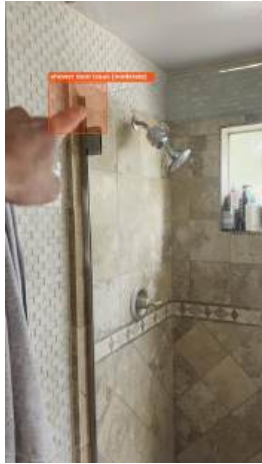
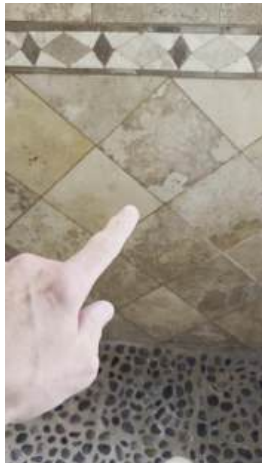
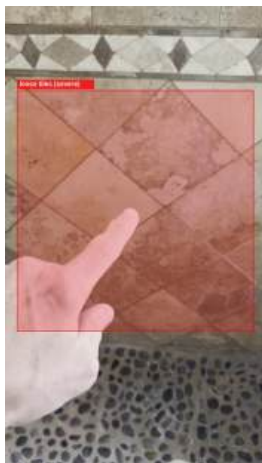
The observed leakage could cause additional damage to the framing member and floor decking. Water staining and dampness were noted in one or more areas, as confirmed by a moisture meter. This condition increases the risk of insect infestation, mildew, and decay. It is recommended to consult a licensed contractor to identify and rectify the source of the dampness, which may involve improving exterior drainage, installing a waterproofing system, or sealing foundation cracks.

The shower door was observed to be striking the adjoining glass and is misaligned. This condition can cause damage to the glass or hardware and may lead to failure if not corrected. It is recommended that a qualified glass/frameless-shower contractor or handyman evaluate the door alignment, adjust hinges or track, and install additional support or reinforcement as necessary to prevent further damage.

Loose tiles were observed in the master bathroom shower and were reported as a potential safety hazard. Loose or detached tiles can fall or create sharp edges and often indicate compromised substrate or prior water intrusion. It is recommended to discontinue use of the shower until a qualified tile contractor or licensed plumber assesses the condition, secures or replaces loose tiles, and evaluates the underlying substrate for moisture damage or continued leaks. Prompt repair is advised to prevent injury and further deterioration.
