PROPERTY INSPECTION REPORT FORM

Binsr Demo	2025-08-13
Name of Client	Date of Inspection
251 N Bristol Ave, Los Angeles, CA 90049	
Address of Inspected Property	
Binsr	
Name of Inspector	TREC License #
Name of Sponsor (if applicable)	TREC License #

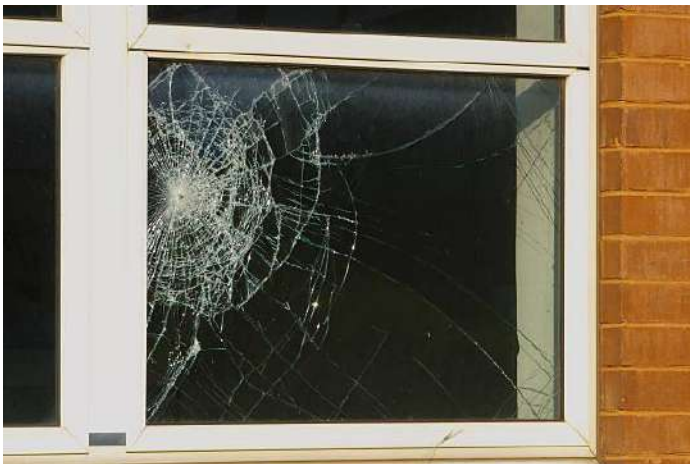
M#2: photo

A glass pane on one or more windows was broken. It is recommended to replace broken windows to restore their intended function.

The damaged glass pane may expose sharp edges and reduce the thermal barrier against the elements. Further evaluation by a qualified contractor is recommended to repair or replace the damaged window as needed.

A missing insect screen was observed on the backside of the house (window or door). Replace or reinstall a properly fitted screen to restore insect protection and normal function. If the opening is part of a door, ensure the replacement screen is installed to allow safe operation and proper sealing.

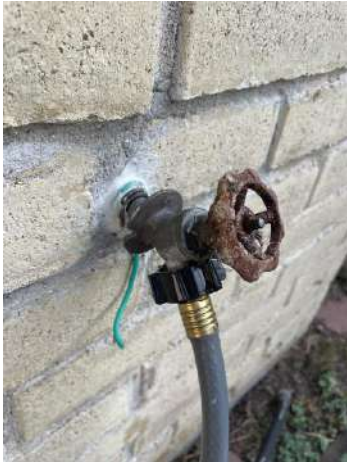
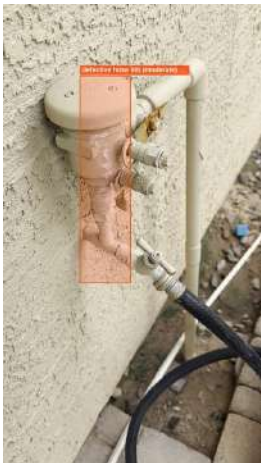
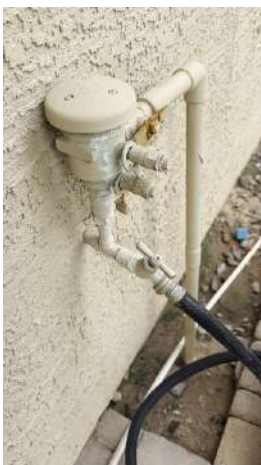
The exterior hose bib (outdoor faucet) was observed to be non-operational or not functioning properly at the time of inspection. Repair or replacement is recommended to restore function and prevent water intrusion or damage. Recommend evaluation and repair by a licensed plumber or qualified handyperson.

The handle for the exterior spigot was damaged or missing. Repairs or replacement as needed are recommended to be performed by a qualified individual to ensure proper operation.

The exterior hose bib was observed to be non-functional. It is recommended to have a licensed plumber evaluate the unit and perform necessary repairs or replacement to restore proper water flow and prevent potential water damage.

The exterior hose bib was observed to be non-functional. Replacement or repair by a licensed plumber is recommended to restore proper operation and prevent water intrusion or damage.

The exterior spigot was not functional at the time of inspection, despite its shutoff valve being in the open position. We recommend consulting with the sellers regarding the presence of a secondary shutoff or having a licensed plumbing professional perform an evaluation.

The exterior hose bib is not functioning properly. Repair or replacement is recommended to restore water flow and prevent potential water damage. Consult a licensed plumber for evaluation and repair.

A vapor or moisture barrier appears to be missing or not installed behind the stucco finish system. This condition could allow moisture to penetrate to the interior framing and cause damage. It is recommended that a qualified licensed contractor further evaluate and perform necessary repairs.

An exterior hose bib (outdoor faucet) was missing on the northwest side of the house. This limits water access and may leave an exposed plumbing stub. Recommend a licensed plumber or qualified contractor install a properly functioning exterior hose bib, verify the isolation/shutoff valve, and cap or seal any exposed plumbing until replacement. Obtain estimates as needed.

An exterior component on the front side of the house was observed to be non-functional. A licensed contractor should evaluate the specific component and perform repair or replacement as needed to restore proper operation and prevent related damage.

Inspector recommends repairing or replacing the exterior hose bib to make it fully operational. Confirm functionality after repair and check for leaks. Obtain quotes from a licensed plumber or qualified contractor as needed.

The exterior hose bib located at the front of the house requires replacement. Replace the damaged/failed exterior faucet to prevent leaks and potential water intrusion. It is recommended that a qualified plumber or licensed contractor replace the unit and verify the isolation valve operation.

The broken exterior hose bib on the front side of the house should be repaired or replaced by a licensed plumbing professional. Verify the isolation/shutoff valve and confirm the hose bib is fully operational and leak-free after repairs.

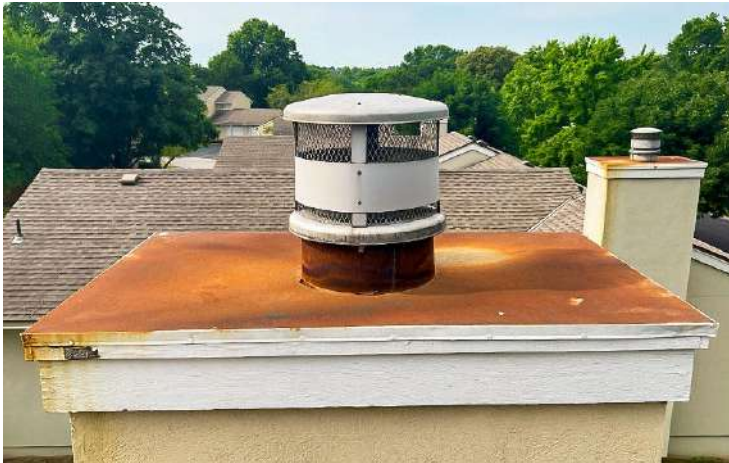
M#6: photo

Stucco damage was observed. Gaps or cracks in stucco can allow for moisture intrusion, accelerating deterioration. It is recommended that a qualified contractor evaluate and perform necessary repairs.

The chimney cap displayed signs of corrosion. Regular maintenance, such as sealing, is recommended to prevent further damage and extend its longevity.

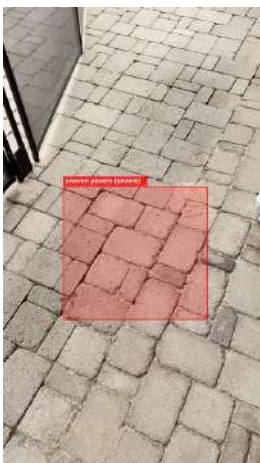
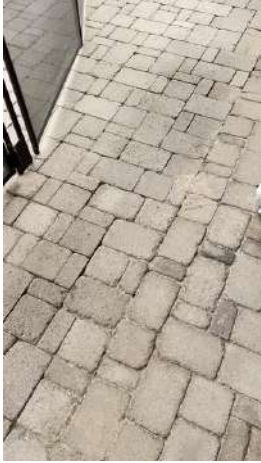
Uneven paver stones were observed in the backyard, creating a potential trip hazard to occupants and visitors. This condition presents an immediate safety concern and should be corrected. Recommend evaluation and repair by a qualified hardscape contractor or landscaper to re-level, reset, or replace affected pavers to eliminate the trip hazard.

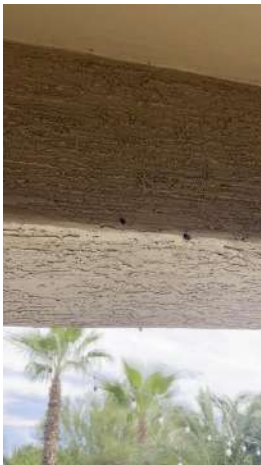
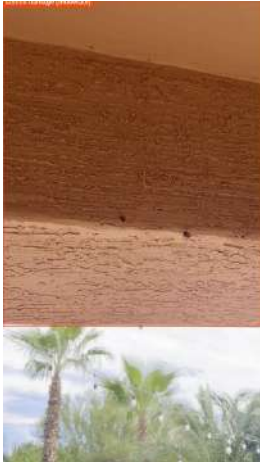
Evidence of prior repairs was noted on the exterior cladding. It is advisable to consult with the property owner to ascertain the nature of these repairs and whether any associated moisture intrusion incidents were reported.

Stucco damage was observed. Gaps or cracks in stucco can allow for moisture intrusion, accelerating deterioration. It is recommended that a qualified contractor evaluate and perform necessary repairs.

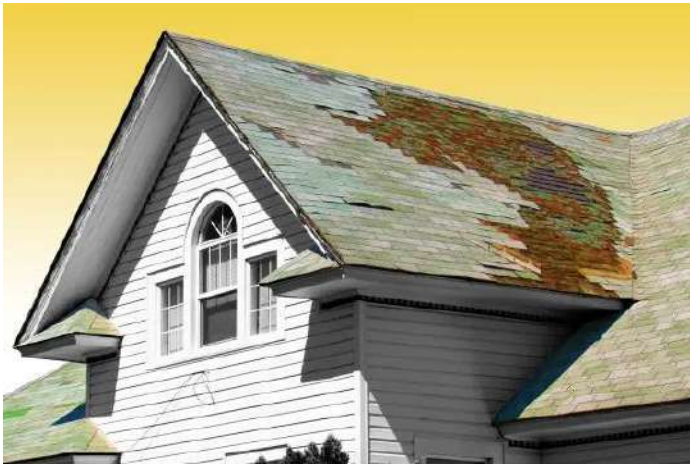
M#12: photo

Several roof shingles were observed to be broken. This condition may lead to water intrusion and should be addressed promptly to maintain the roof's integrity.

Based on the age and type of shingle, the roof has exceeded its expected service life. Even with current repairs, the design of the shingle is beyond its intended lifespan. It is recommended to consult a qualified roofing professional for suggestions and quotes regarding roof replacement.

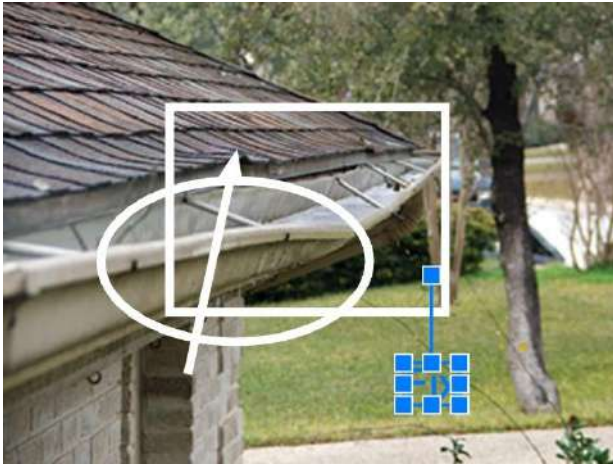
M#13: photo

One of the gutters was observed to be improperly installed and hanging off the structure. This can lead to ineffective drainage and potential water damage to the property.

A gutter hanger was observed to be missing or damaged. It is recommended to properly secure or replace the gutter hangers to ensure the intended stability and proper alignment of the gutter system.

The inspector recommends that gutter replacement/repair be performed by a licensed contractor to ensure proper attachment, flashing, and drainage performance. Obtain quotes and confirm contractor licensing and insurance prior to work.

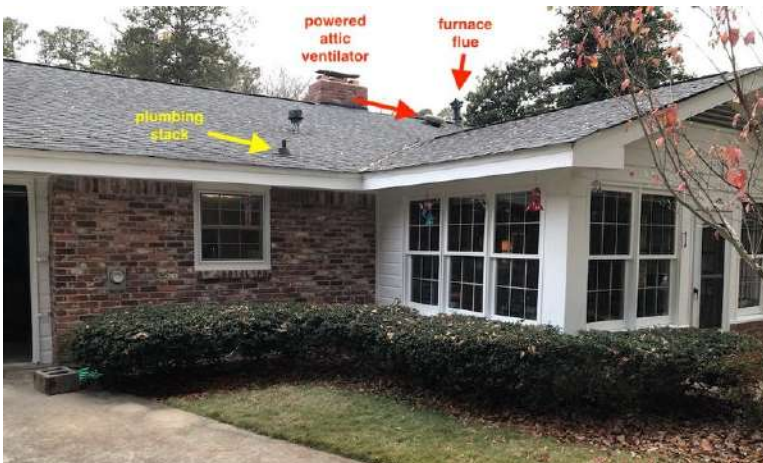
M#14: photo

The plumbing vent displayed insufficient clearance from a rooftop deck. For proper ventilation and to prevent sewer gases from entering recreational areas, vents should typically extend at least 6 feet above a rooftop deck. It is recommended to consult with a licensed professional to ensure appropriate vent height and mitigate potential health concerns.

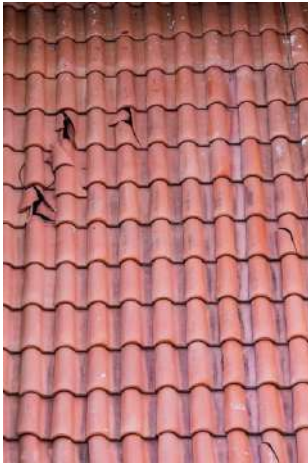
M#15: photo

One or more composition roof shingles exhibited cracking and/or brittleness. Cracked and brittle shingles typically indicate that the roof is nearing the end of its useful life. It is recommended to have a qualified licensed roofing contractor further evaluate and perform necessary repairs.

Cracked tiles were observed in various locations on the roof. It is recommended that a qualified roofing contractor assess and repair these areas as necessary. This type of roofing system typically benefits from annual evaluations and prompt repairs.

Inspector flagged the broken roof tiles as a maintenance item for repair/replacement. Refer to the Roofing Material Integrity comment for details and recommended actions.

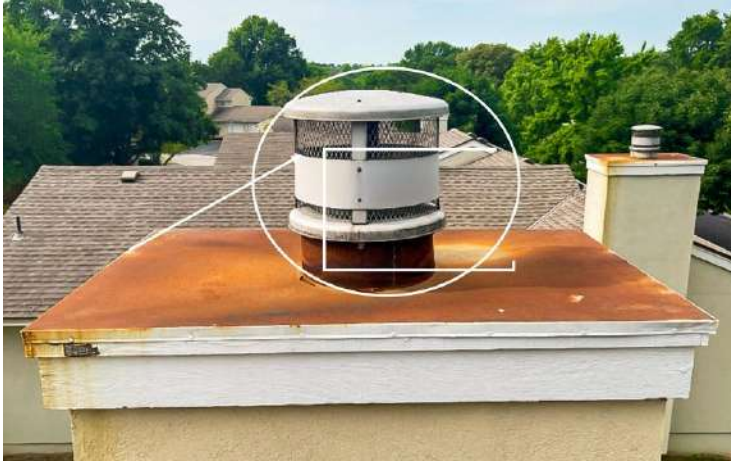
M#17: photo

The bushing for the electrical supply wiring on the food waste disposer was missing. This condition could potentially expose live wiring. It is recommended to have the bushing reinstalled.

A damaged or missing vent cover could allow debris and small pests to enter. It is recommended to repair or replace the vent cover to ensure proper operation.

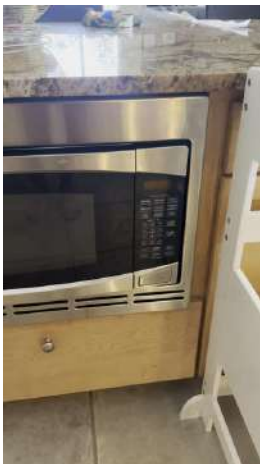
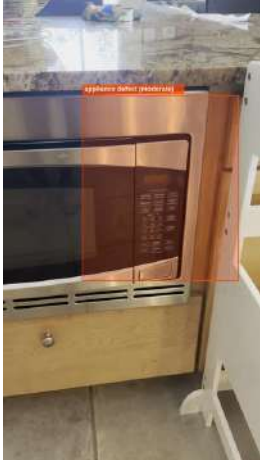
The microwave oven appeared to be non-operational or was malfunctioning. It is advised that a qualified appliance technician evaluate and perform necessary repairs or replacement.

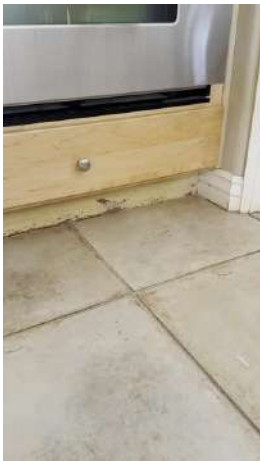
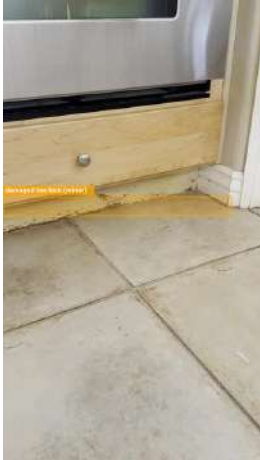
The paint finish exhibited signs of failure or peeling in one or more locations. It is recommended that a qualified contractor perform the necessary repairs.

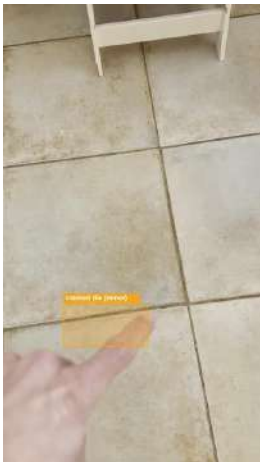
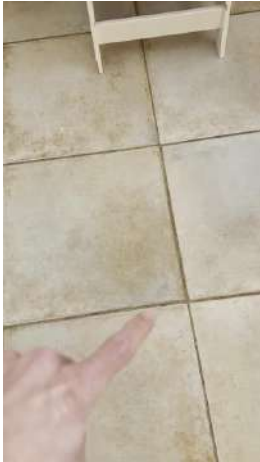
Two small cracks were observed in the kitchen floor tile. Cracked tile can allow moisture to penetrate the substrate and may deteriorate further over time. Recommend repair or replacement of the affected tile(s) by a qualified flooring contractor and verify the integrity of the surrounding substrate and grout. Obtain estimates as needed.

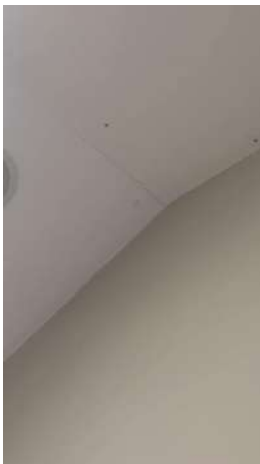
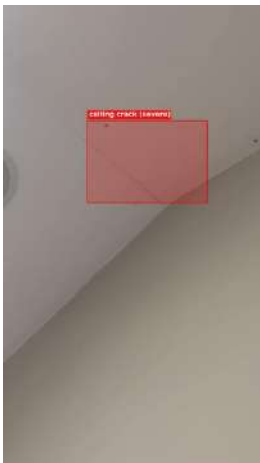
Significant drywall imperfections, including damage, cracking, or inconsistencies, were noted in the referenced area(s). It is advisable to inquire with the current homeowner(s) regarding any past alterations. Repairs should be undertaken by a drywall contractor as desired.

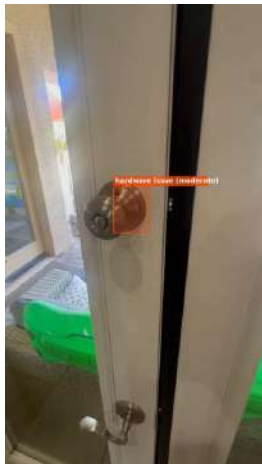
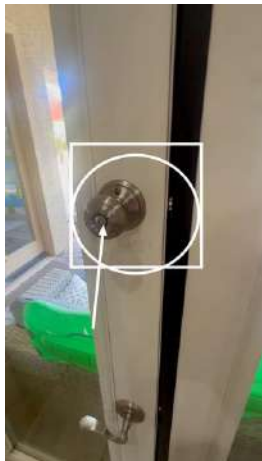
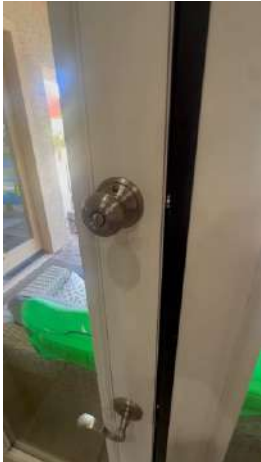
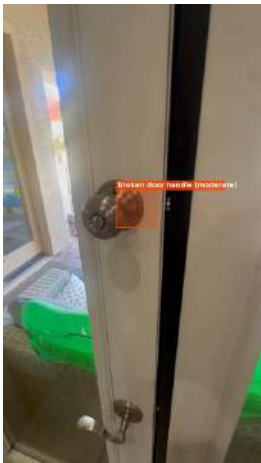
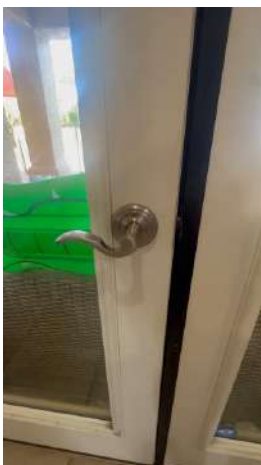
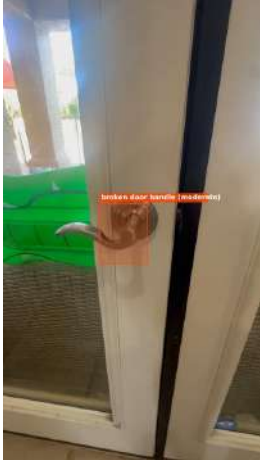
The deadbolt mechanism exhibits difficulty in proper operation. It is recommended to consult a qualified locksmith for necessary adjustments or replacement of the lock.

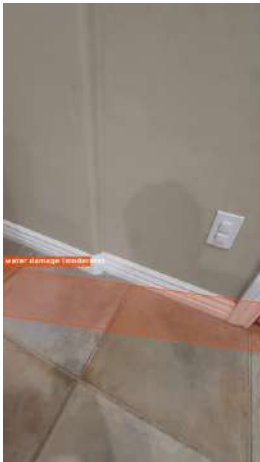
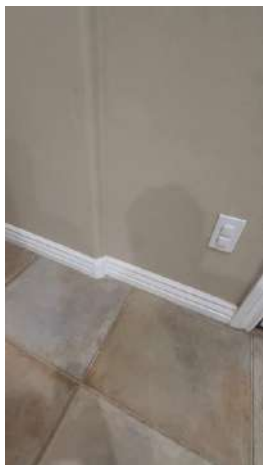
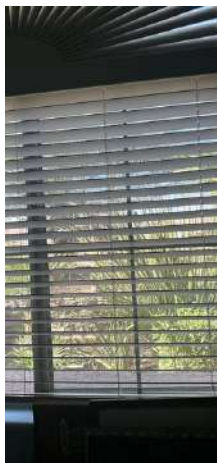
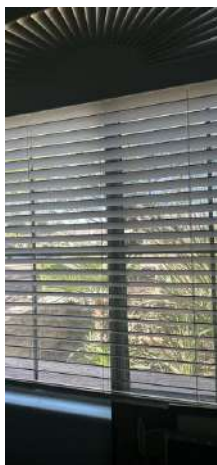
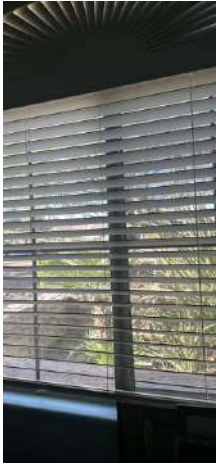
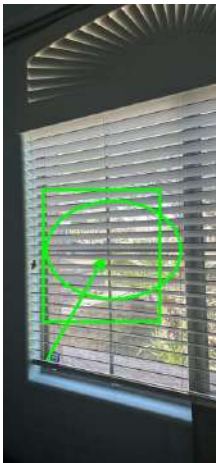
Water damage was observed on the subflooring during the assessment. This damage may signify a historical or ongoing leak. It is advised to consult with the seller regarding the nature of the damage and any prior repairs. Alternatively, monitor the affected area for any subsequent deterioration.

It is advised to engage a certified pest control company to address any wood-destroying organisms. Upon completion, have the affected areas repaired by a licensed building or remodeling contractor.

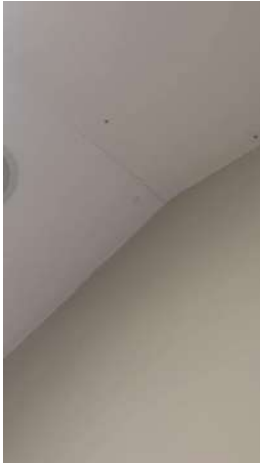
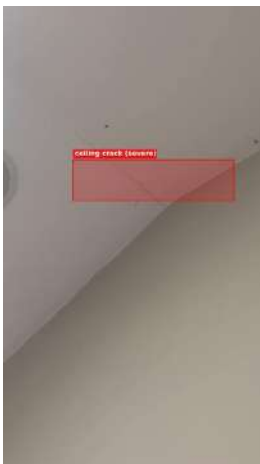
Significant cracking was observed in the ceiling in the Living Room that may indicate underlying structural movement or damage. A licensed contractor or structural engineer should be engaged to evaluate the extent and cause of the cracking and to recommend necessary repairs. This condition may represent a safety risk and should be addressed promptly.

Visible indications of atypical settlement or foundation movement were present. A comprehensive evaluation by a licensed structural engineer is strongly recommended, with subsequent repairs performed as determined necessary.
