1992 CONSTRUCTION

FATAL

WORKERS'
COMPENSATION
BOARD
OF BRITISH
COLUMBIA

POSTER # Const. 9-10

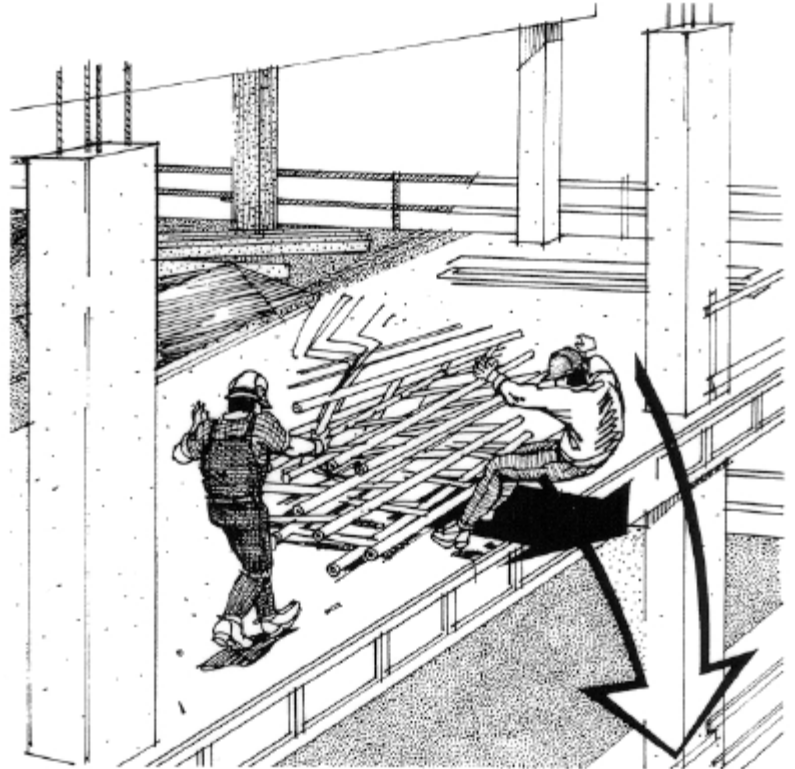
In preparation for placing a bundle of steel scaffolding on the third floor of this new building, the outer standard guardrails were removed. A banded bundle of frames was placed on the third floor approximately eight feet from the building edge. The frames were standing on edge and had to be turned by hand on the flat before they could be unstacked. The worker was trying to tip the scaffold frames on their side, but the steel strapping broke and kicked the bottom of the stack towards the ledge and pushed the worker off the building. He was killed by the fall.

Ensure that any changes to work procedures that could affect safety are reviewed before work commences. You must also ensure that workers receive adequate direction and instruction in the safe performance of their duties.

Follow all safe work procedures provided by the employer — don't use any other means if they are hazardous.
