# Gadsden County Road Safety Study

## Supplement 2 - Countermeasures for Immediate Implementation

7/31/2017

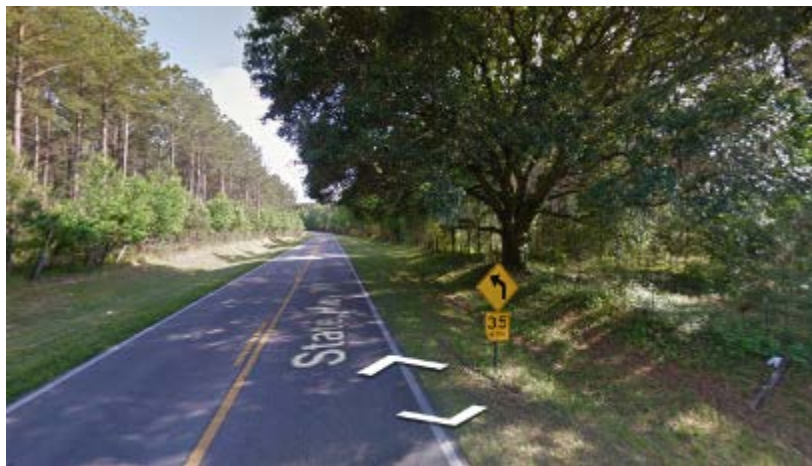
Figure 7 Existing curve warning sign(southbound) on High Bridge Road north of I – 10

- Add Flashing beacon southbound at advanced warnings sign (Figure 7).
- Install chevrons at two curves.
- Upgrade pavement markings through curves.

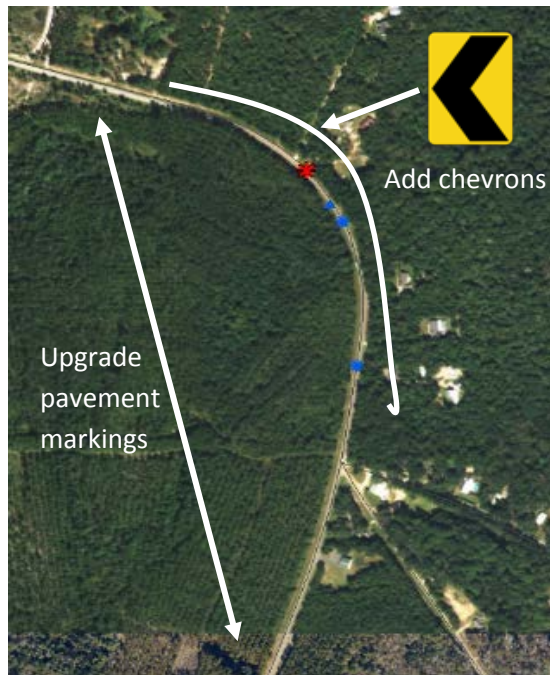
Figure 10 Cooks Landing Road

Multiple crashes at curve, including one fatality, two incapacitating injuries

Crashes in non-daylight hours

- Install chevrons throughout the curve
- Upgrade pavement markings through the curve

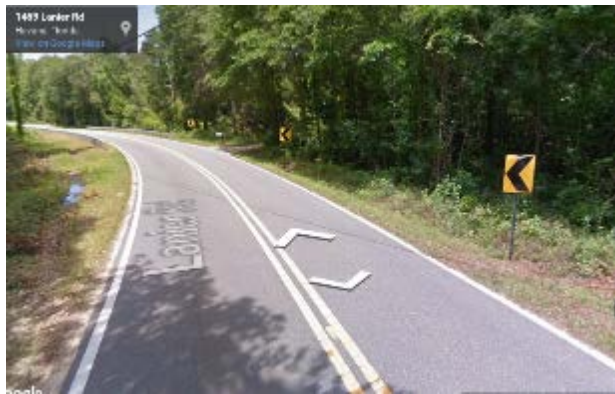
Figure 13 Lanier Road northbound at curve – (chevrons marking curve)

- Install chevrons southbound
- Extend chevrons northbound

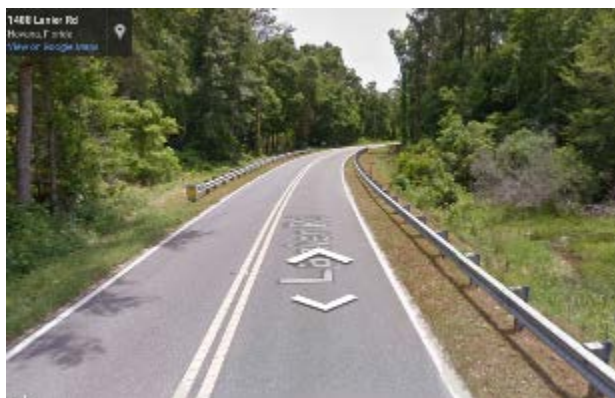
Figure 14 Lanier Road – southbound at curve (no chevrons marking curve)

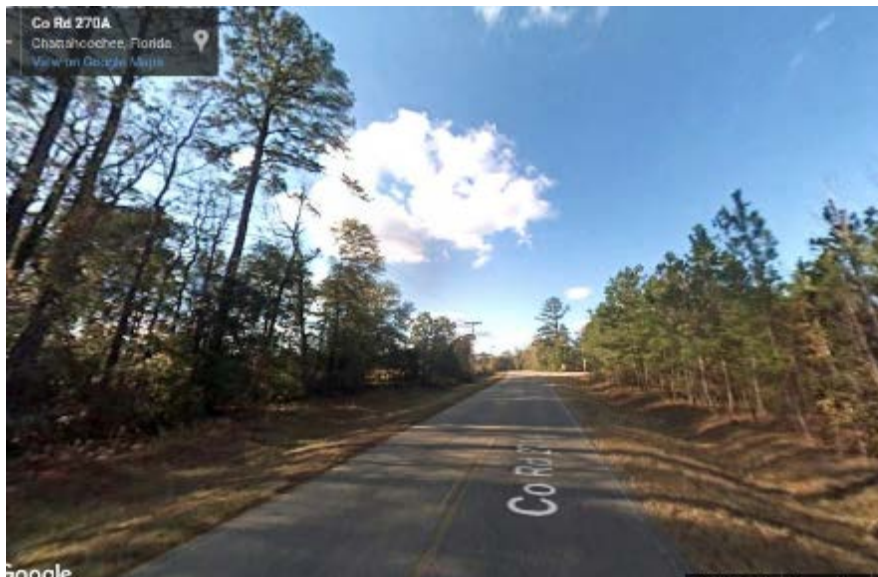
Figure 18 Curve on Flat Creek Road with visual trap westbound

- Add chevrons at the curve

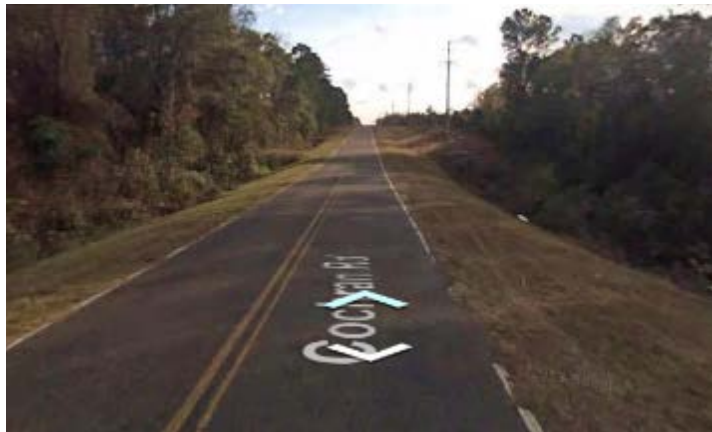
Figure 20 Steep slope near pavement – condition typical throughout area

- Add warning signs
- This may be supplemented with delineators if the condition is especially severe

- Add guardrail

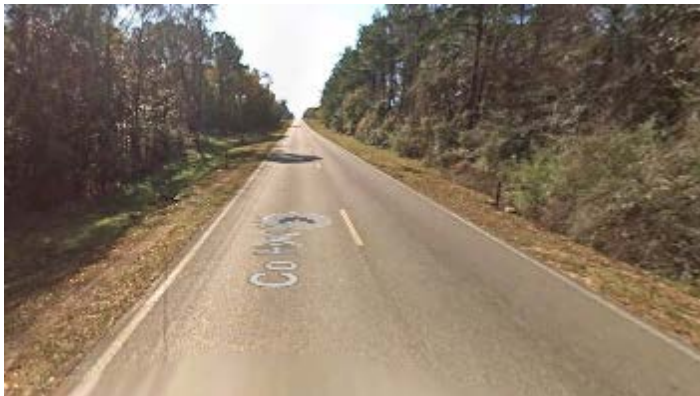
Figure 22 Typical unprotected culvert headwall near edge of pavement

- Install OM3-R object markers where headwalls are very near edge of pavement. This may be supplemented by delineators along the culvert.

- Warning signs where shoulders are very narrow for a significant distance on either side of the headwall, install W8-23 warnings

- Add guardrail
