Stellaris[®] LM3S9B92 RevC Errata

This document contains known errata at the time of publication for the Stellaris[®] LM3S9B92 microcontroller. The table below summarizes the errata and lists the affected revisions. See the data sheet for more details.

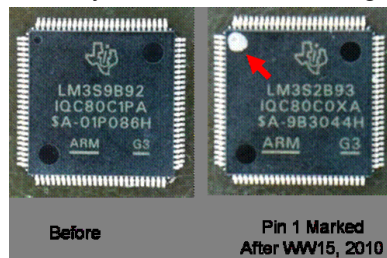
Note that two versions of the patch code have been released. Devices that have the patch code pre-programmed in Flash memory have a silver metallic dot located on the pin1 indicator. Devices that have the patch code plus a UART-only flash loader pre-programmed in Flash memory (see "Boot Loader in ROM is unusable" on page 4) have a date code of 05 or later. See Part Marking Examples below.

The silver metallic dot on the part indicating that the patch code was pre-programmed in Flash memory looks like the following:
