Stellaris® LM3S9B95 RevC3/C5 Errata

This document contains known errata at the time of publication for the Stellaris LM3S9B95 microcontroller. The table below summarizes the errata and lists the affected revisions. See the data sheet for more details.

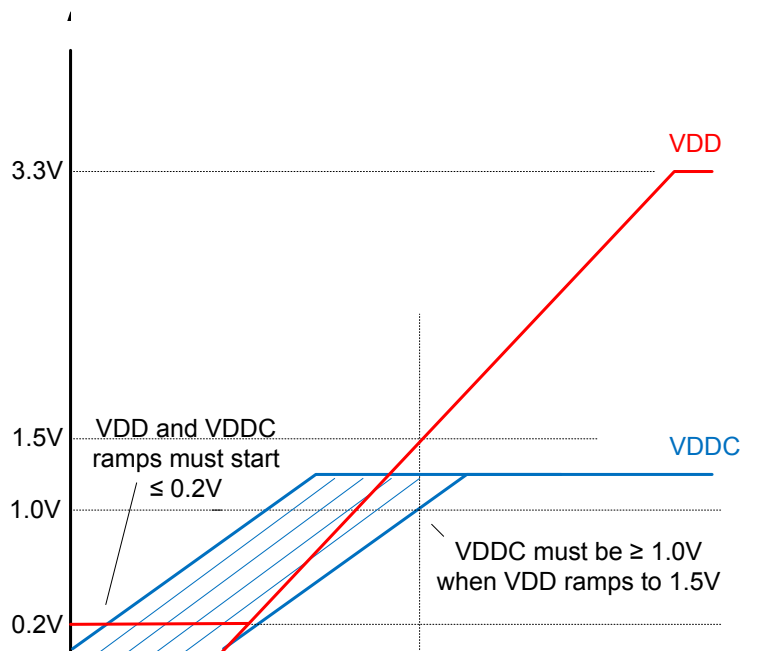
Figure 1. V_{DDC} and V_{DD} Rise Time Relationships

There is a small risk of flash corruption or device failure on power up. The issue can occur with certain V_{DD} and V_{DDC} power sequences. The failure is not in the flash memory itself but in the control logic to the flash.

- The ramp of both V_{DD} and V_{DDC} must begin below 0.2 V.
- V_{DDC} must reach at least 1.0 V before V_{DD} rises above 1.5 V.

Figure 1 on page 6 details these requirements. Three workaround circuits have been identified that meet these requirements and are described below.

Normally V_{DDC} is supplied by the device's internal voltage regulator from the LDO output pin, however in some circuits the internal regulator may not meet this V_{DDC} timing requirement. A circuit combining an external 1.2 V regulator, a voltage supervisor and a power switch can be used to ensure that this timing requirement are met. The 1.2 V regulator has an integrated Power-OK (POK) circuit that is used to enable V_{DD} when V_{DDC} reaches 1.08 V. During power-down or transient conditions, the POK circuit disables the load switch if V_{DDC} drops below 1.02 V or V_{DD} drops below 1.5 V. The load switch has an internal clamp to accelerate V_{DD} decay.
