Stellaris® LM3S9B92 RevB1 Errata

This document contains known errata at the time of publication for the Stellaris® LM3S9B92 microcontroller. The table below summarizes the errata and lists the affected revisions. See the data sheet for more details.

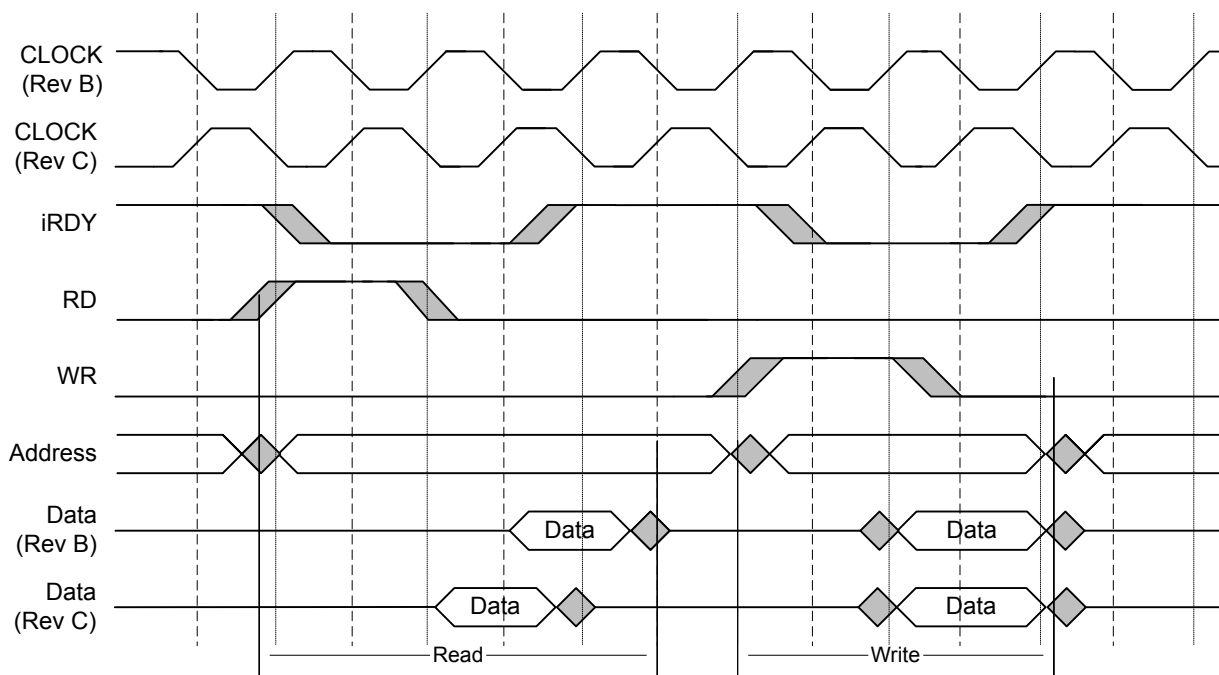
Figure 1. Timing Differences Between Rev B and Rev C Devices

The clock signal that is output on the EPIO31 signal in General-Purpose mode is inverted. Figure 1 on page 13 shows the timing differences between Rev B parts and Rev C parts.

Use the opposite edge for timing when designing with this interface. During read cycles, ensure that the data meets set up and hold times for the appropriate edge as shown in the diagram above.

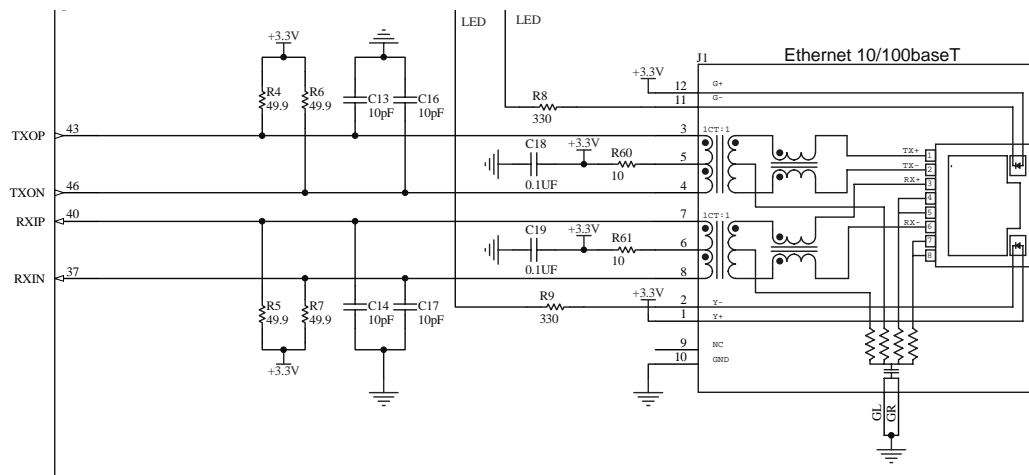
Figure 2. Recommended Center-Tap Connections

The microcontroller experiences some packet loss with Ethernet cables longer than 50 meters in normal operating conditions.

1. Add 10 Ω resistor to the center-tap of the transformer as shown in the figure. These resistors should be replaced by a direct connection for silicon that has this item fixed.
2. Continue using the recommended circuit, but limit cable lengths to 50 meters.

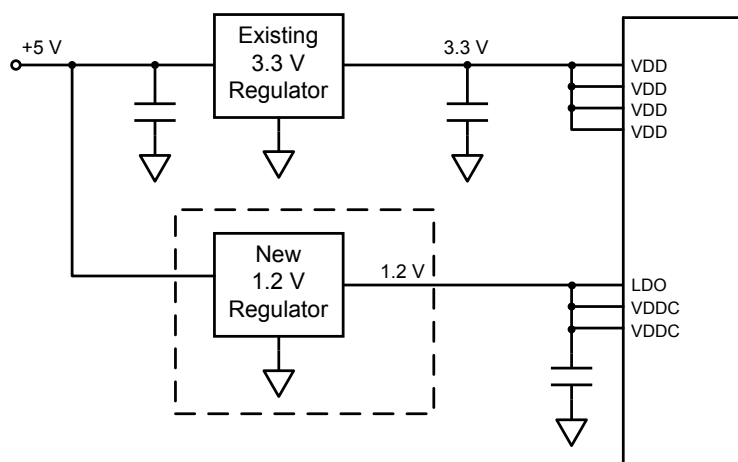
Figure 7. Configuration of External Regulator

Incorrect power sequencing during power up can disrupt operation and potentially cause device failure.

V_{DDC} must be applied approximately 50 μs before V_{DD} . Normally V_{DDC} is controlled by the part's internal LDO voltage regulator. The workaround requires the addition of an external regulator (see Figure 7) to ensure that V_{DDC} sequencing requirements are met (see Figure 8). A recommended regulator is the TI TPS73101DBVR.
