UNIVERSITY OF THE
WITWATERSRAND,
JOHANNESBURG

Analysis of Torpedo Ladle Refractories Experiencing Premature Failure at the Spout

MSc (50/50) RESEARCH REPORT

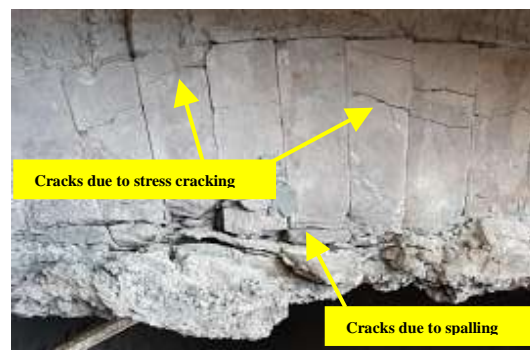
Figure 11: Upper arch of torpedo ladle

Cracks are visible towards the hot face and cold face. The cracks closer to the hot face appear to be a result of spalling. Uneven expansion and contraction within the refractory is caused by rapid temperature changes. This generates internal stresses and strains, which eventually cause cracks to appear and propagate. The cracks present at the back are due to stress cracking. The cold face of the brick is not exposed to temperature that can cause thermal shock. Thus, as stated in literature (Bhatia, 2011), this is a consequence of improper installation as it occurs when joints are too tight, which does not cater for expansion, thus the bricks experience excessive stress, causing them to crack.

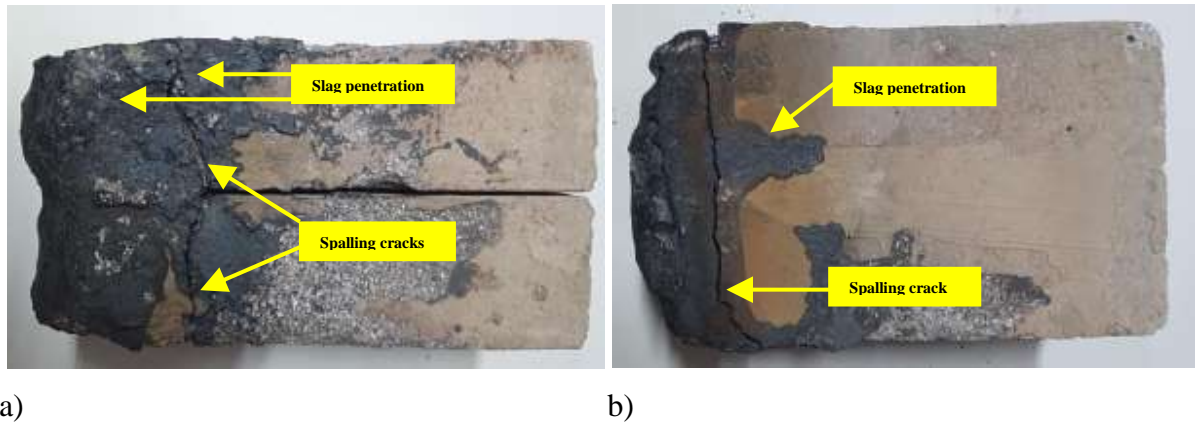
Figure 12: Spalling cracks and slag penetration shown from (a) top view and (b) side view

The cracks are clear and well defined and they are evidence of spalling. Other than overfilling, spalling may also occur as a result of inadequate pre-heating or standing too long at steel plant. The darker areas close to, around and behind the spalling cracks indicate that slag has entered and reacted with the brick. There is also slag penetration inside the crack, as shown in Figure 13.

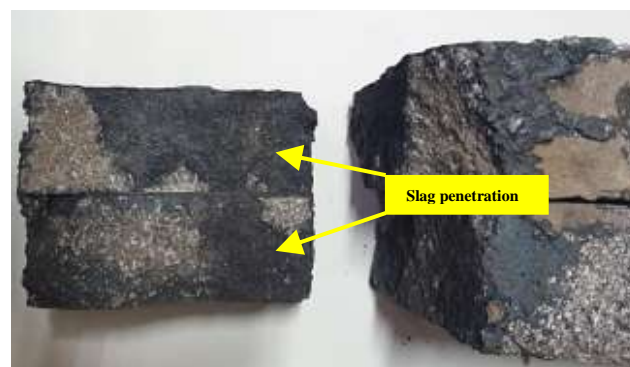
Figure 13: Slag penetration inside spalling crack

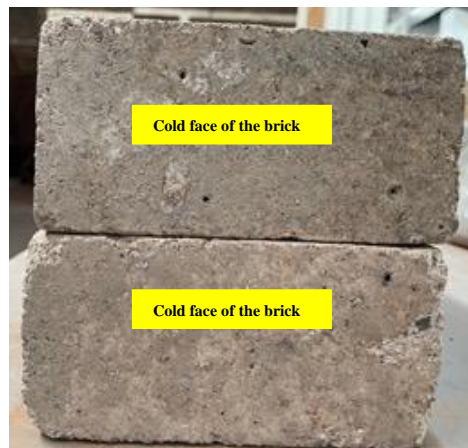
Figure 14 shows the cold face of the bricks, which are in a good condition as there is no evidence of severe damage.

Figure 14: Cold face of the brick

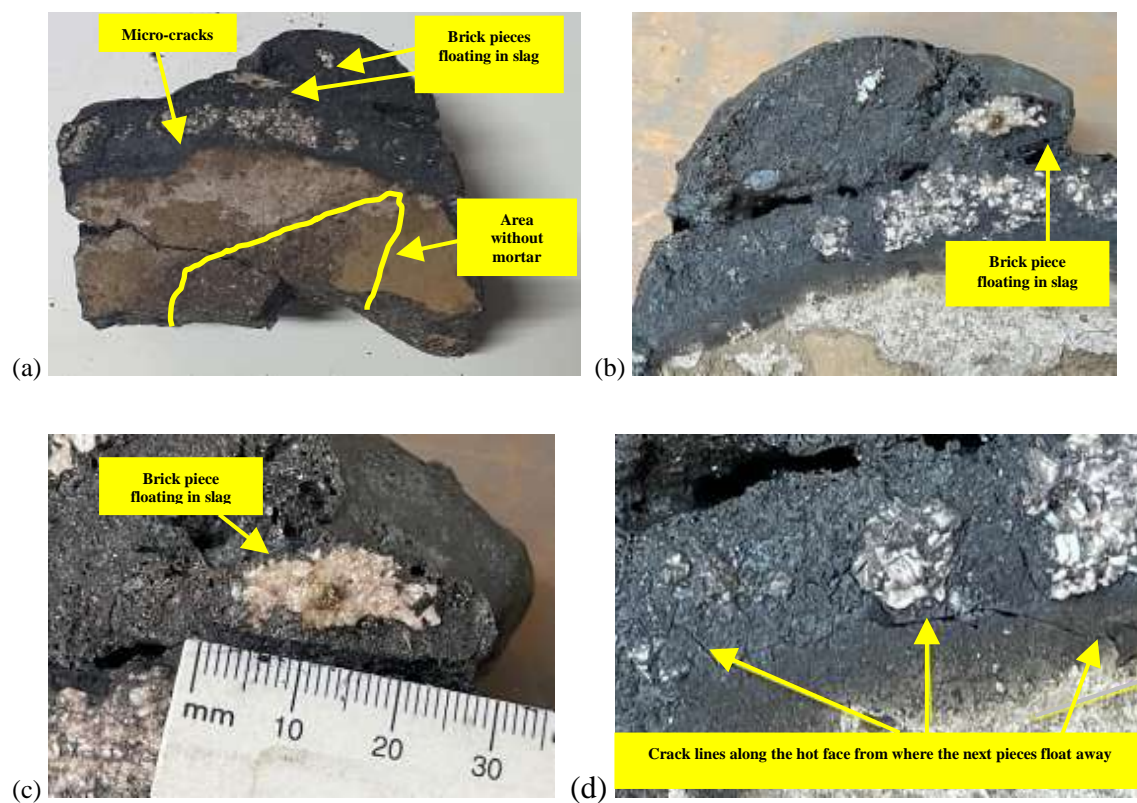
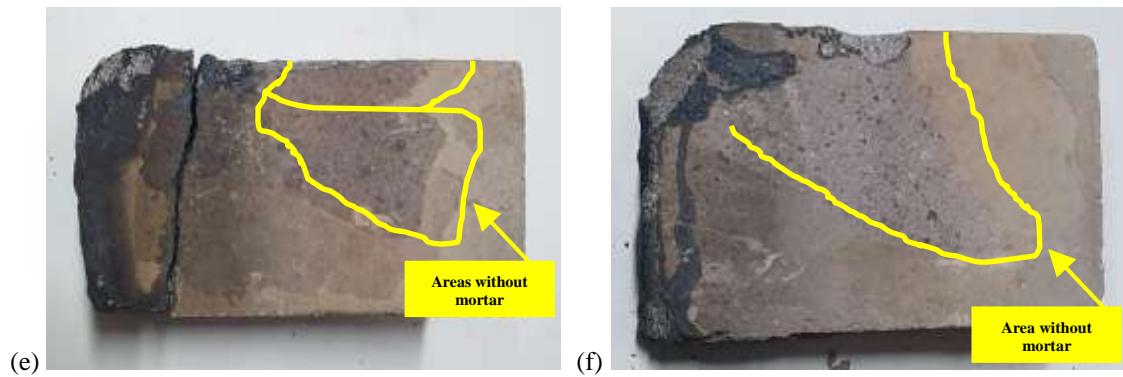
Figure 15: Problems occurring within refractory brick: (a) Evidence of micro-cracks, brick pieces floating in slag and area without mortar, (b) Brick piece floating away in slag, (c) Length of brick piece floating in slag, (d) Cracks along hot face, (e) Area of brick not covered by mortar, and (f) Area of brick not covered by mortar.

There are large pieces that have spalled off the hot face of the brick that can be seen floating in the slag, which is shown in Figure 15 (a) and (b). The brick appears to be unreacted, which indicates that the brick has good slag resistance. However, due to spalling, the pieces of brick may be removed during operation, which, as seen in Figure 15 (c), is at least 20 mm. Removal of such large pieces will cause rapid deterioration of the brick. Micro-cracks are also visible, which are likely initiated due to spalling or when the brick is penetrated with slag, which may react with the refractory, forming products that have a higher expansion coefficient. They also indicate the next pieces that will be removed by the slag. When these cracks propagate, it results in material loss. Figure 15 (a), (e) and (f) shows areas on the brick that are not covered by mortar. This indicates that the application of mortar during installation is incorrect. The purpose of the joint is to accommodate expansion and contraction during operation, without causing damage to the brickwork (Bhatia, 2011). When there are opened spaces in the joint, liquid metal or slag may penetrate it, which expands and contracts during operation, causing further damage to the brick as the degree of expansion cannot be accommodated. Thus, improper mortar application may also lead to stress cracking in the brickwork.

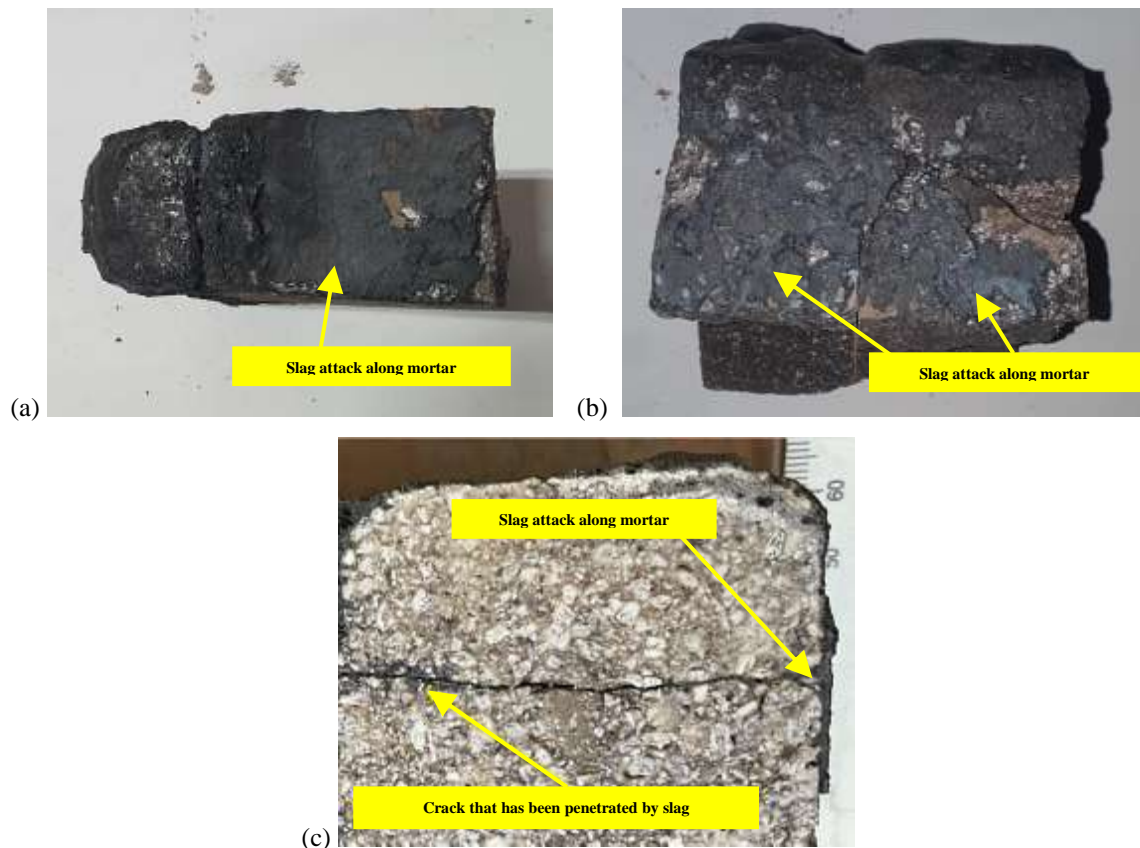
Figure 16: Slag penetration and attack of (a) mortar joint, (b) mortar joint, and (c) mortar and crack via joint

The rule of thumb for mortar selection is, to select a material of superior quality to the brick. Even though the mortar used in this application has a high alumina content, it contains 7% impurities, such as TiO_2 and Fe_2O_3 , which may make it more susceptible to slag attack. Furthermore, when there are areas that are not covered by mortar, the joint may be penetrated far deeper than the hot face. This also allows slag to enter between spalling cracks and penetrate from within, as shown in Figure 16 (c). The brick is still in good condition, thus, penetration probably occurred through the crack, via the joint. Slag penetration and attack is evident by the darker coloured area on either side of the crack. This speeds up crack propagation, and ultimately, material removal. Metal penetration may also occur, however, it does not react with the refractory brick. Thus, the metal remains between the crack and the joint, as shown in Figure 17 (a) - (c).

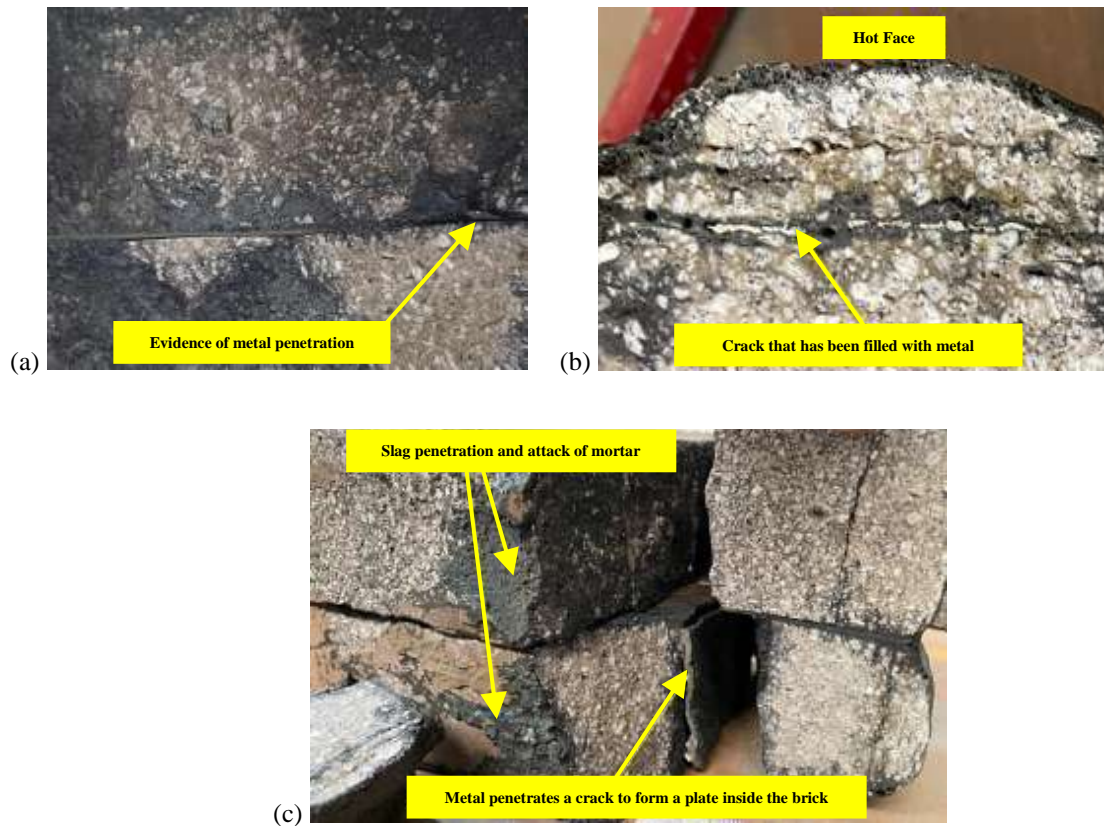
Figure 17: Metal penetration of refractory evident (a) as a metal chip, (b) between a crack, and (c) as a metal plate

Due to poor mortar application and thermal expansion of the hot face of the brick, there is sometimes iron penetration through the joint. The metal expands and contracts during operation as it is exposed to a wide range of temperatures. Upon expansion, new cracks may develop and existing cracks may propagate, increasing the frequency of material loss. Since penetration of joints, either by slag or metal, adversely affects the effect the brickwork's ability to accommodate expansion, this may also contribute to the stress cracking experienced by the bricks.

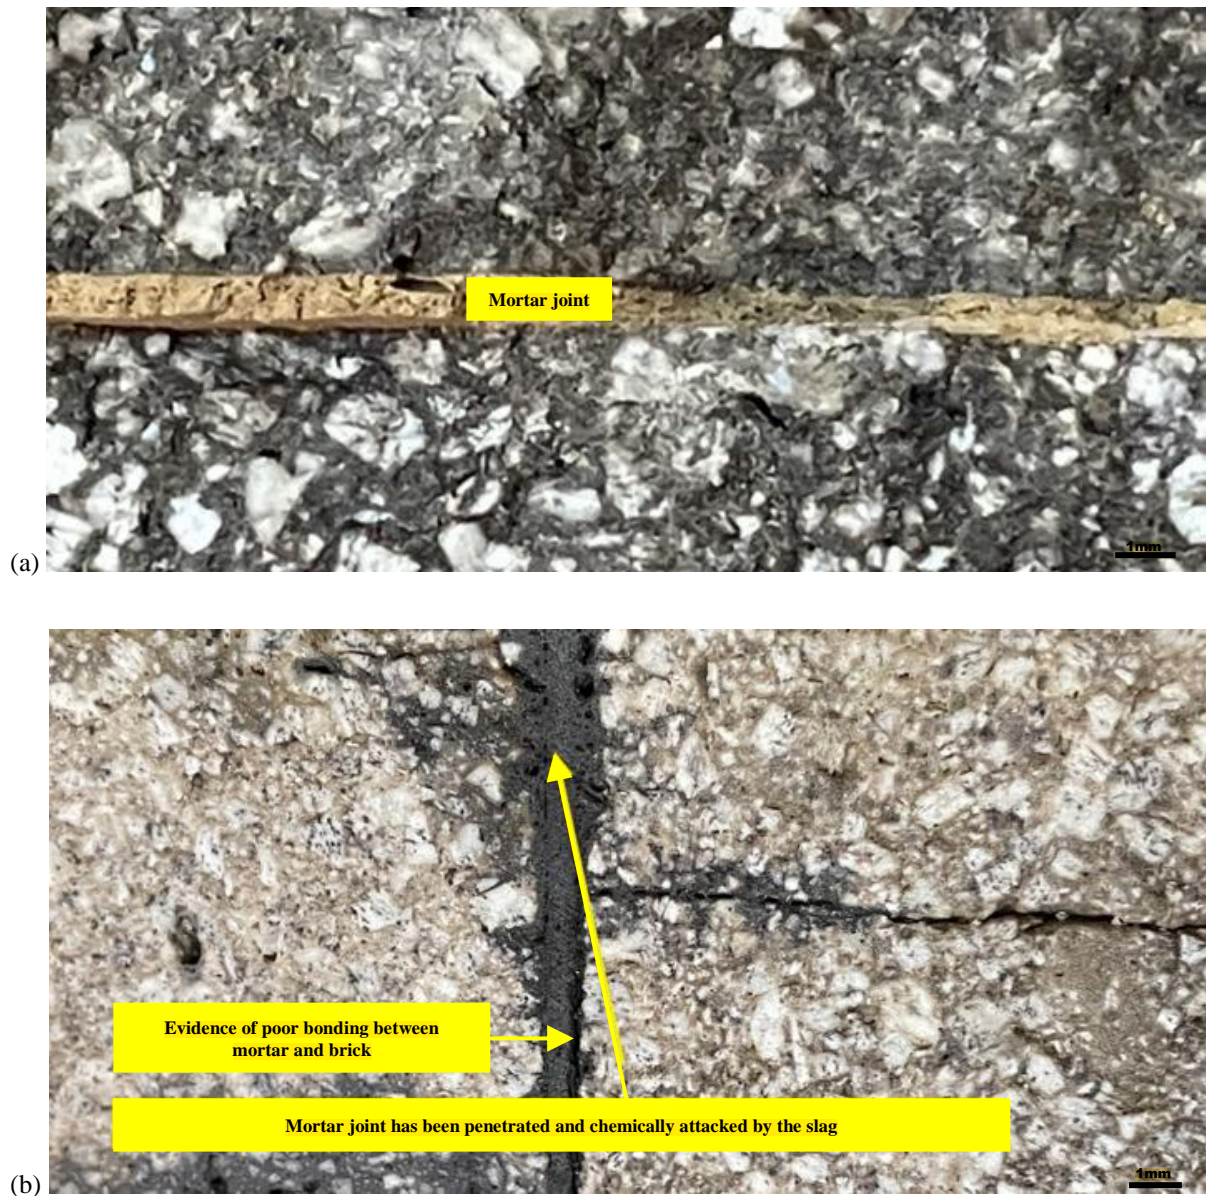
Figure 18: Micrographs of (a) unpenetrated and (b) penetrated mortar joints

There are three important things to note about the mortar joints. Firstly, the mortar joints are not uniform. Joints are required to be 1mm; however, it can be seen in Figure 18 (a), the joint are noticeably thinner in some areas. This has a strong influence on whether the torpedo brickwork is able to accommodate expansion without causing damage. Uneven joints may decrease the ability to accommodate expansion, leading to stress cracking. The second problem is that there is slag penetration and chemical attack of the mortar joint, as shown in Figure 18 (b), which may result in products that either have higher expansion coefficients, which impose more stress and strain on the brick, or those that have lower melting points, which result in material removal with liquid slag. The area of attack shows open spaces, which implies that there was removal of material due to liquid formation. In comparison to

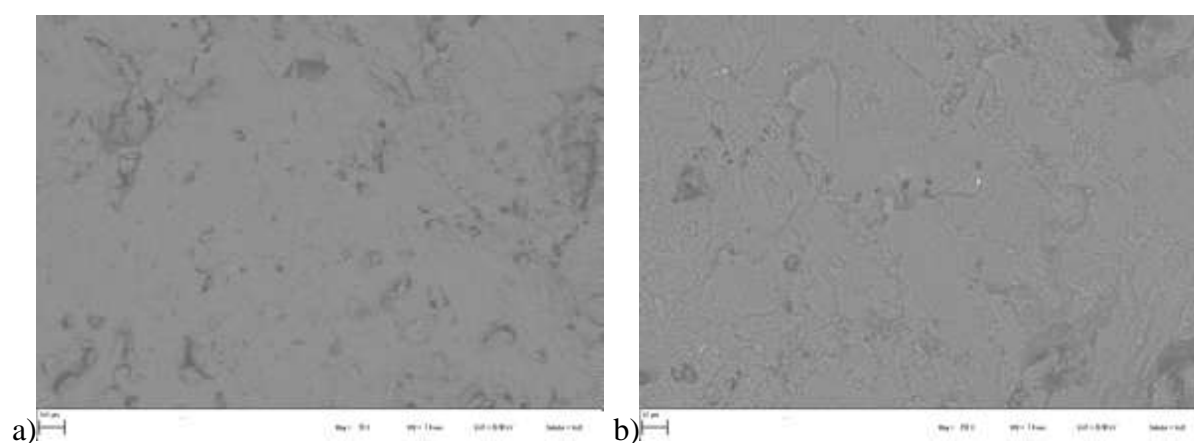
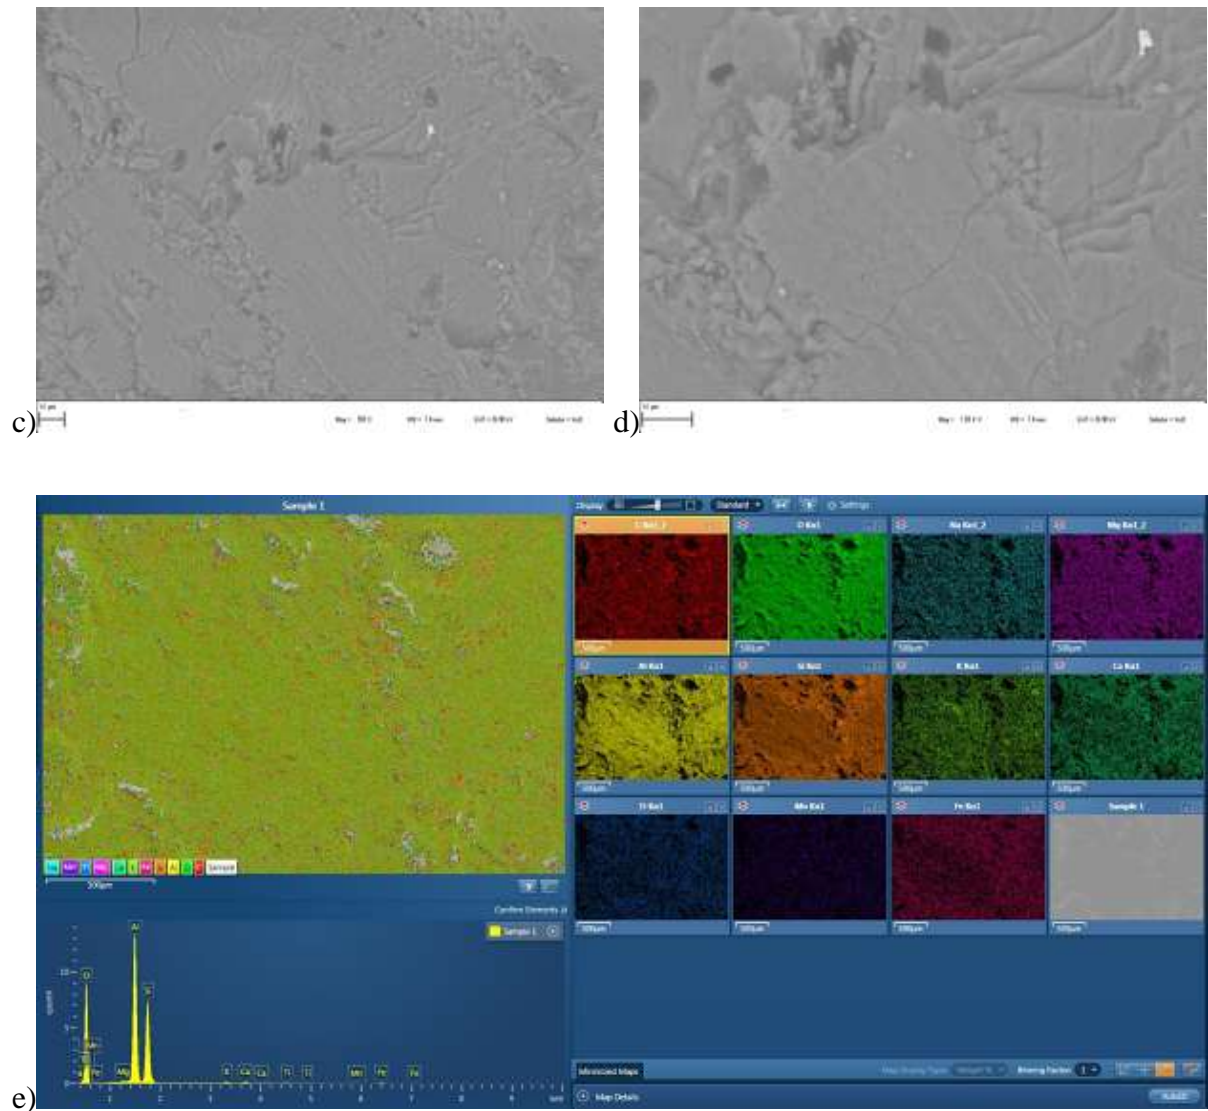
Figure 20: SEM images of cold face a) at 50x magnification, b) at 250x magnification, c) at 500x magnification, d) at 1000x magnification, and e) with EDS

In Figure 20 a), it can be seen that the image is mostly one shade of grey. The homogeneous appearance indicates that the cold face is unreacted. The darker areas result from damage to the brick, where material has been removed. As the magnification of the brick increases, as seen in Figures 20 b) & c), the damage to the brick is more visible. Cracks are also seen in Figure 20 d). Figure 20 e), the SEM image with EDS of the cold face, shows the elemental distribution of the cold face, which mostly comprises of aluminium (Al), silicon (Si) and Oxygen (O) and other trace elements. This shows that the cold face has had little or no change from its original state.

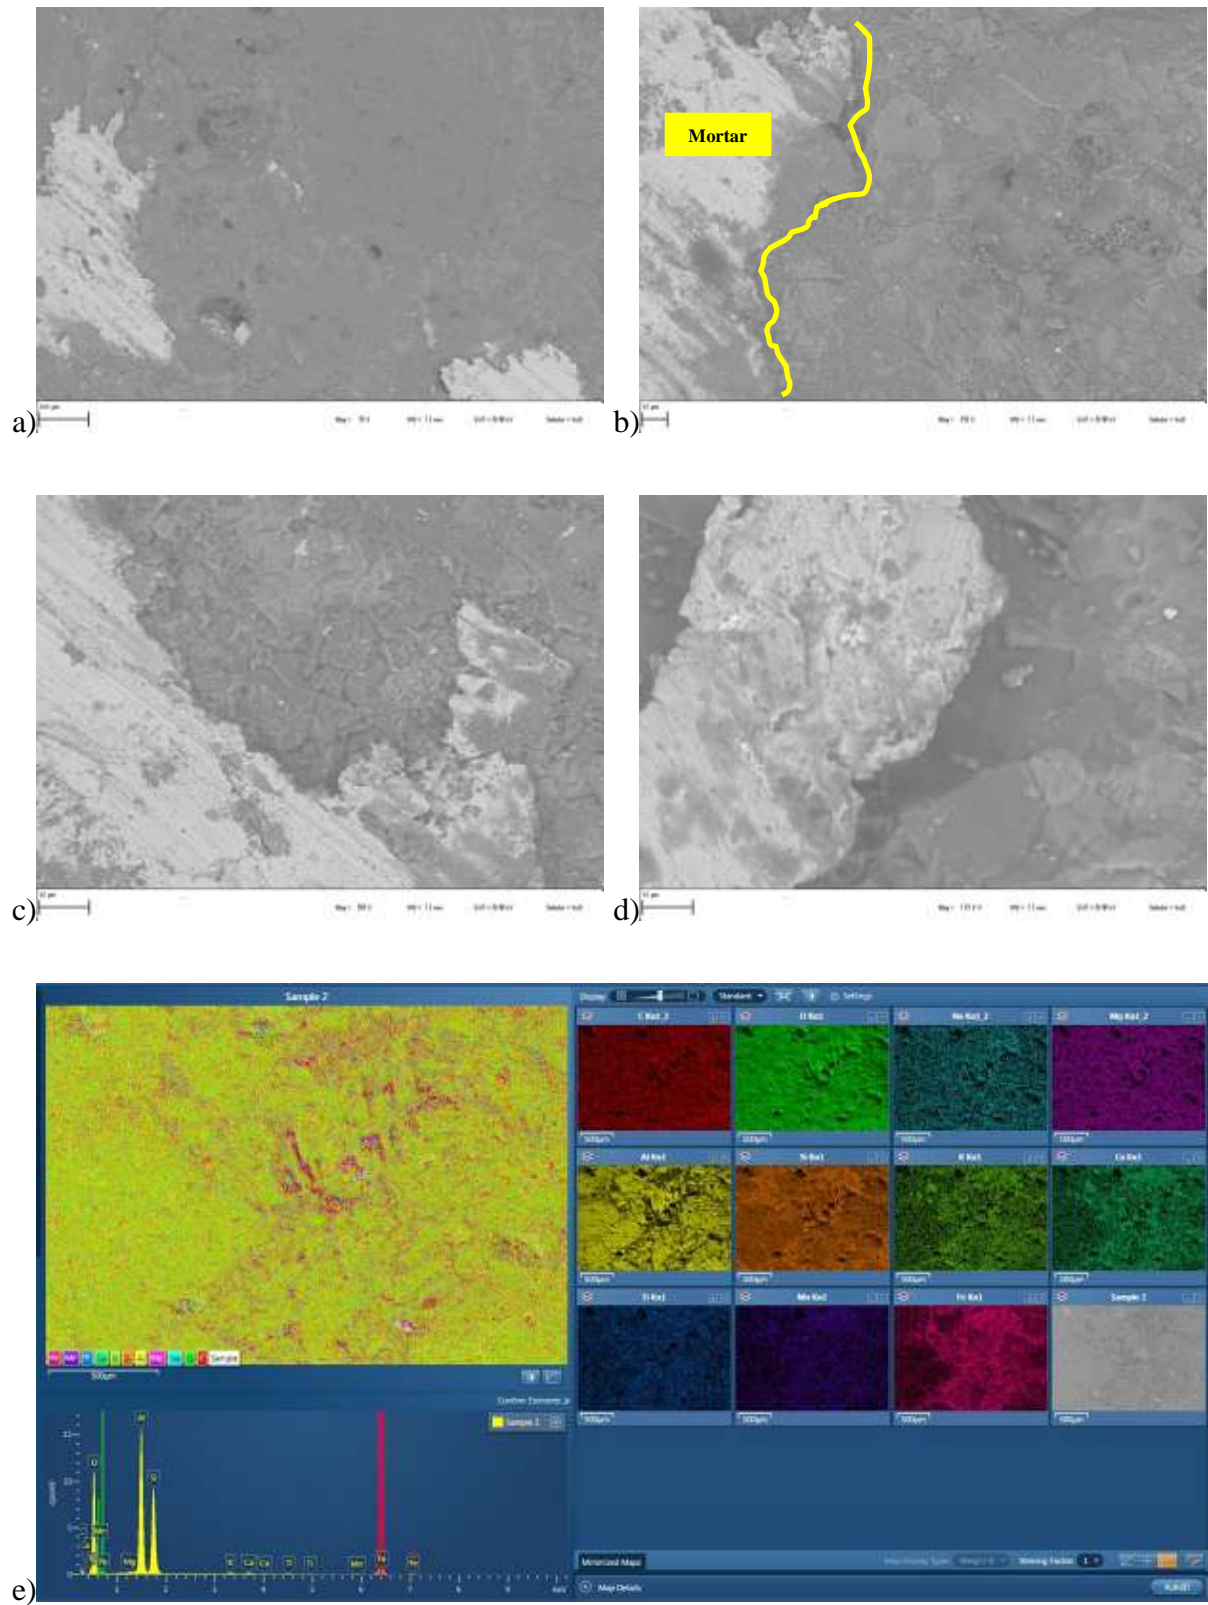
Figure 21: SEM images of refractory-slag interface a) at 50x magnification, b) at 250x magnification, c) at 500x magnification, d) at 1000x magnification, and e) with EDS

Figure 21 a) is mostly one shade of grey, with two distinct lighter areas. Since heavier elements appear lighter in SEM images, this indicates the presence of iron. In Figure 21 b) and c), the iron can be seen on a layer of mortar, thus, the amount of iron may be less than it appears to be. Figure 21 d) shows an enhanced image of the brick where there are some lighter spots, which may indicate some iron infiltration. Figure 21 e) shows the elemental distribution of the refractory-slag interface, which mostly comprises of aluminium (Al), silicon (Si) and Oxygen (O) and other trace elements, however, there is now a small, but significant amount of iron (Fe) present. This shows that the interface is subjected to elemental changes due to iron infiltration in areas where the brick has been damaged.

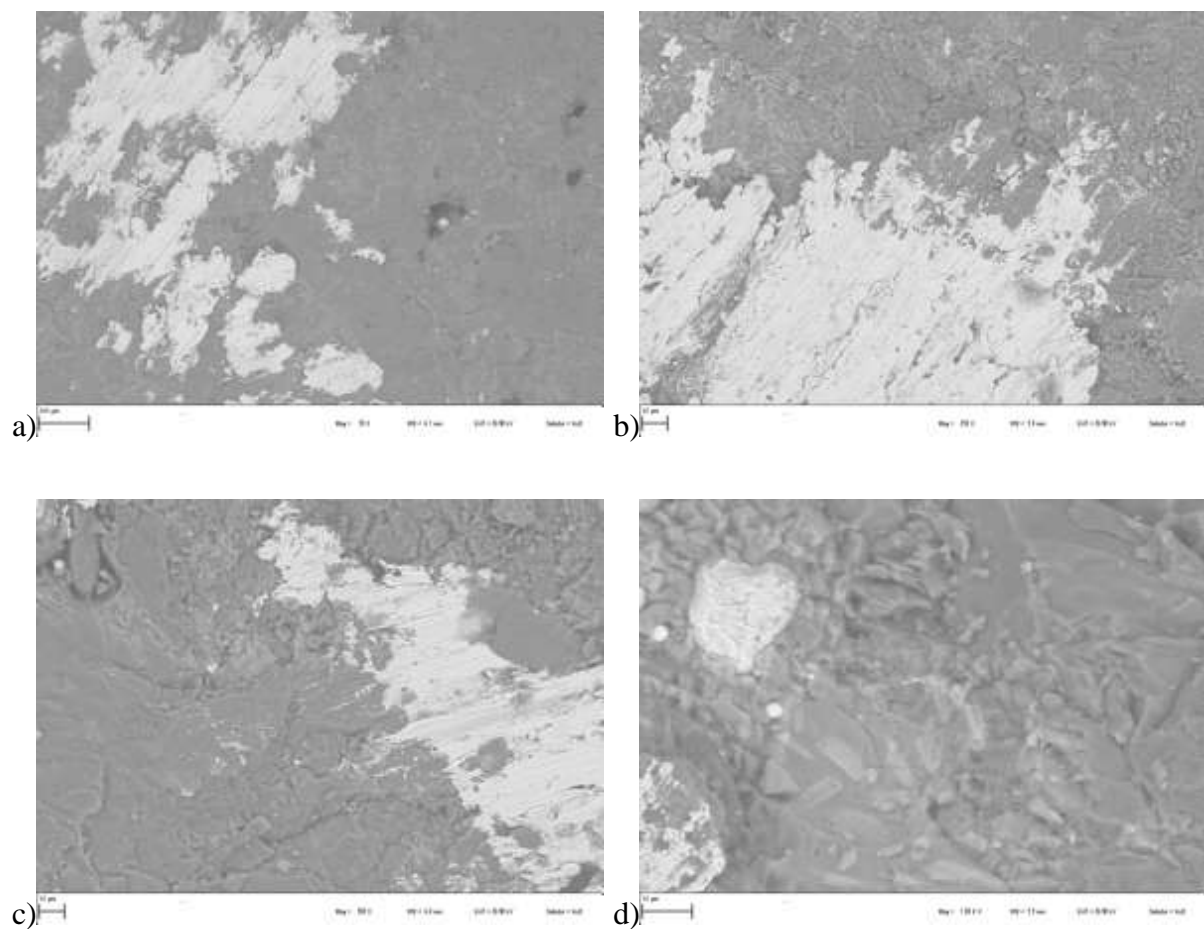
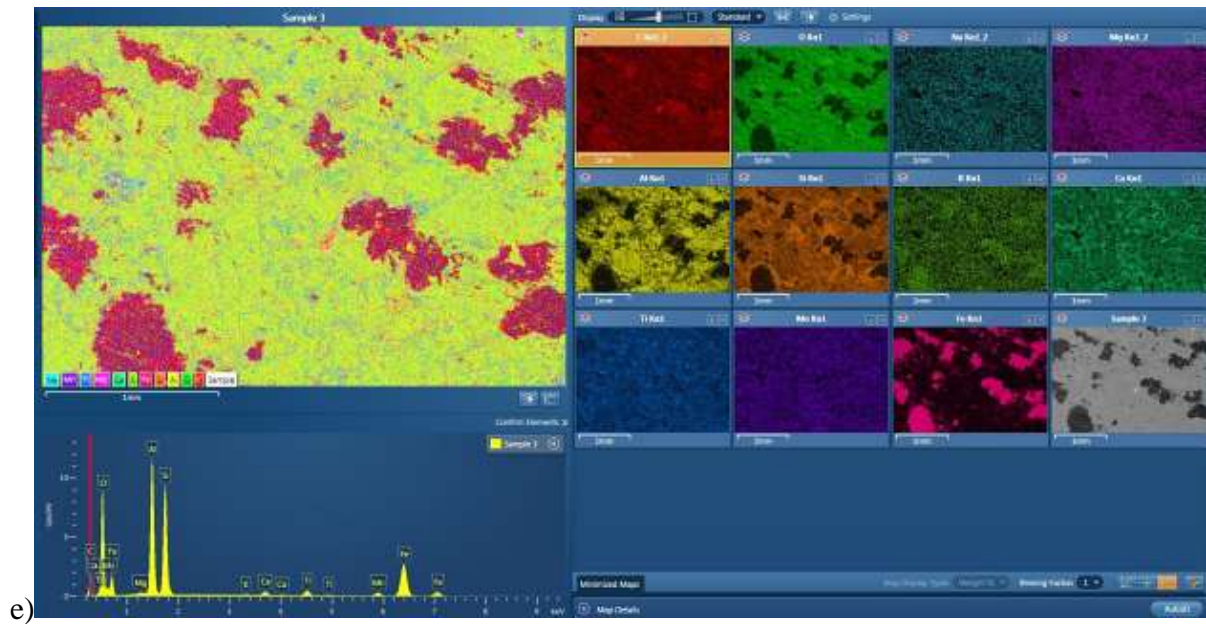
Figure 22: SEM images of hot face a) at 50x magnification, b) at 250x magnification, c) at 500x magnification, d) at 1000x magnification, and e) with EDS

Figure 22 a) has more lighter areas than the cold face and interface, indicating that there is a higher presence of iron at the hard face. This is due to iron infiltration, and enhanced in improper operating conditions that promote skull formation. Figures 22 b), c) and d), the iron can be seen on a layer of mortar, as well as in the brick matrix. Figure 21 e) shows the elemental distribution of the hot face, which mostly comprises of aluminium (Al), silicon (Si) and Oxygen (O), however, the amount of trace elements and iron (Fe) has increased significantly. This indicates that there is iron and slag infiltration, and possibly some degree of corrosion at the hot face.
