ANALYSIS OF NR FLOWMARK DEFECT & TROUBLESHOOTING GUIDE

FROM : TOP GLOVE – F05 (IPOH)

PREPARED BY : MR. KC. KONG

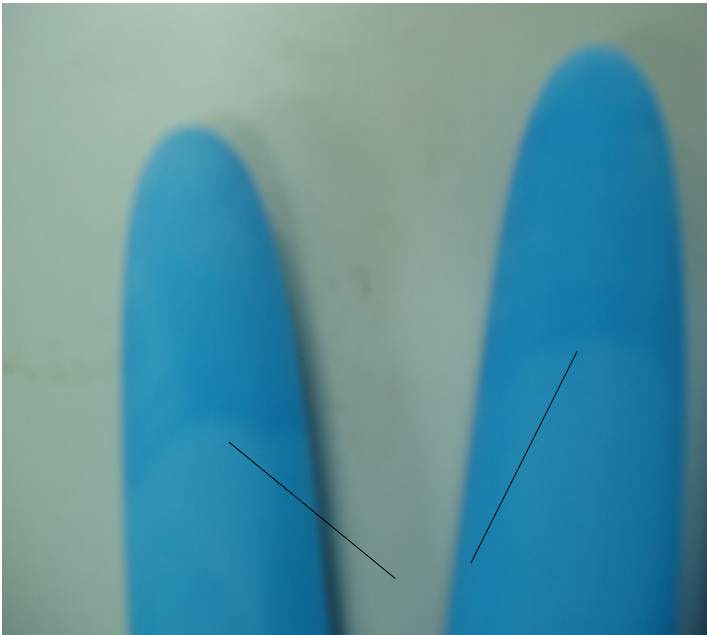
At Fingertip Area

The ring marking as Coagulant circulating at the fingers area especially for XS and S size or more glazed formers.

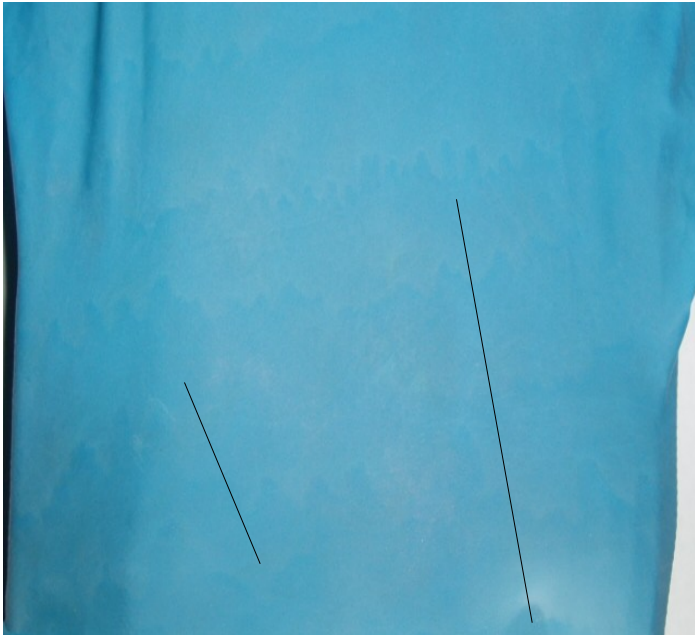
At Cuff Area

The flow mark appearance and can be seen on the gloves when pressed and more obvious especially for lower weight gloves eg TW50. (Picture beside showed of the segments of flow).

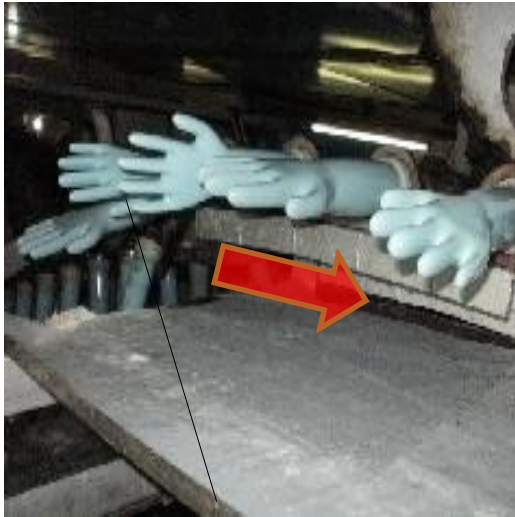
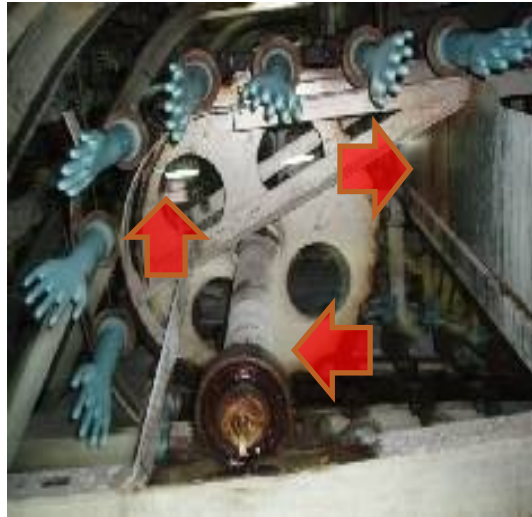
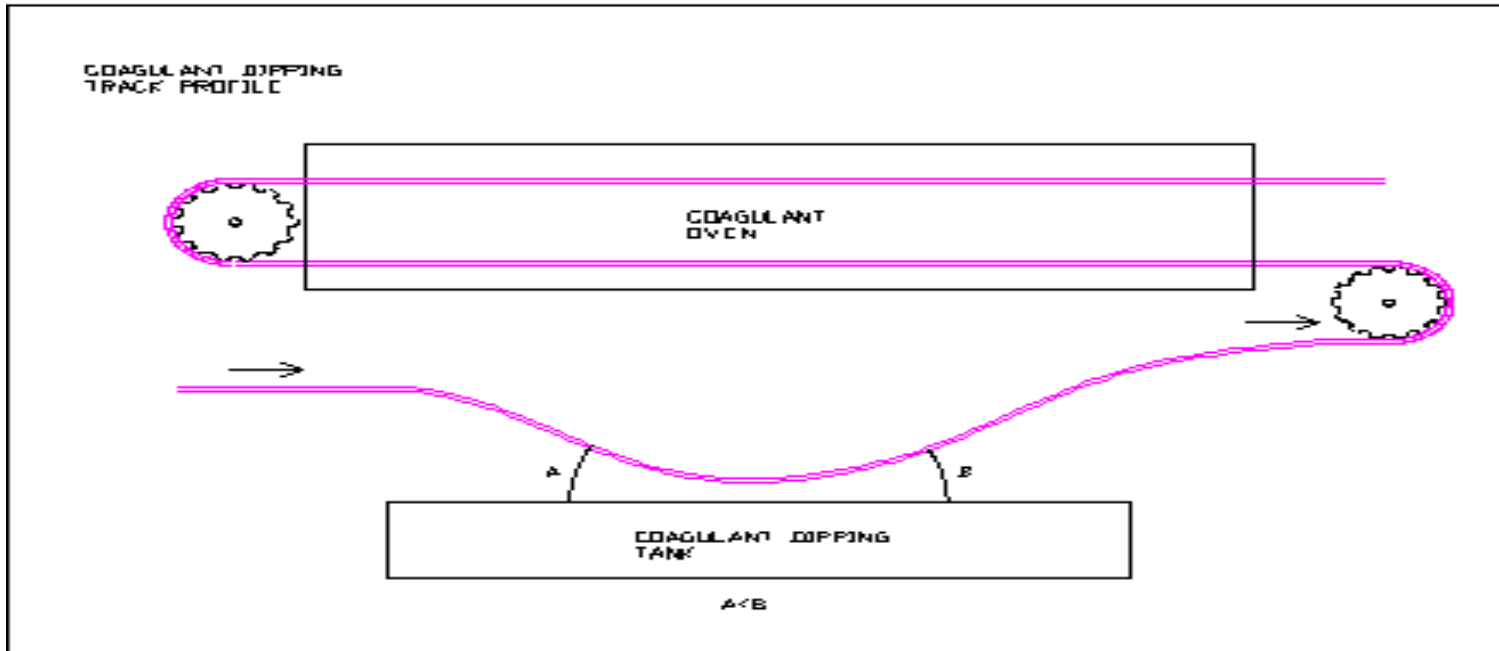
There is a 'C' plate immediately after formers withdrawal from Coagulant that causes the Coagulant accumulate at finger & less Coagulant flow downwards.

- Ensure the horizontally of the formers before Coagulant dryer not focusing on the fingers area
- Design the line for future with better dripping & have better rotation before going into Coagulant dryer
- Dipping lower weight products type at single layer Coagulant
