Structural Repair Quality Analysis Report

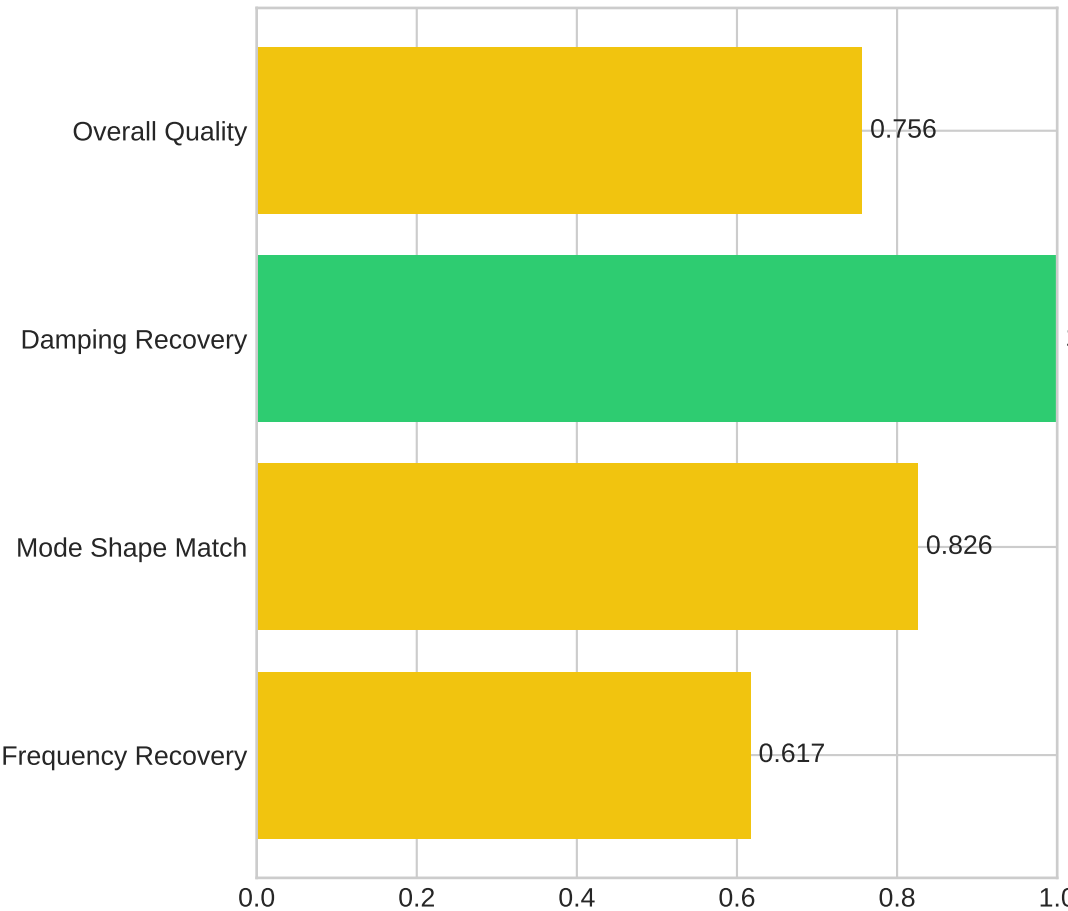
Quality Score Breakdown

0.756

Repair Quality Score

Good - Acceptable Repair
