Structural Repair Quality Analysis Report

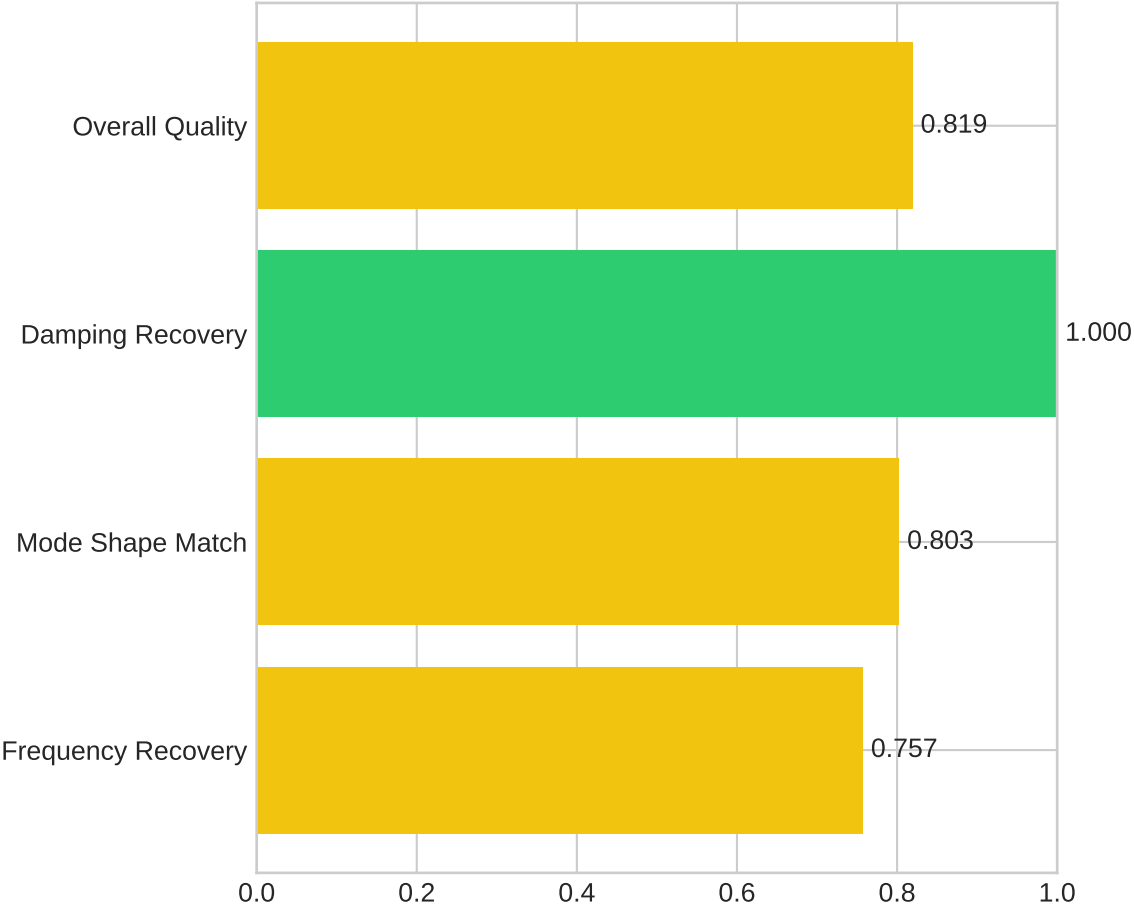
Quality Score Breakdown

0.819

Repair Quality Score

Good Restoration - Acceptable Recovery
