Structural Repair Quality Analysis Report

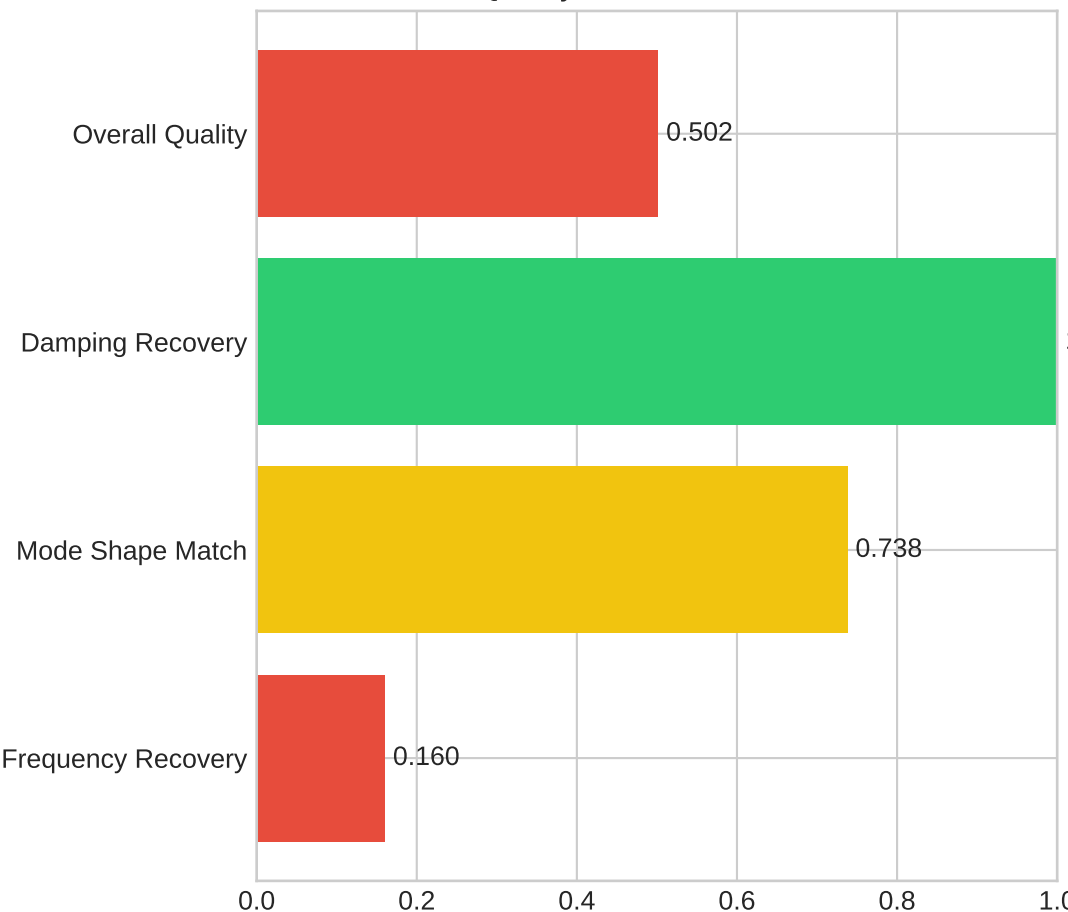
Quality Score Breakdown

0.502

Repair Quality Score

Fair - Partial Improvement
