Structural Repair Quality Analysis Report

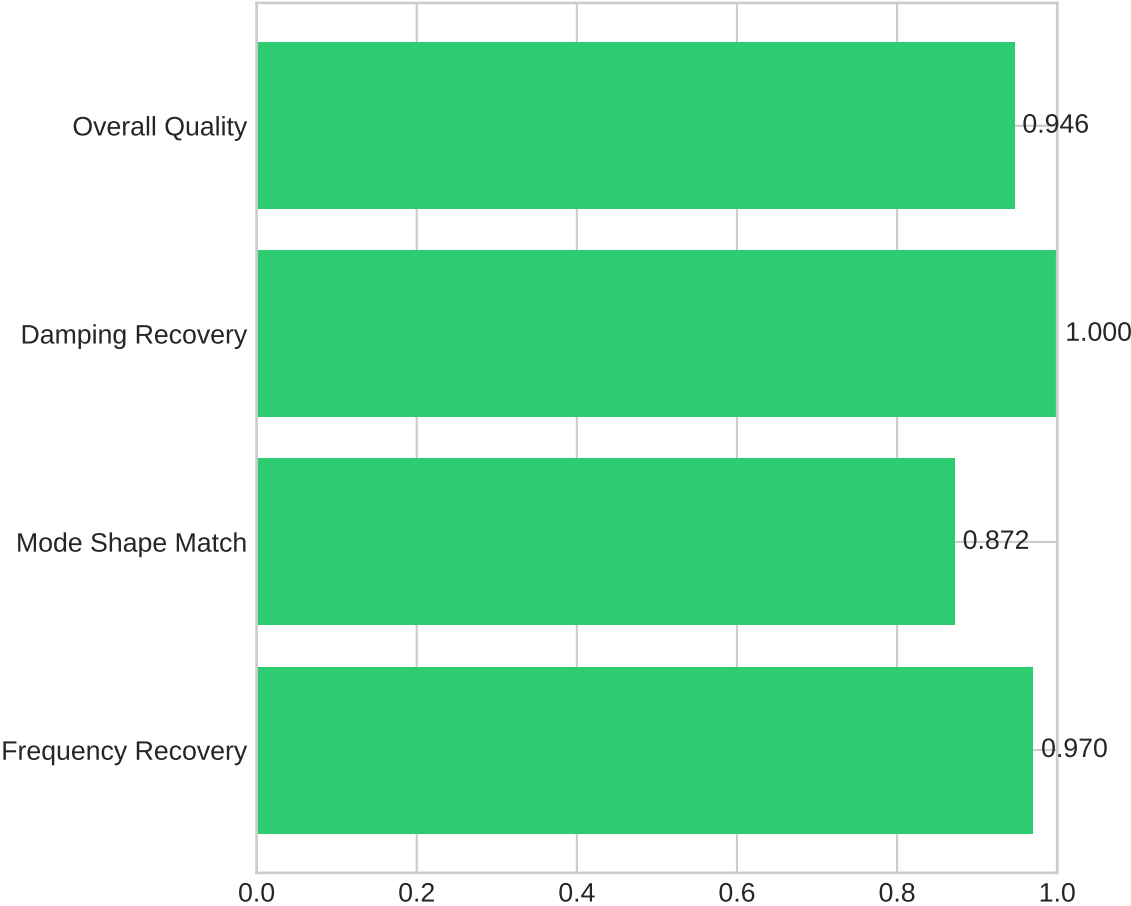
Quality Score Breakdown

0.946

Repair Quality Score

Very Good - Highly Effective Repair
