Structural Repair Quality Analysis Report

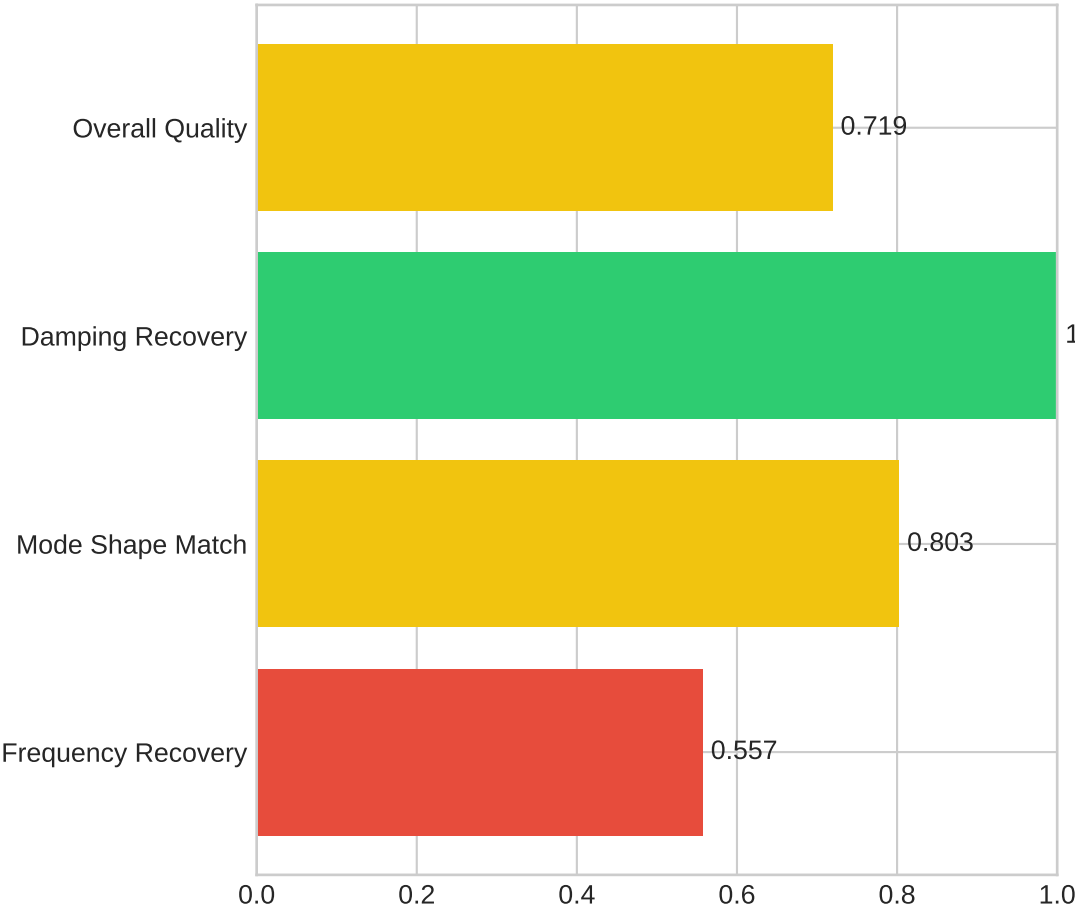
Quality Score Breakdown

0.719

Repair Quality Score

Good Restoration - Acceptable Recovery
