Structural Repair Quality Analysis Report

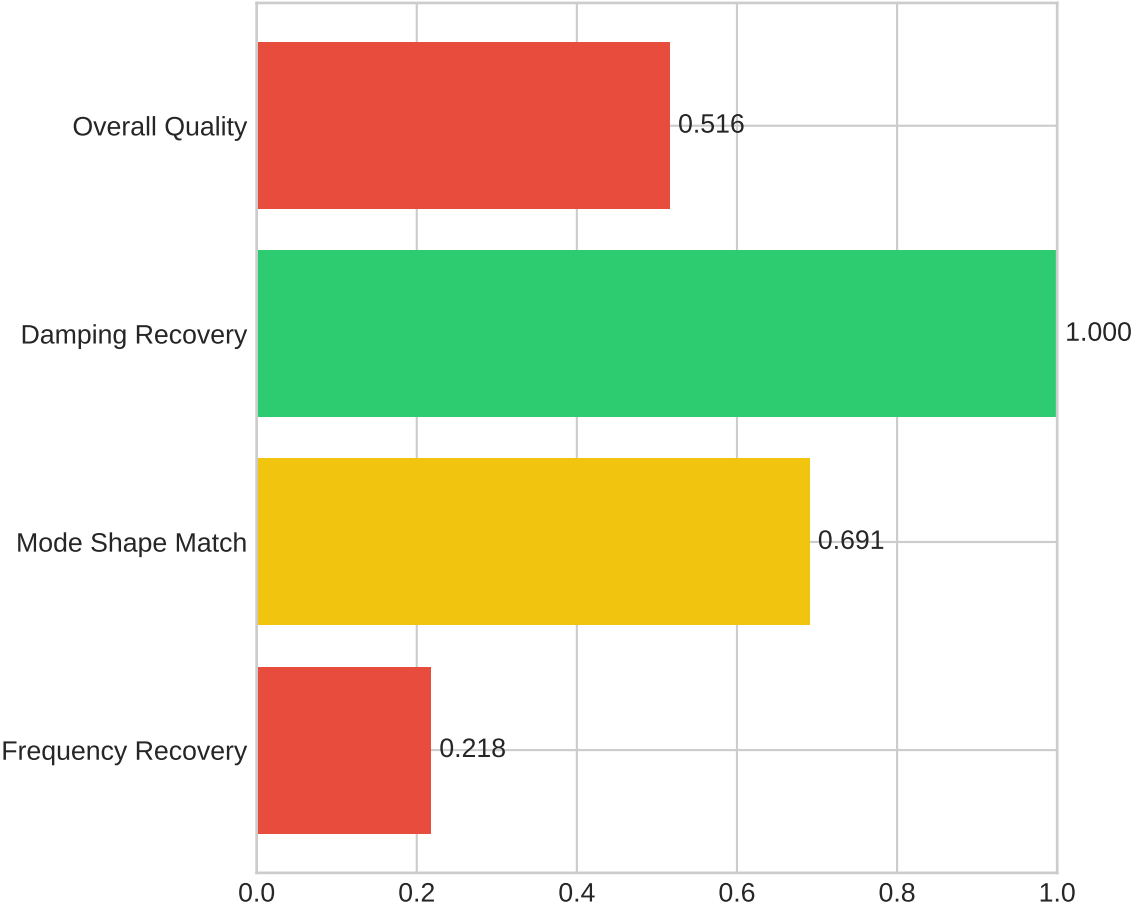
Quality Score Breakdown

0.516

Repair Quality Score

Fair - Partial Improvement
