Structural Repair Quality Analysis Report

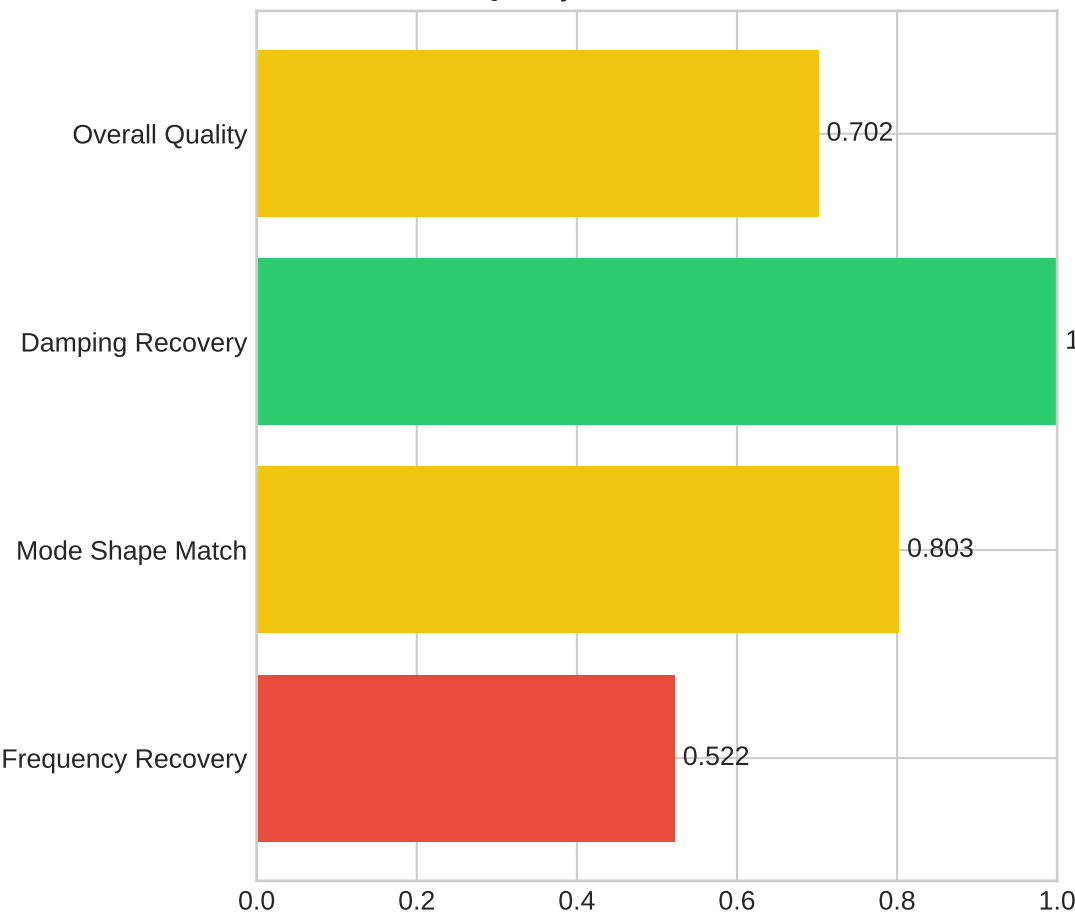
Quality Score Breakdown

0.702

Repair Quality Score

Good - Acceptable Repair
