Structural Repair Quality Analysis Report

Overall Assessment

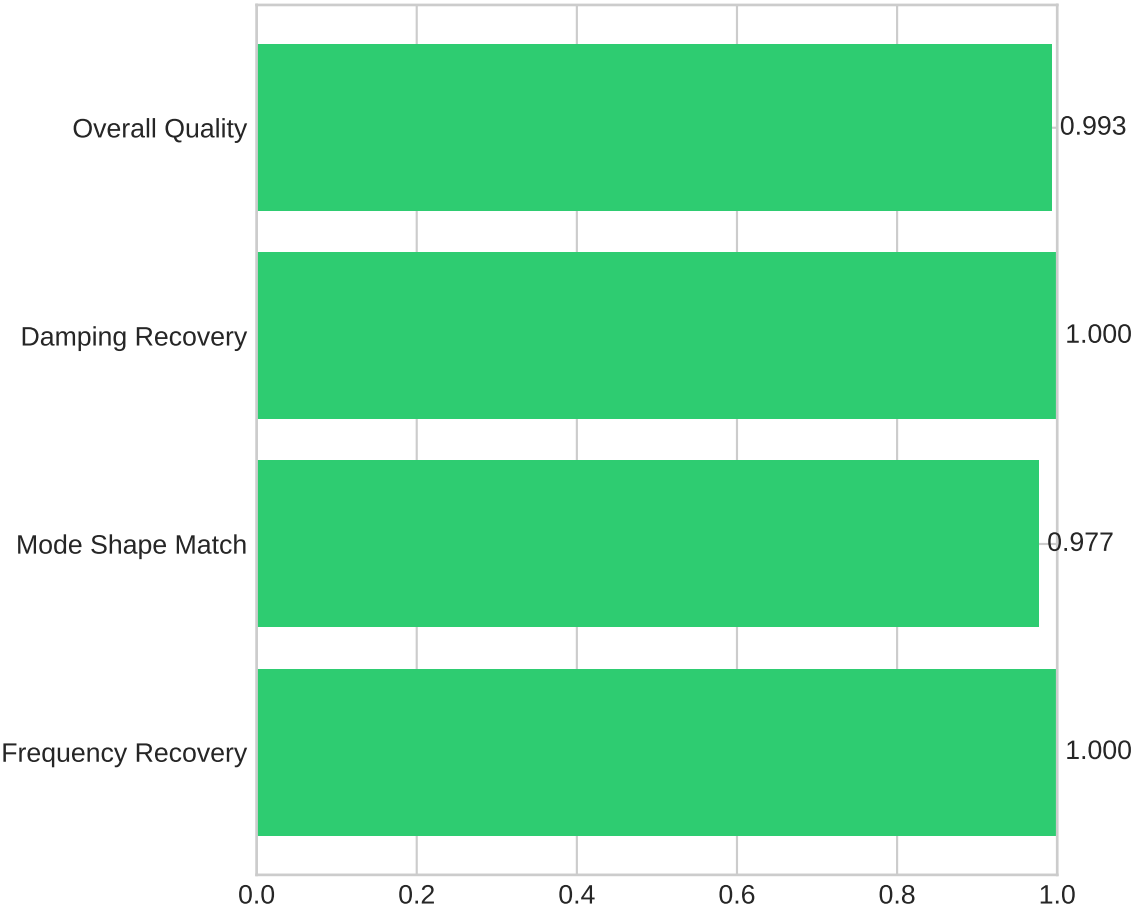
Quality Score Breakdown

0.993
Repair Quality Score
Excellent - Nearly Perfect Repair
2026-01-17 20:33:42
