Structural Repair Quality Analysis Report

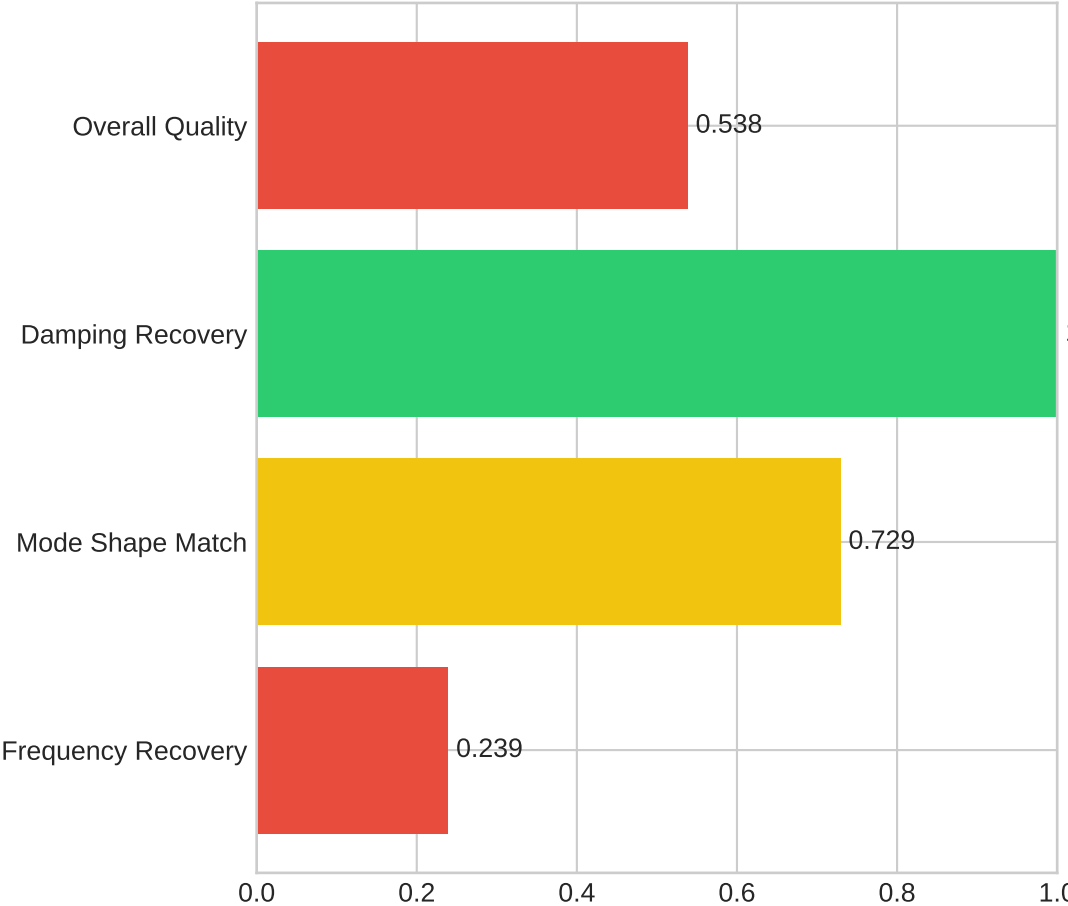
Quality Score Breakdown

0.538

Repair Quality Score

Fair - Partial Improvement
