# Structural Repair Quality Analysis Report

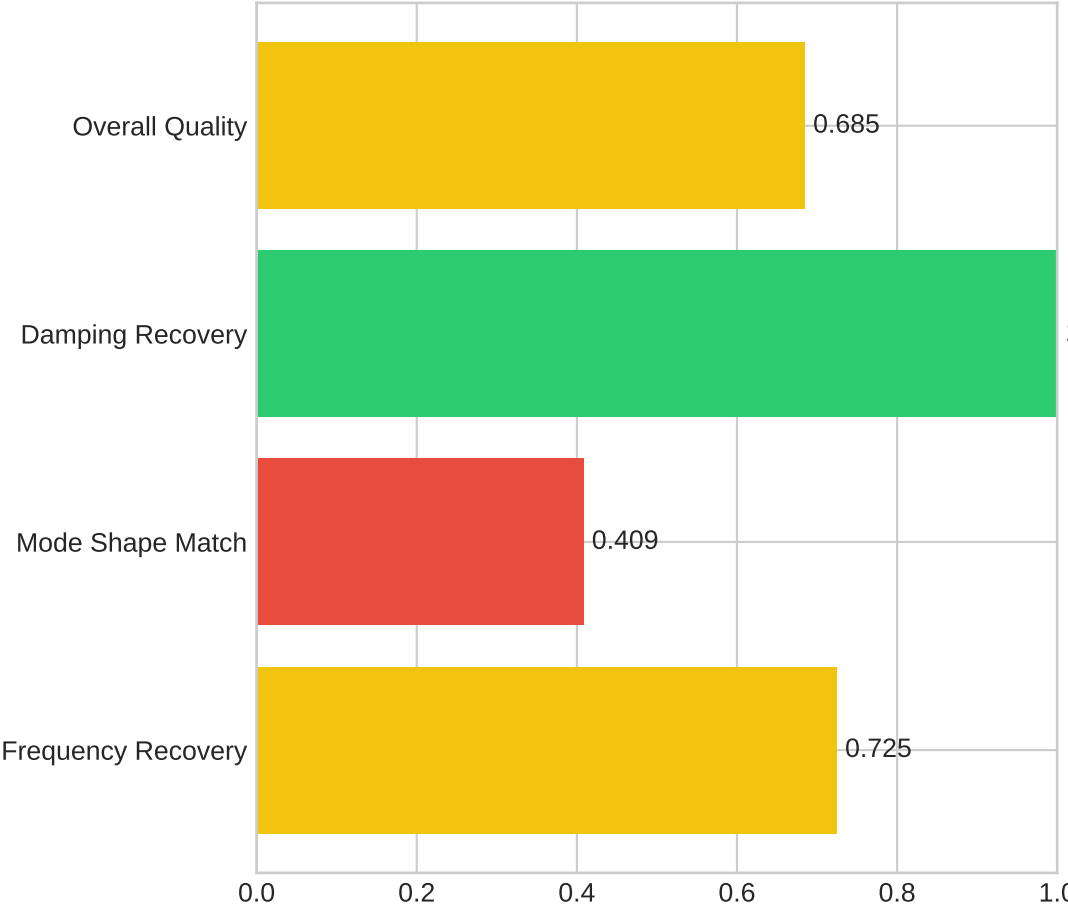
Quality Score Breakdown

0.685

Repair Quality Score

Fair - Partial Improvement
