Structural Repair Quality Analysis Report

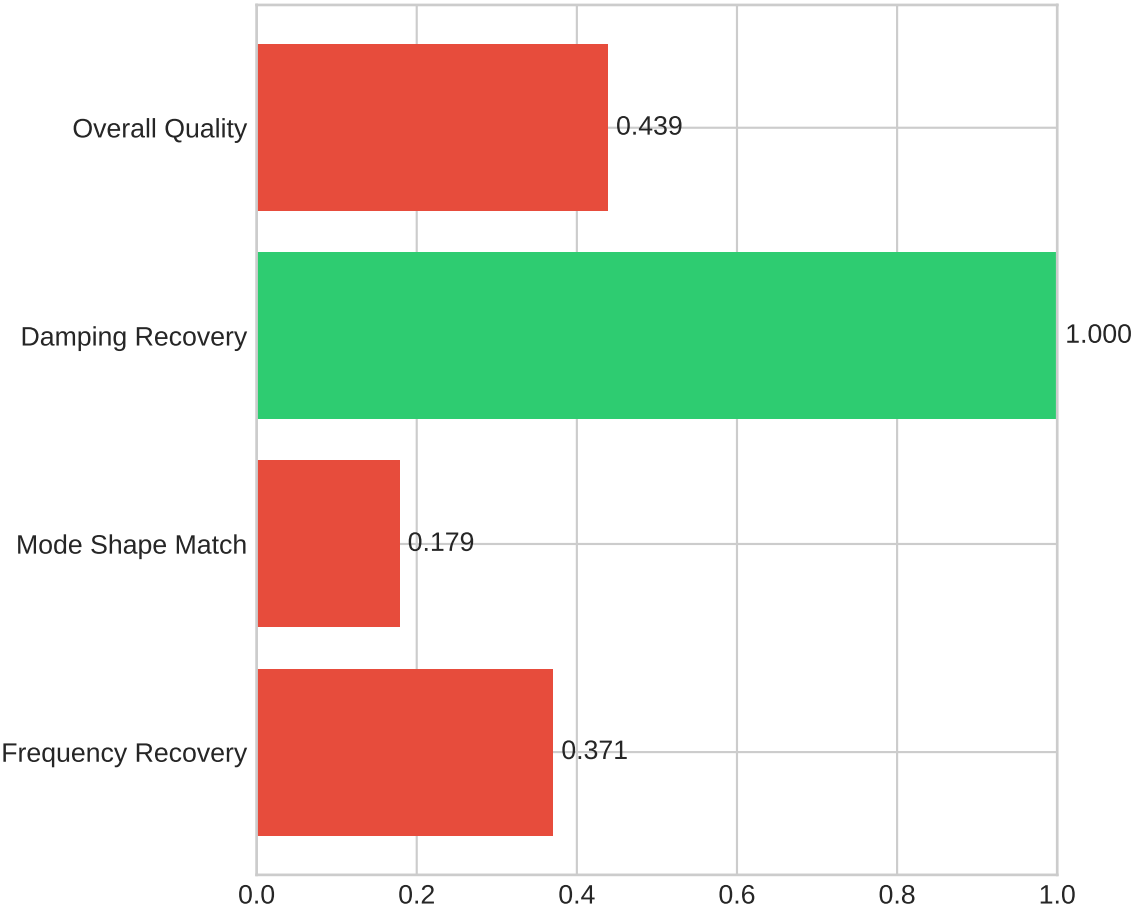
Quality Score Breakdown

0.439

Repair Quality Score

Poor - Minimal Improvement
