Structural Repair Quality Analysis Report

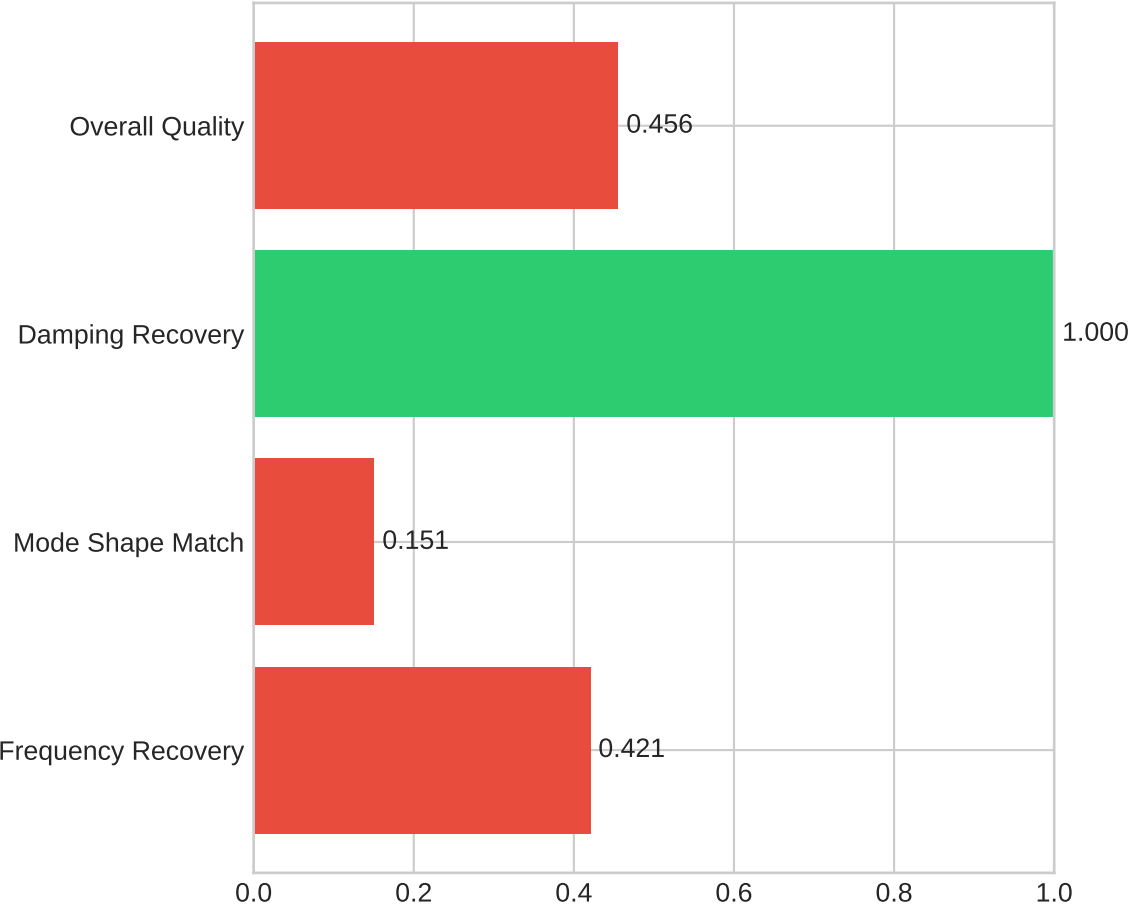
Quality Score Breakdown

0.456

Repair Quality Score

Poor - Minimal Improvement
