Structural Repair Quality Analysis Report

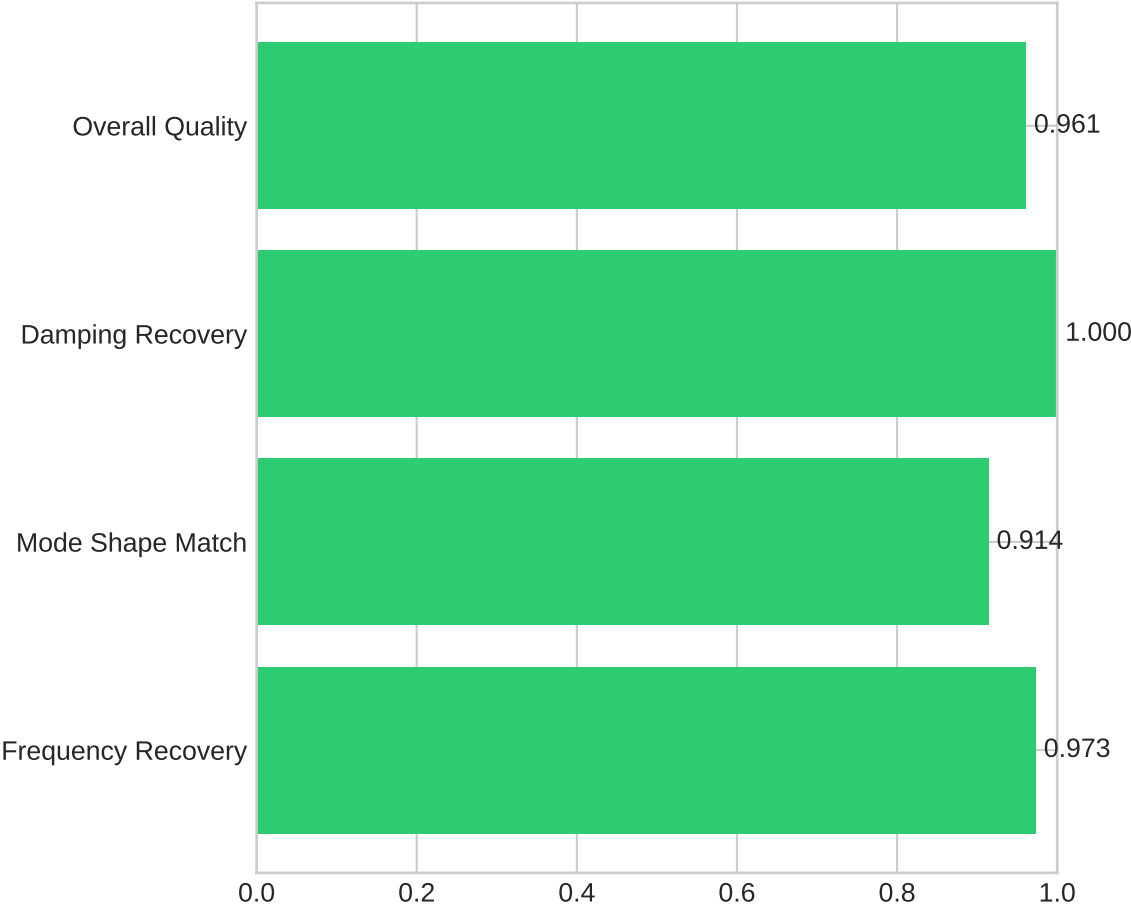
Quality Score Breakdown

0.961

Repair Quality Score

Excellent - Nearly Perfect Repair
