Structural Repair Quality Analysis Report

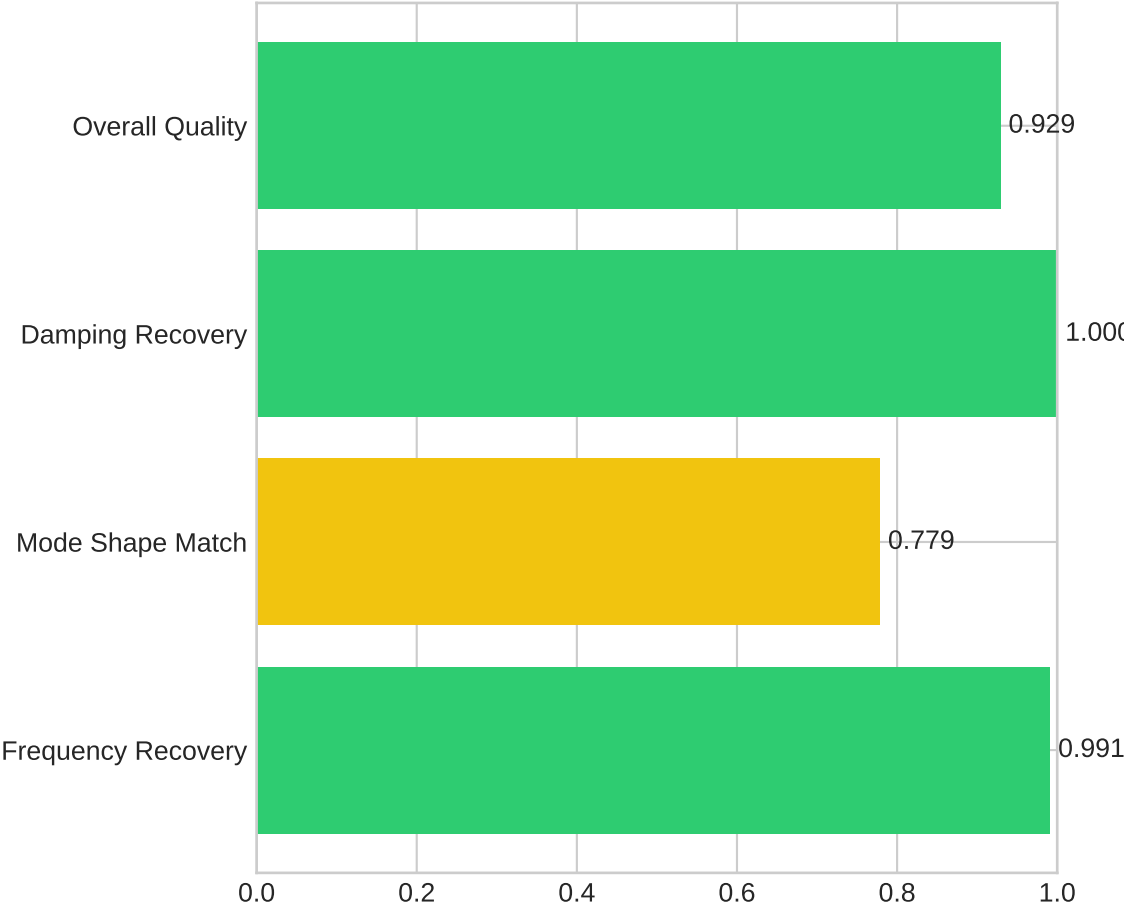
Quality Score Breakdown

0.929
Repair Quality Score
Very Good - Highly Effective Repair
2026-01-17 20:33:01
