Structural Repair Quality Analysis Report

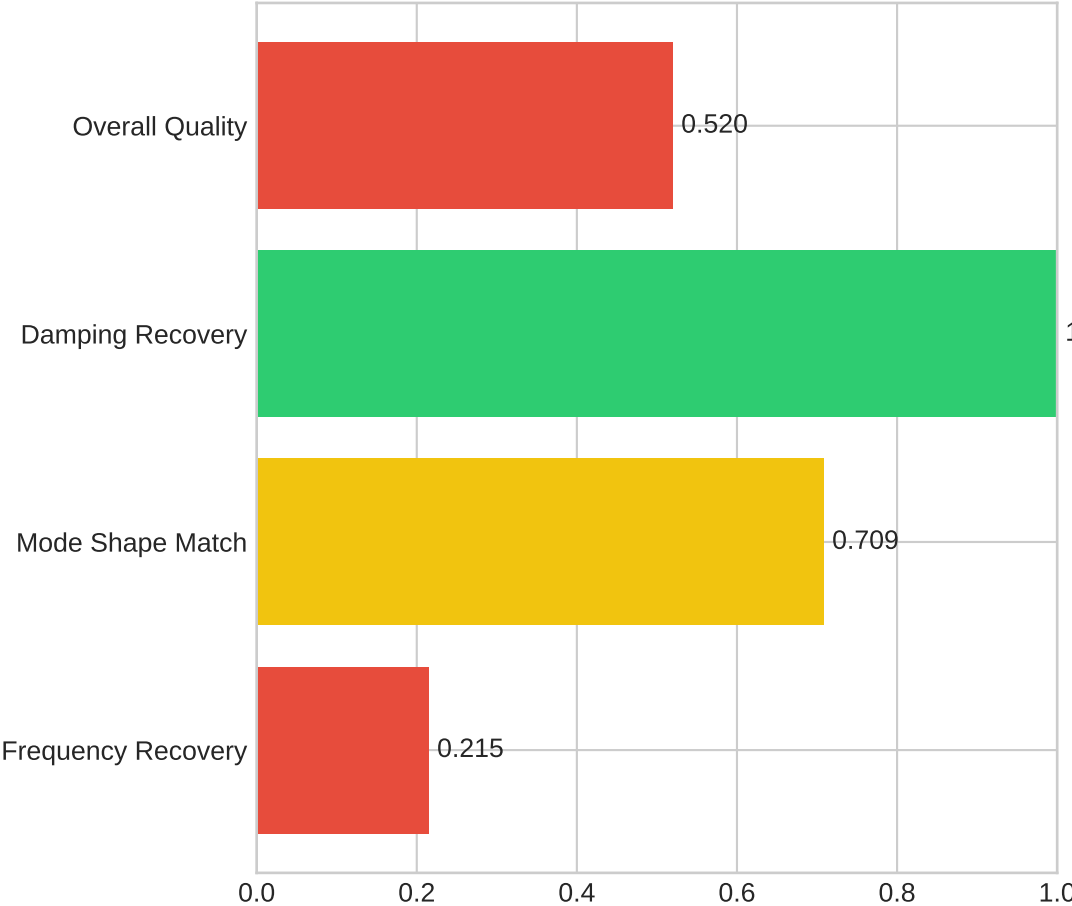
Quality Score Breakdown

0.520

Repair Quality Score

Fair - Partial Improvement
