Structural Repair Quality Analysis Report

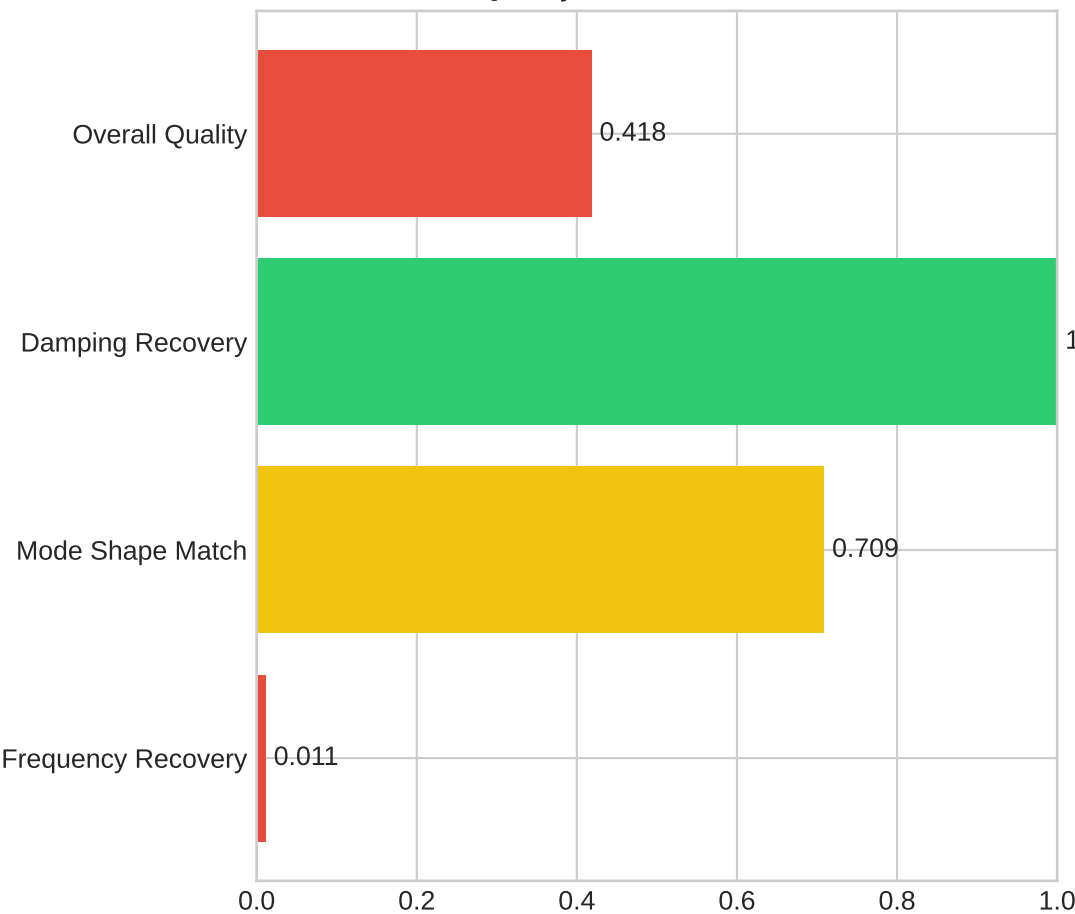
Quality Score Breakdown

0.418

Repair Quality Score

Poor - Minimal Improvement
