Structural Repair Quality Analysis Report

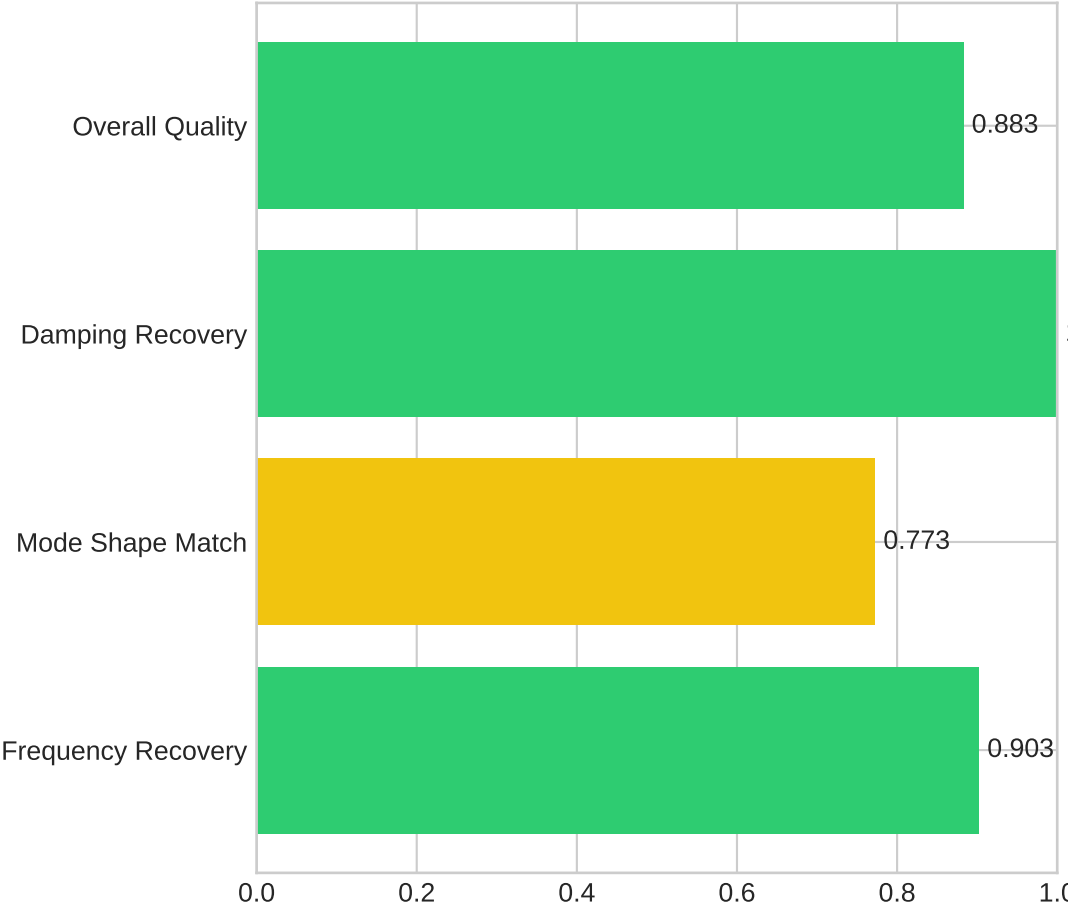
Quality Score Breakdown

0.883
Repair Quality Score
Very Good - Highly Effective Repair
2026-01-17 19:02:01
