Structural Repair Quality Analysis Report

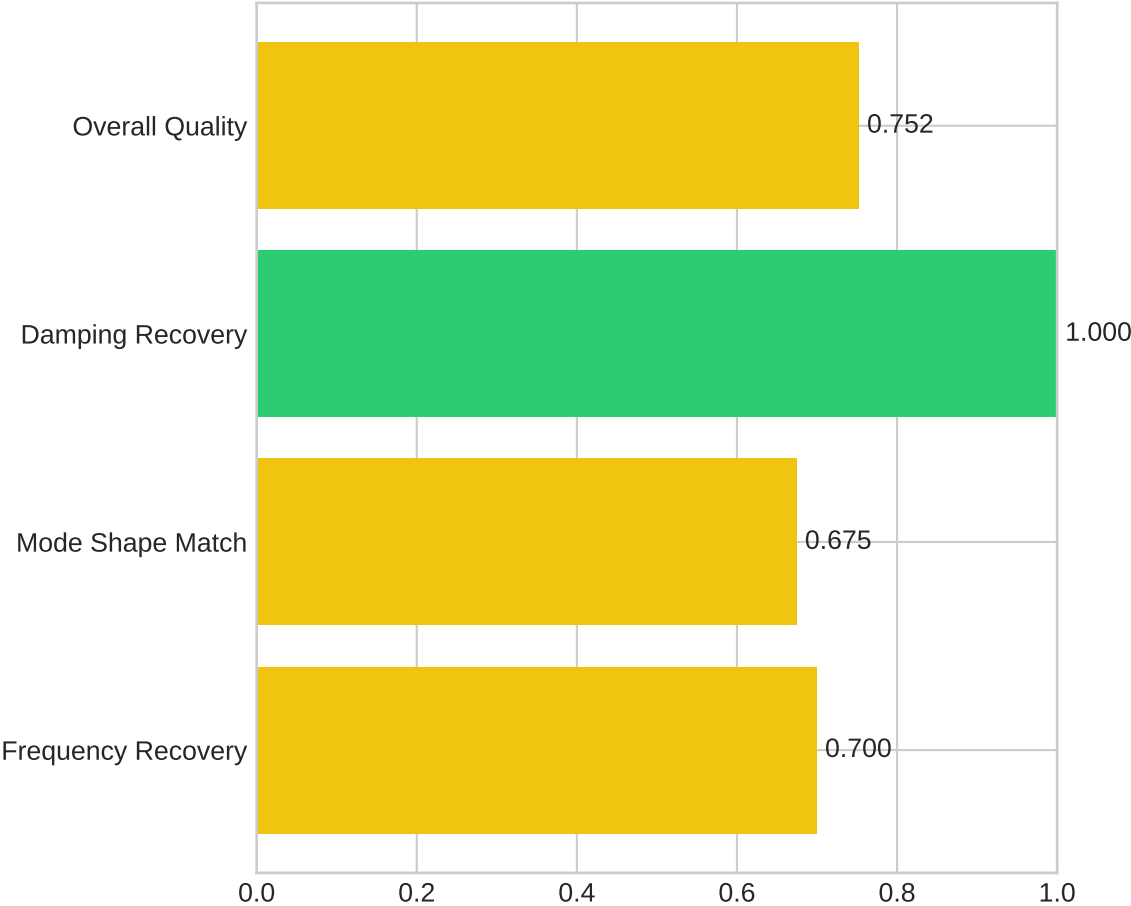
Quality Score Breakdown

0.752
Repair Quality Score
Good - Acceptable Repair
2026-01-15 20:46:13
