# Structural Repair Quality Analysis Report

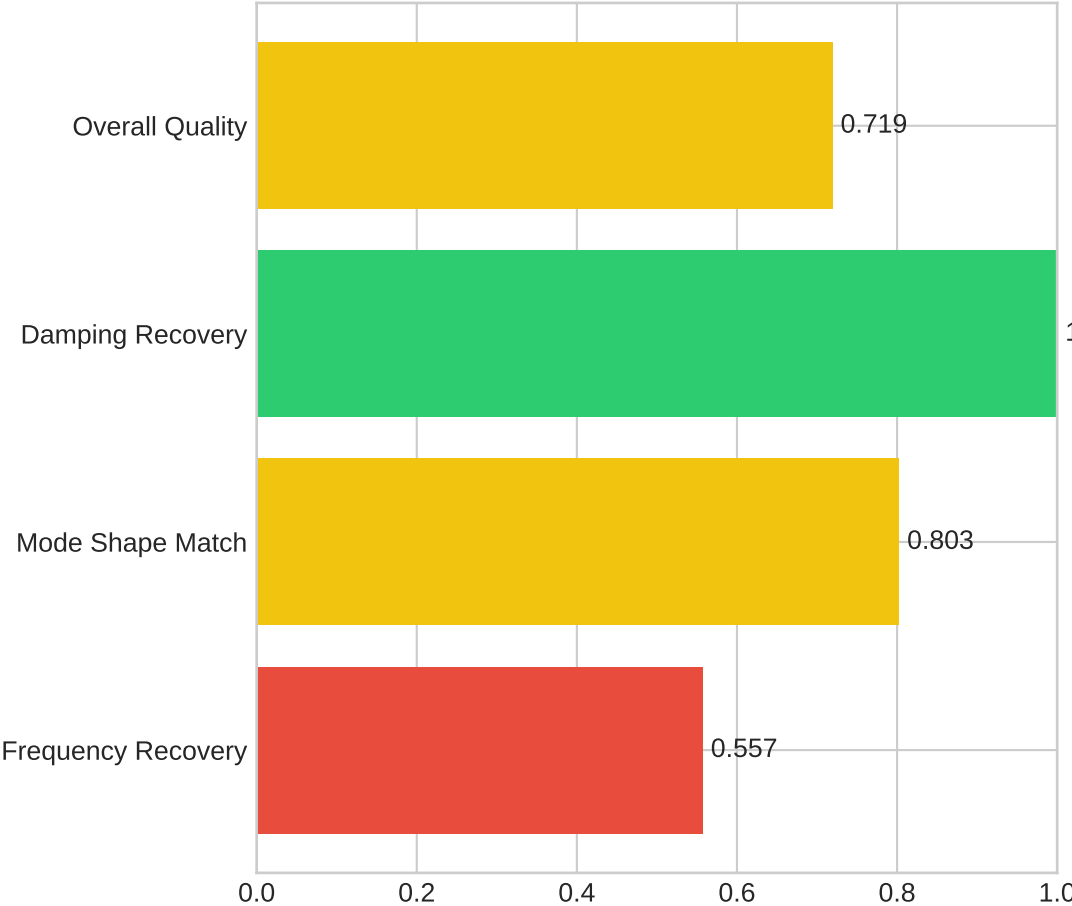
Quality Score Breakdown

**0.719**  
Repair Quality Score  
**Good - Acceptable Repair**  
2026-01-28 12:58:13
