Structural Repair Quality Analysis Report

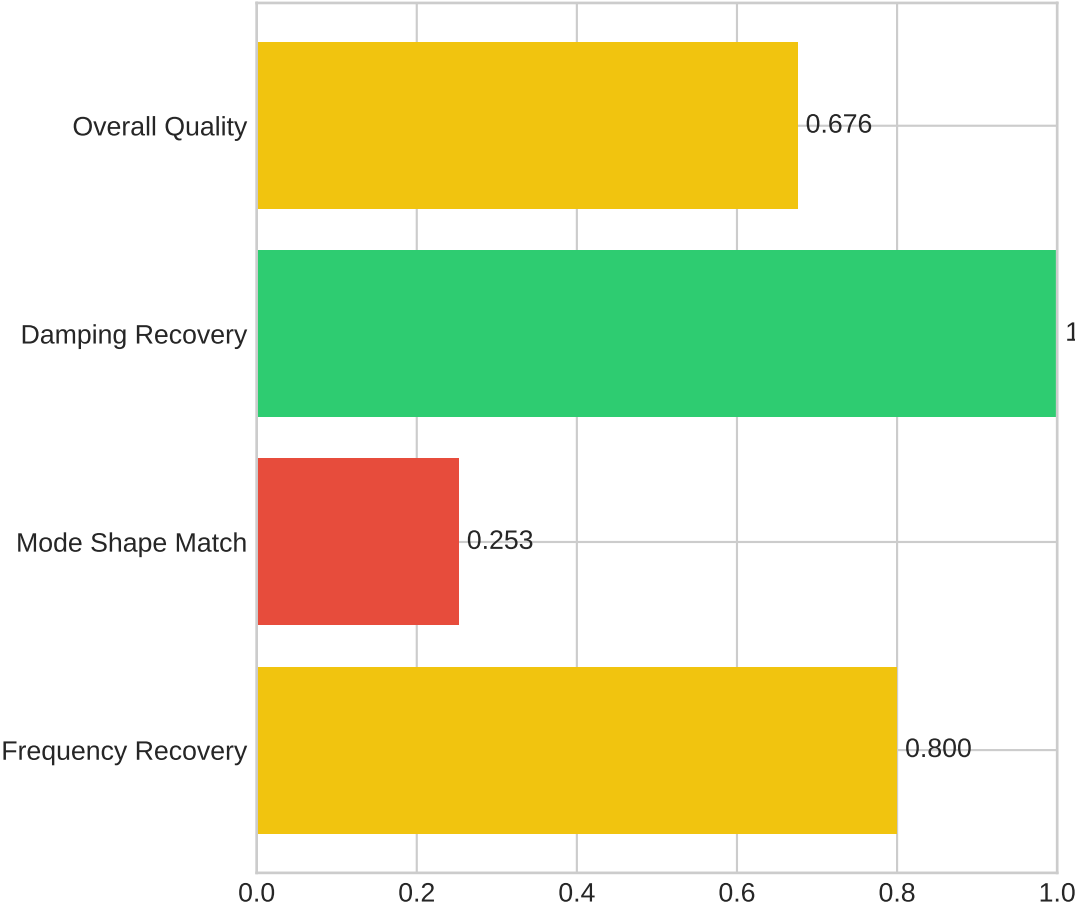
Quality Score Breakdown

0.676

Repair Quality Score

Fair - Partial Improvement
