Structural Repair Quality Analysis Report

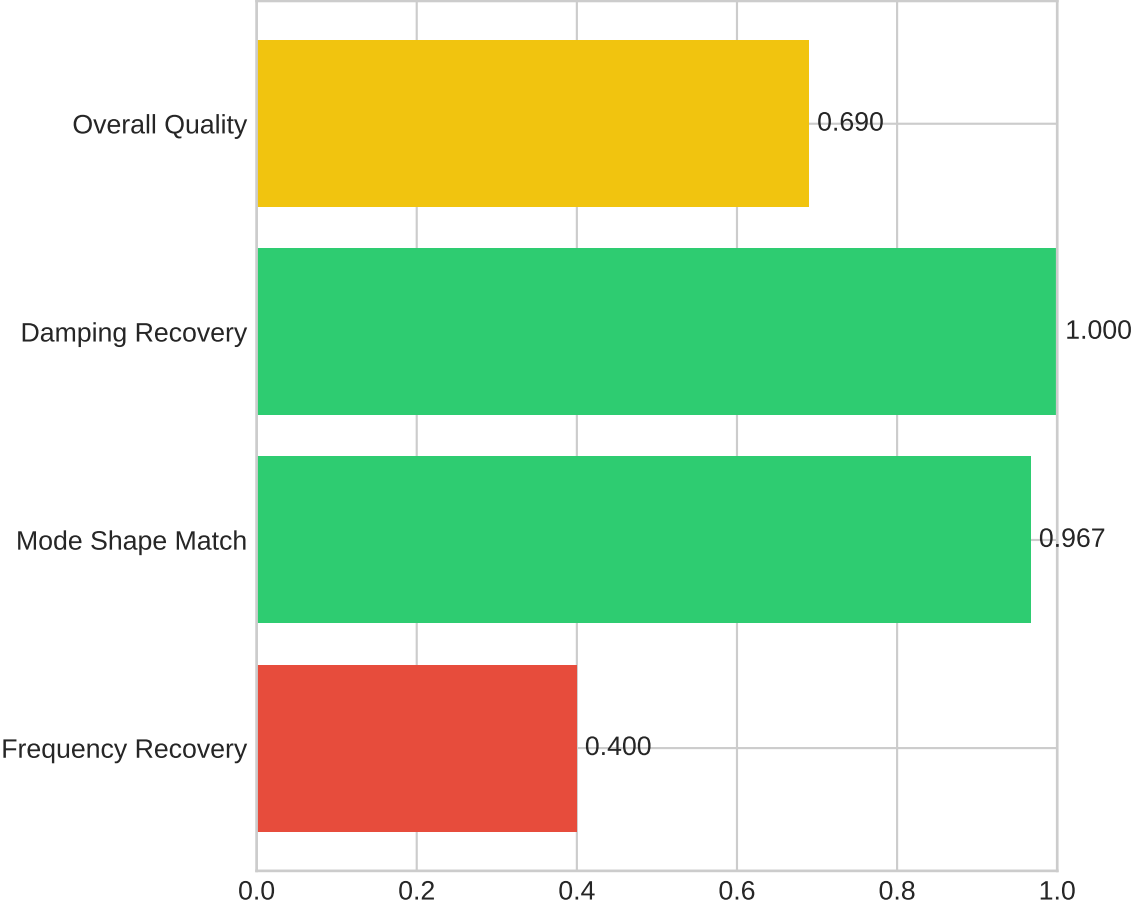
Quality Score Breakdown

0.690

Repair Quality Score

Fair - Partial Improvement
