Structural Repair Quality Analysis Report

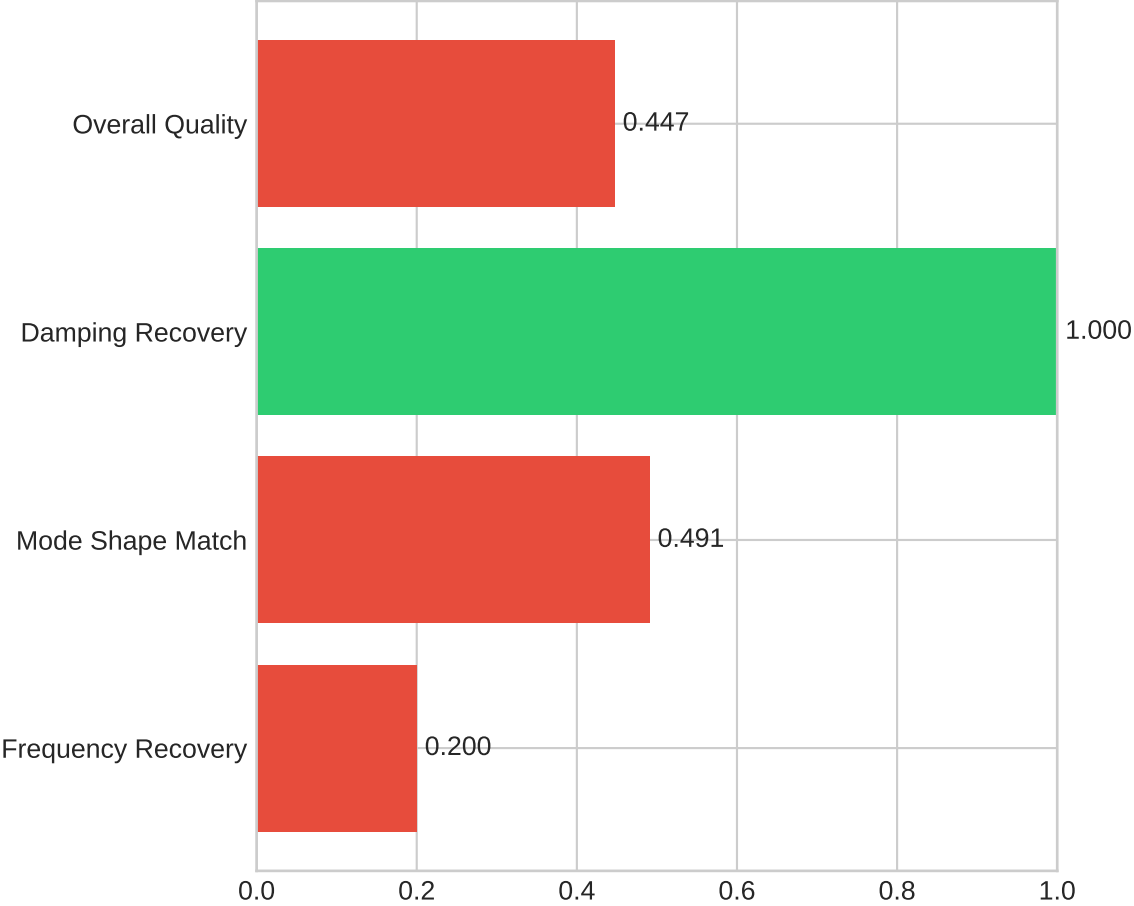
Quality Score Breakdown

0.447

Repair Quality Score

Poor - Minimal Improvement
