Structural Repair Quality Analysis Report

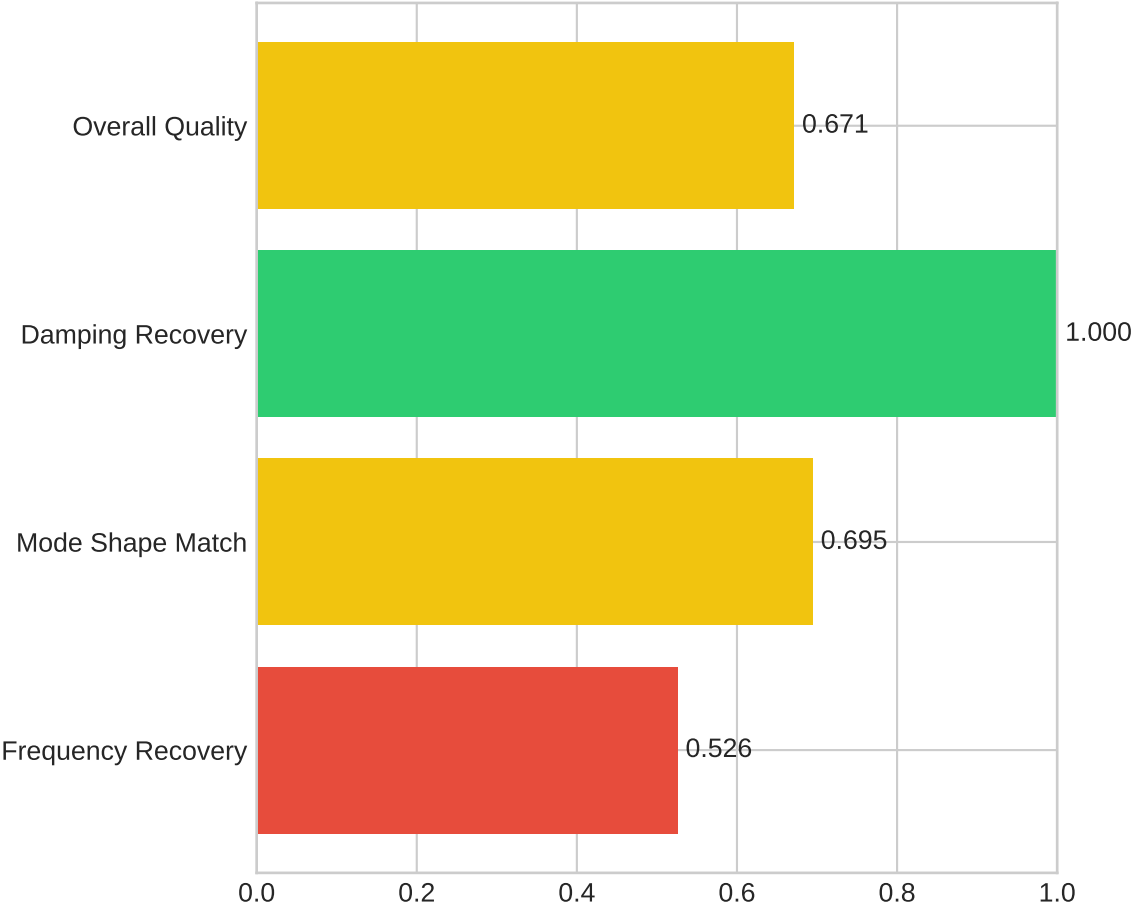
Quality Score Breakdown

0.671

Repair Quality Score

Fair - Partial Improvement
