Structural Repair Quality Analysis Report

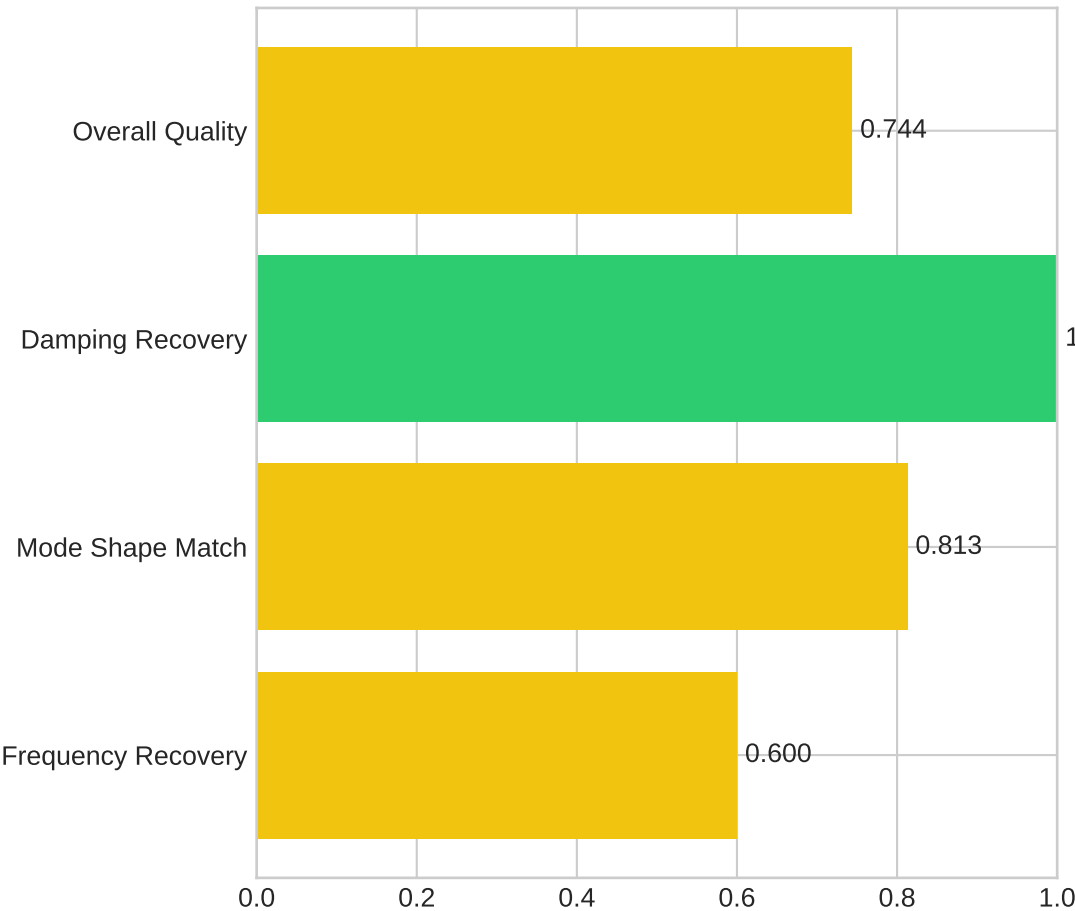
Quality Score Breakdown

0.744

Repair Quality Score

Good - Acceptable Repair
