Structural Repair Quality Analysis Report

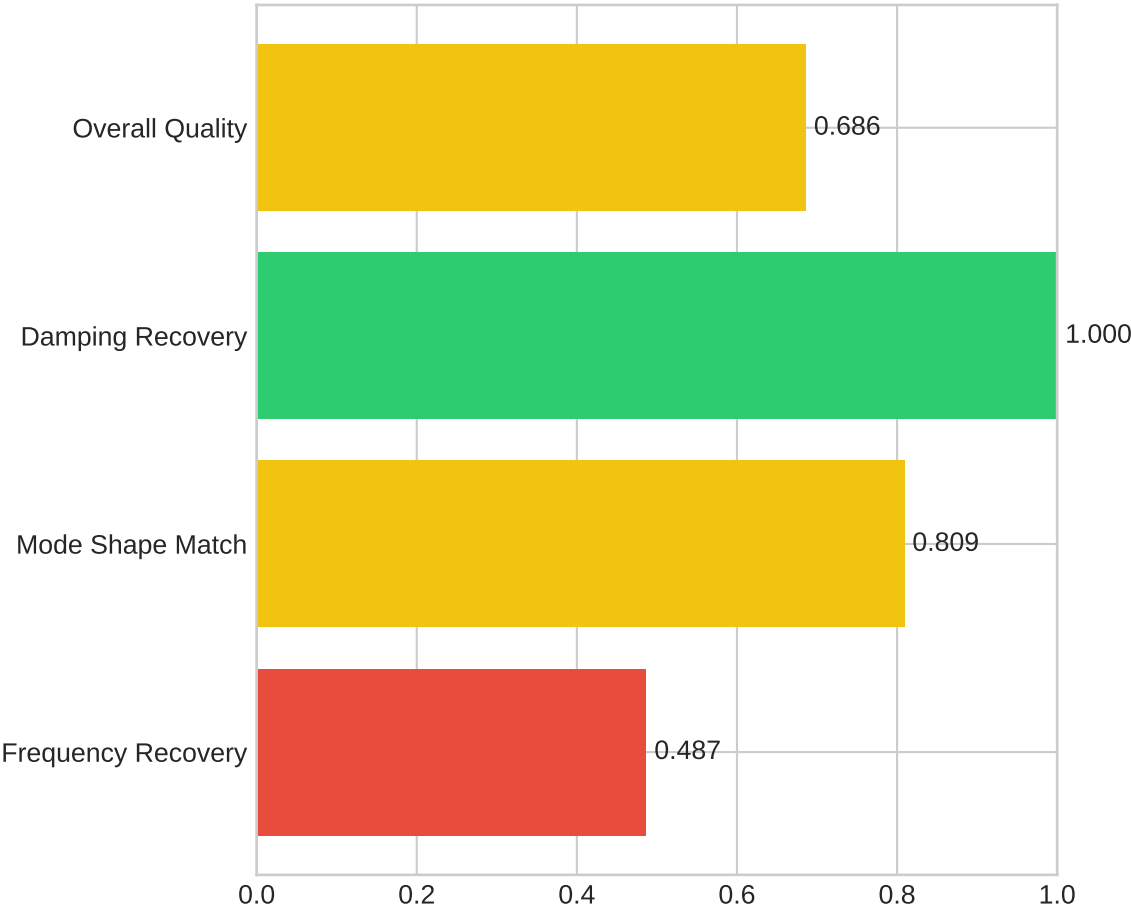
Quality Score Breakdown

0.686

Repair Quality Score

Fair - Partial Improvement
