Structural Repair Quality Analysis Report

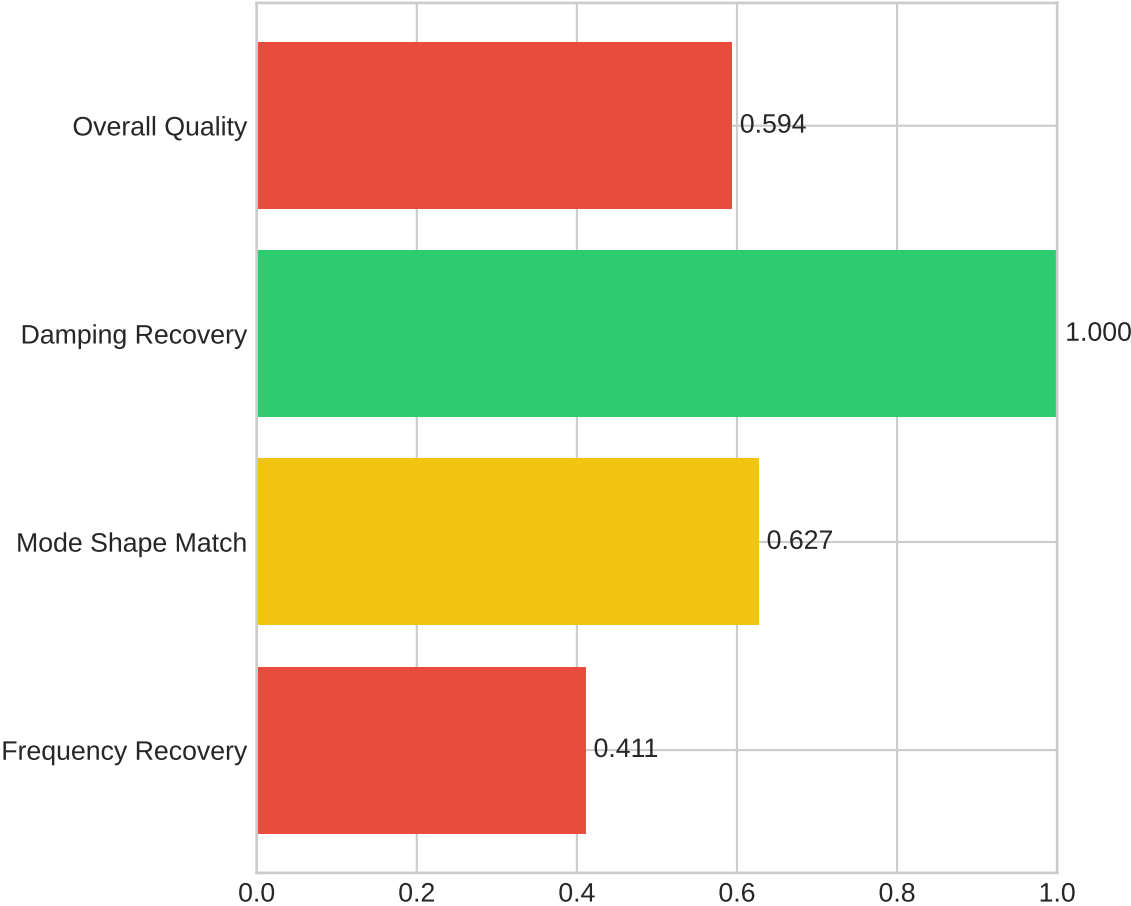
Quality Score Breakdown

0.594

Repair Quality Score

Fair - Partial Improvement
