Structural Repair Quality Analysis Report

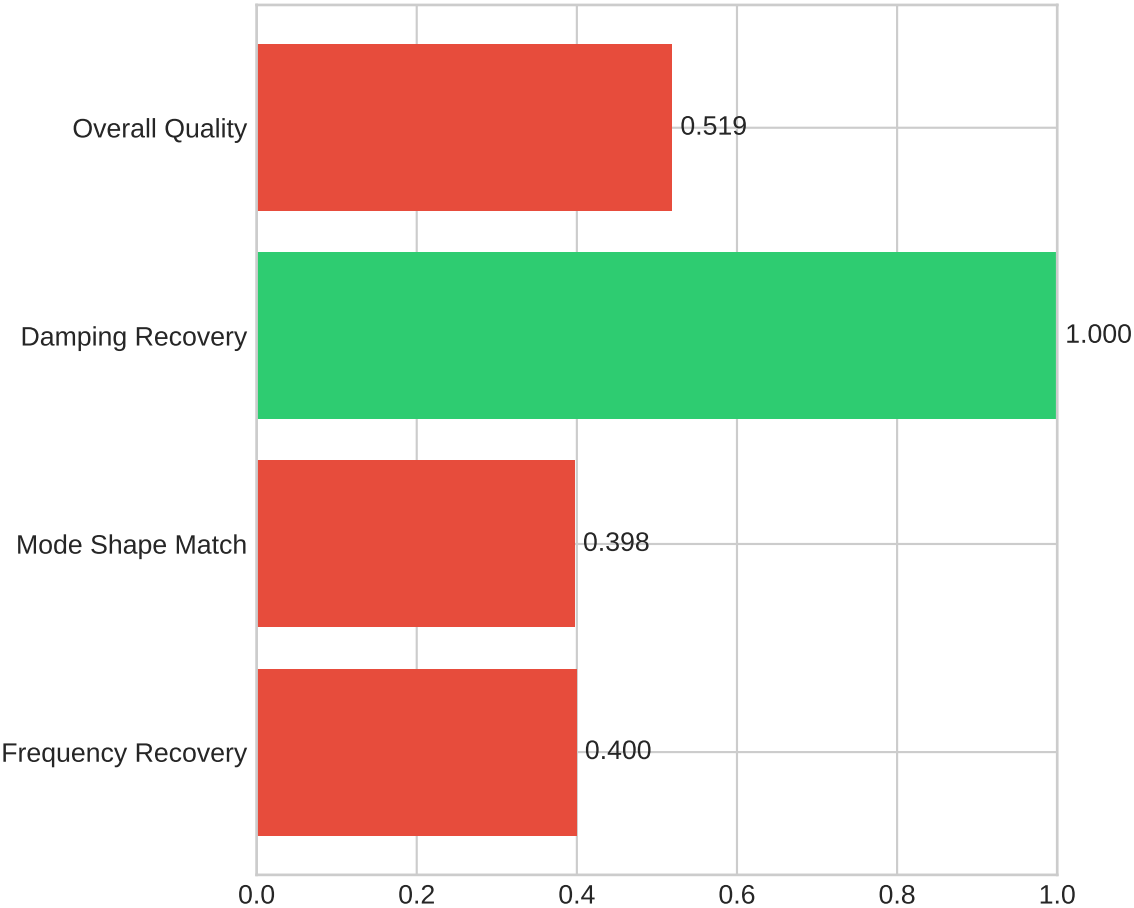
Quality Score Breakdown

0.519

Repair Quality Score

Fair - Partial Improvement
