Structural Repair Quality Analysis Report

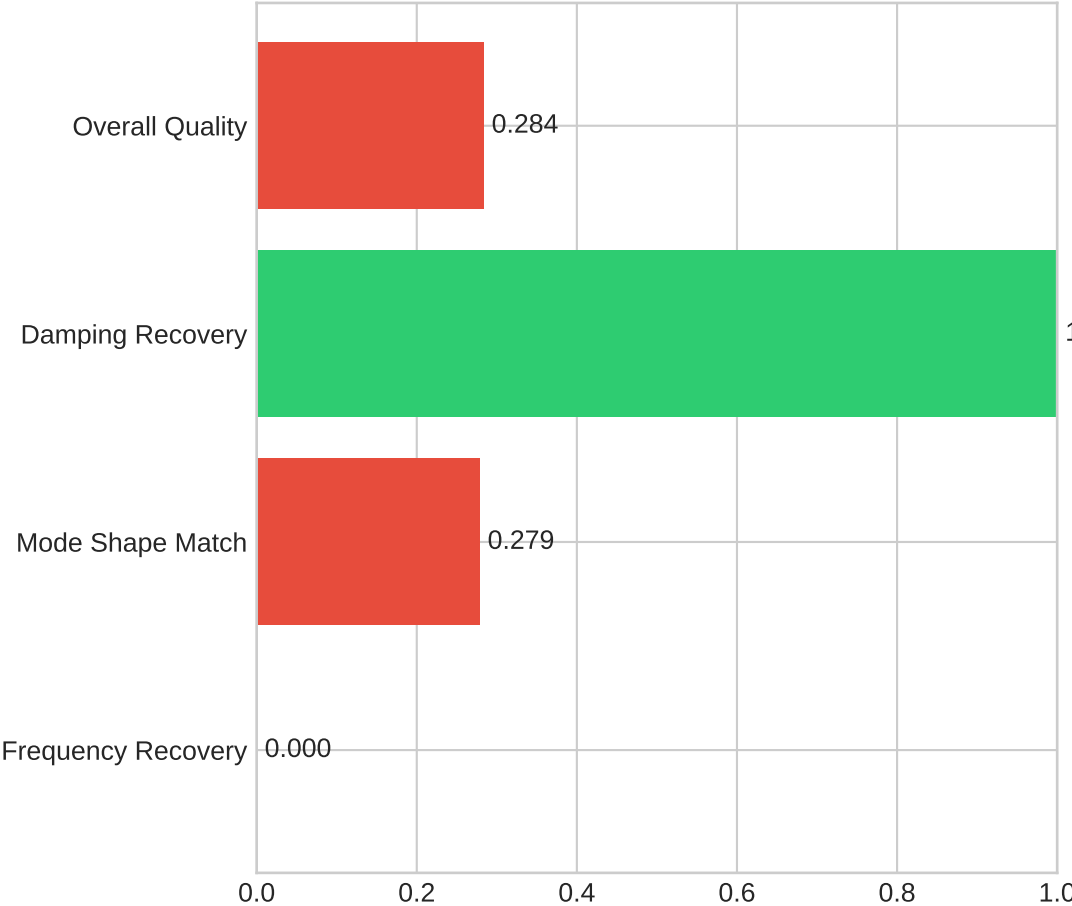
Quality Score Breakdown

0.284

Repair Quality Score

Poor - Minimal Improvement
