Structural Repair Quality Analysis Report

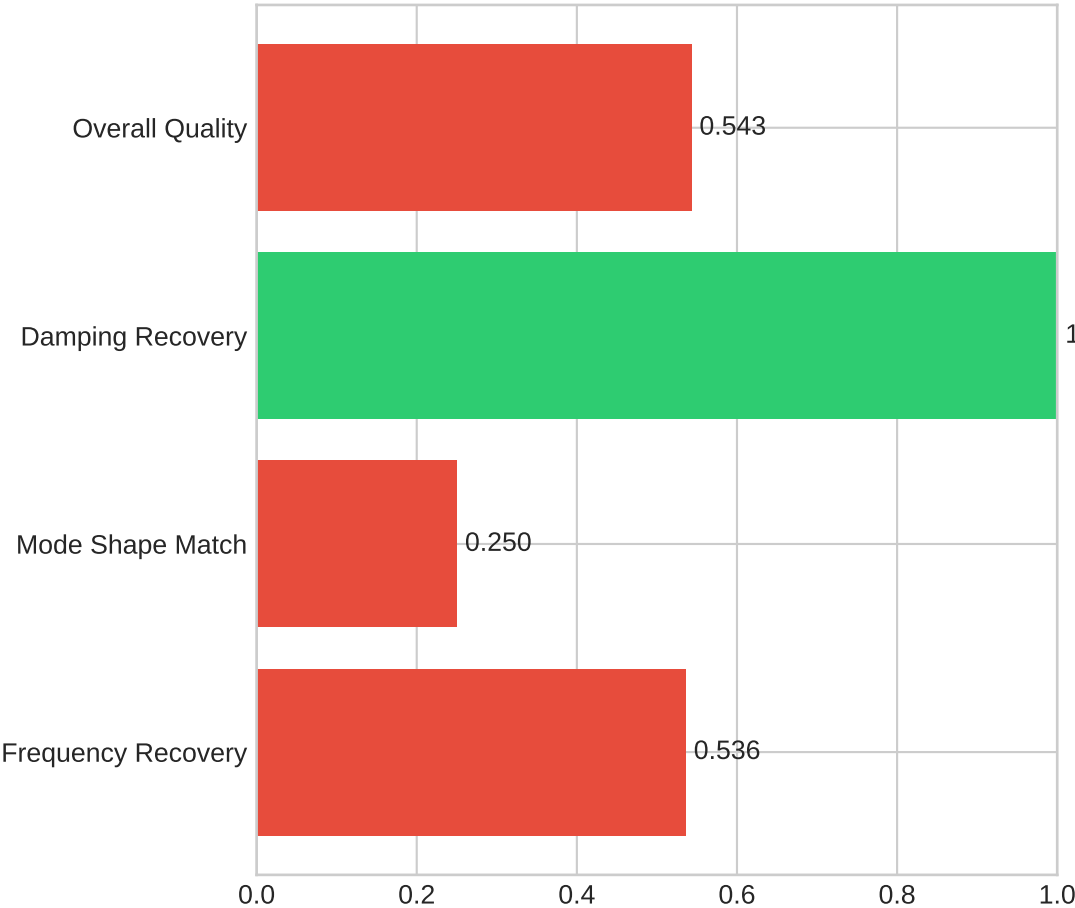
Quality Score Breakdown

0.543

Repair Quality Score

Fair - Partial Improvement
