Structural Repair Quality Analysis Report

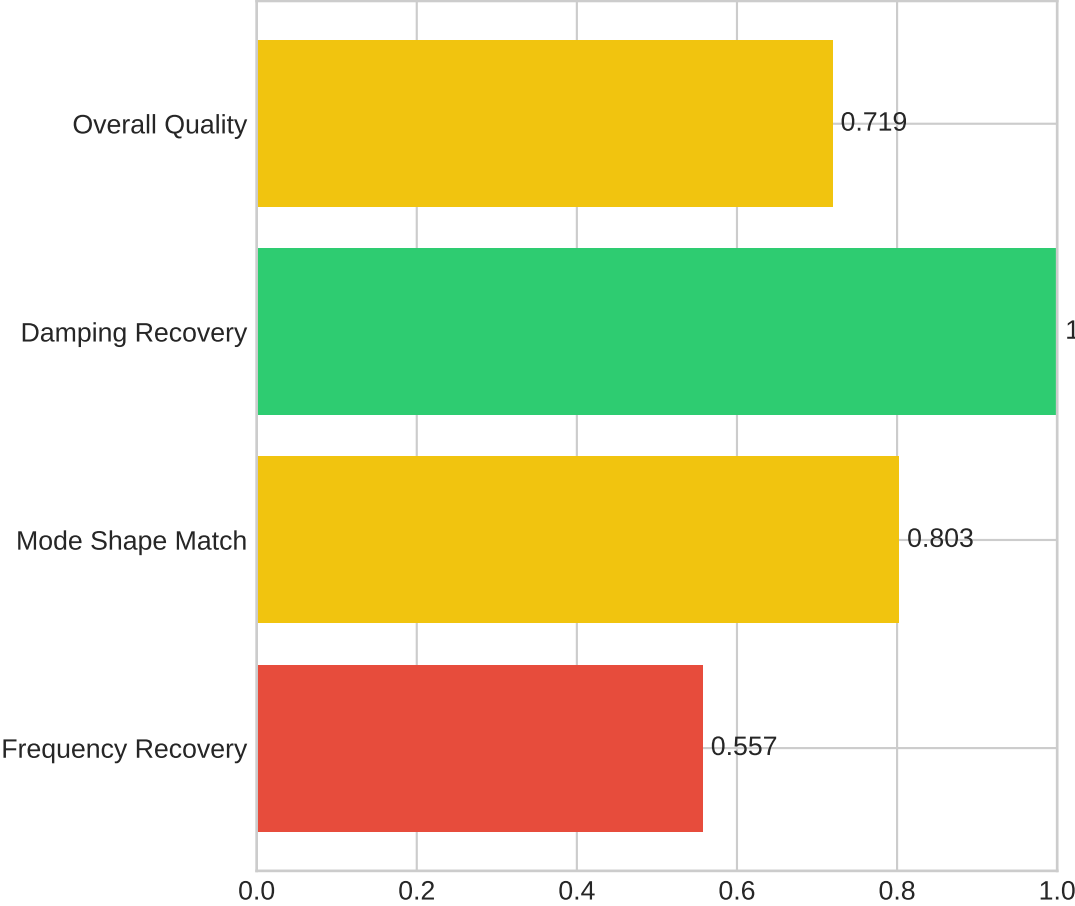
Quality Score Breakdown

0.719

Repair Quality Score

Good - Acceptable Repair
