Structural Repair Quality Analysis Report

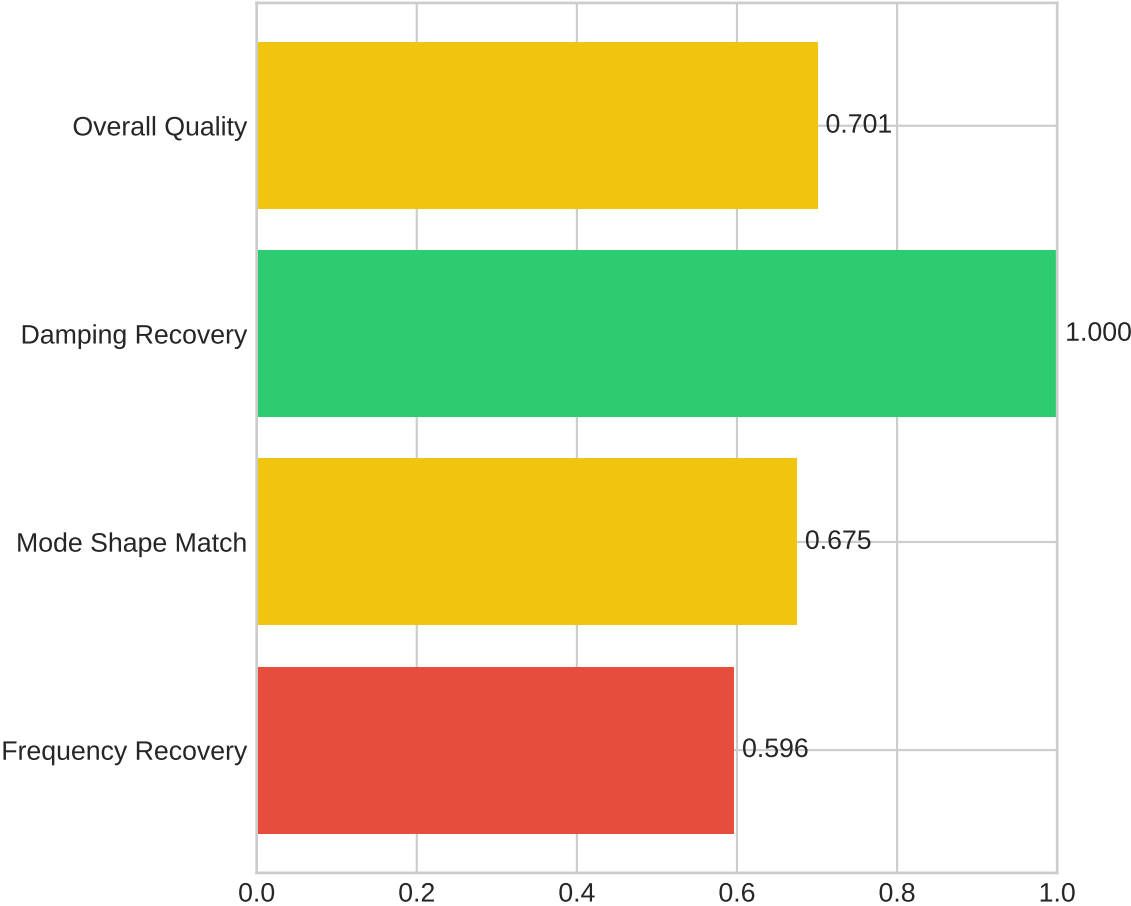
Quality Score Breakdown

0.701
Repair Quality Score
Good - Acceptable Repair
2026-01-15 21:25:44
