Structural Repair Quality Analysis Report

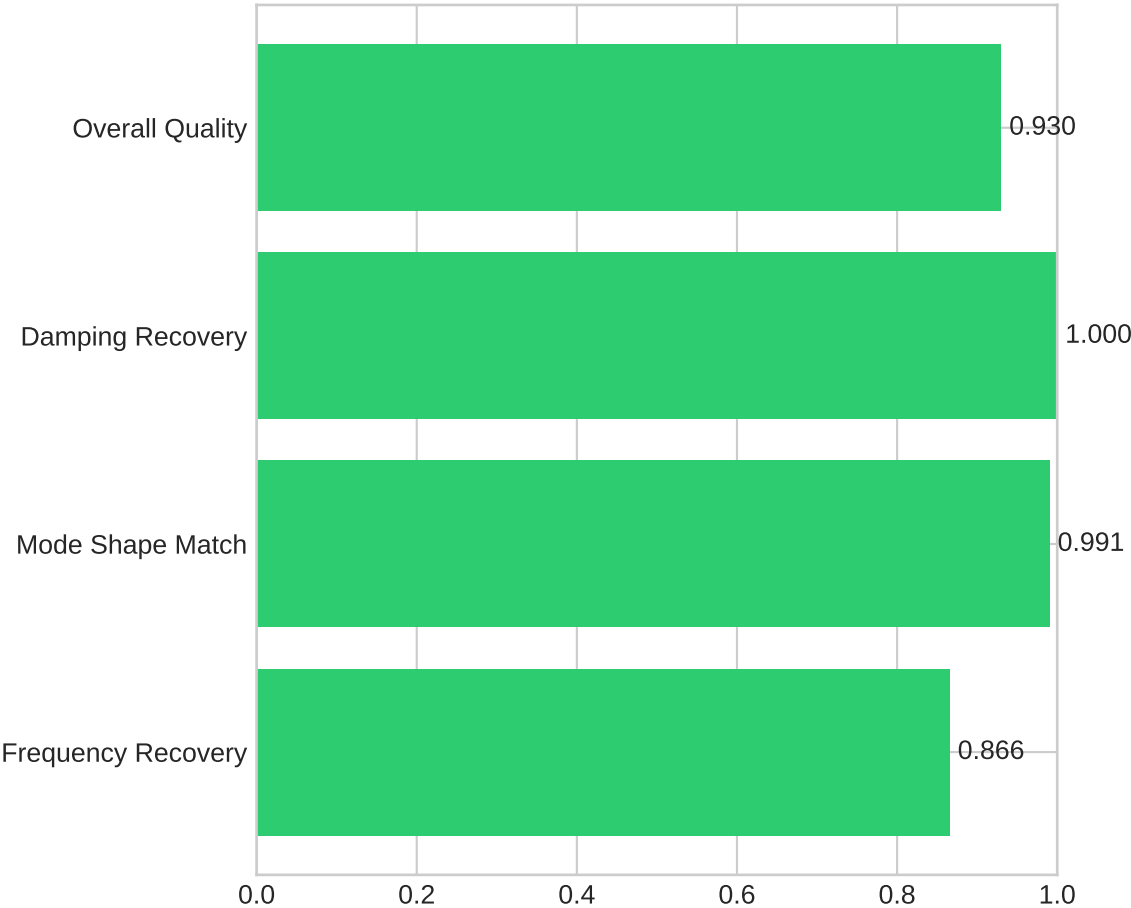
Quality Score Breakdown

0.930
Repair Quality Score
Very Good - Highly Effective Repair
2026-01-17 20:08:46
