Structural Repair Quality Analysis Report

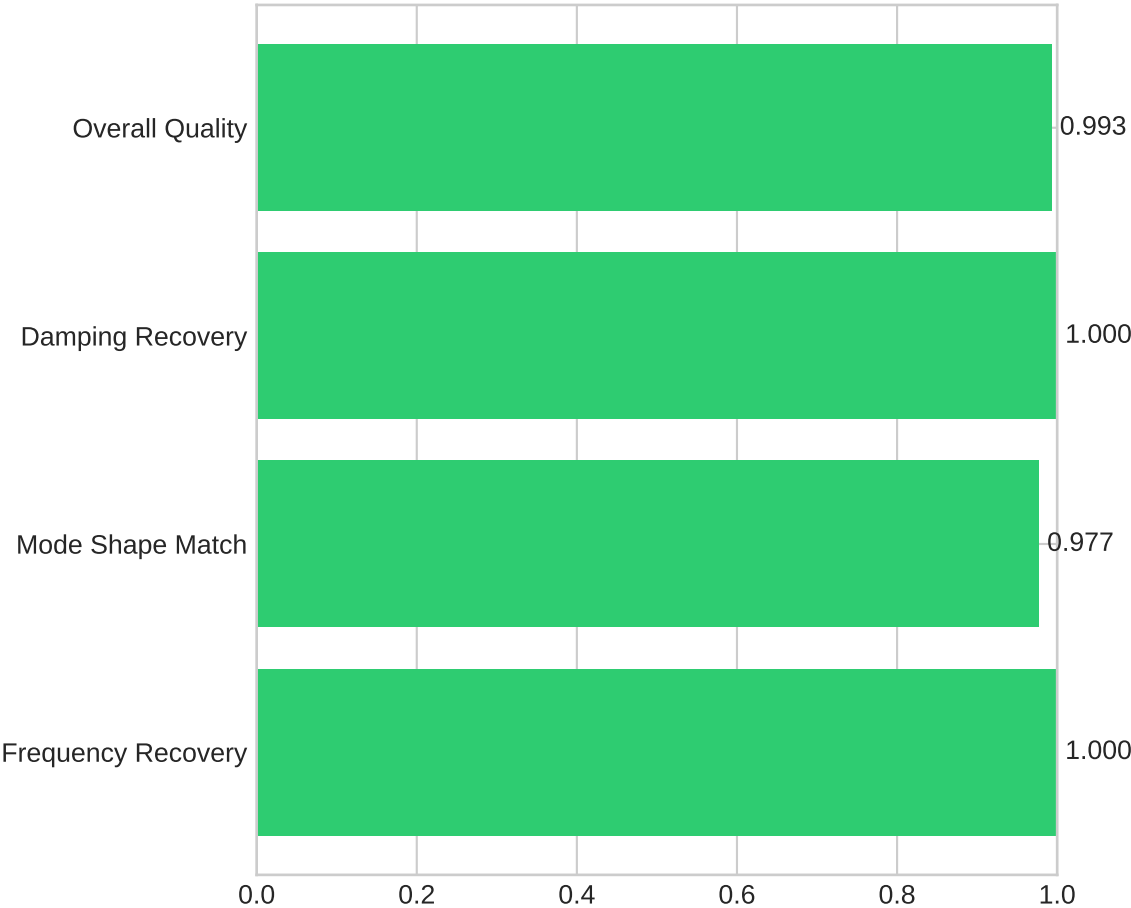
Quality Score Breakdown

0.993
Repair Quality Score
Excellent - Nearly Perfect Repair
2026-01-22 08:01:10
