Structural Repair Quality Analysis Report

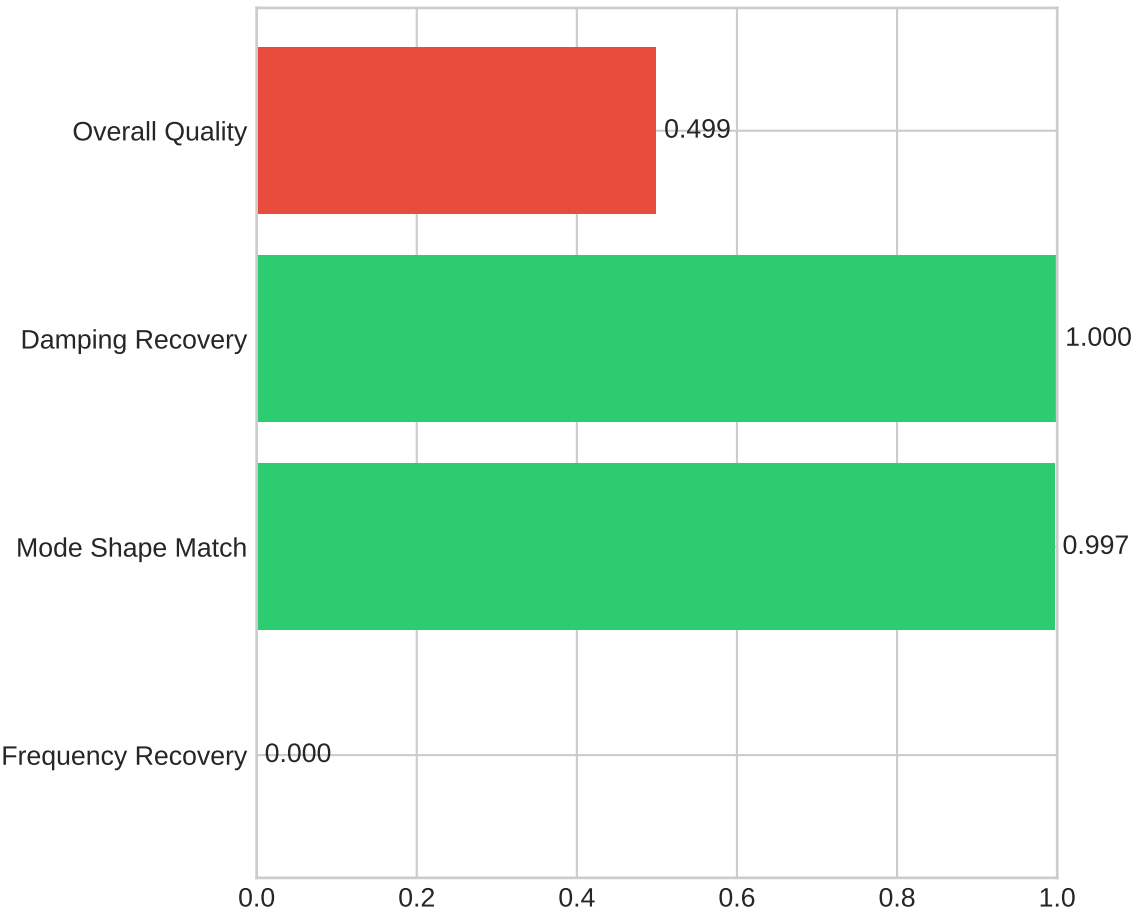
Quality Score Breakdown

0.499
Repair Quality Score
Poor - Minimal Improvement
